Longmorn House,
Longmorn,
Elgin IV30 8SH

Home Report

Single Survey

Property Address	Longmorn House, Longmorn, Elgin IV30 8SH
Reference	1528682
Customer Name	Margaret Bloor
Date of Inspection	14th April 2026
Surveyor's name, qualifications and office	Michael McDonald BLE, MRICS DM Hall LLP Chartered Surveyors 27 High Street Elgin IV30 1EE Tel: 01343 548501 email: elginresidential@dmhall.co.uk
Prepared By	DM Hall LLP

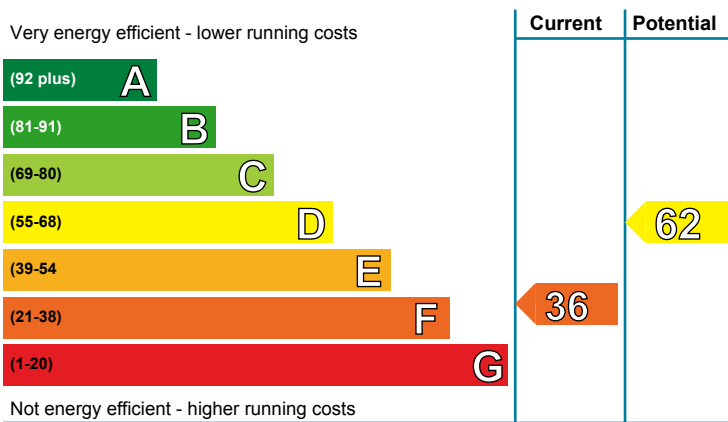
Energy Efficiency Rating

Your current rating is **band F (36)**. The average rating for EPCs in Scotland is **band D (61)**.
