# Home Report

Property address	Roughside Farm New Cumnock Cumnock KA18 4NT
Customer	Eli Banberger
Customer address	Roughside Farm New Cumnock Cumnock KA18 4NT
Prepared by	Shepherd Chartered Surveyors
Date of inspection	27/05/2025

Roofing report and  
associated estimated  
costings to bring roofs into a  
good state of repair.

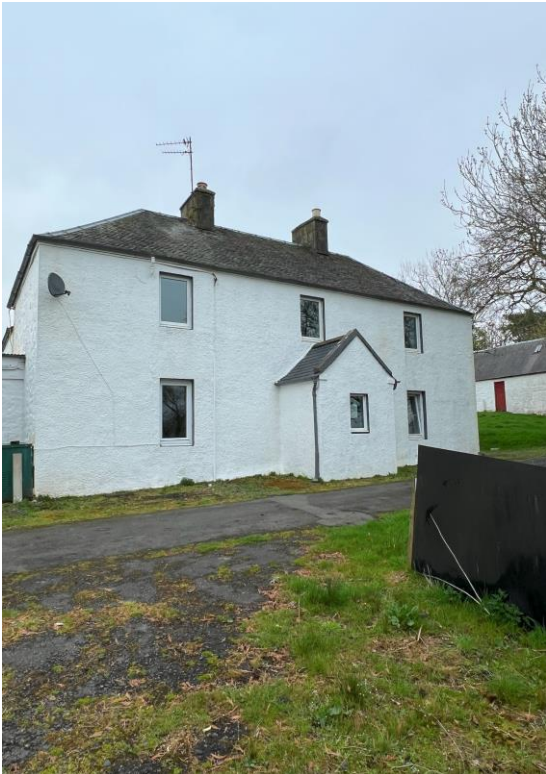
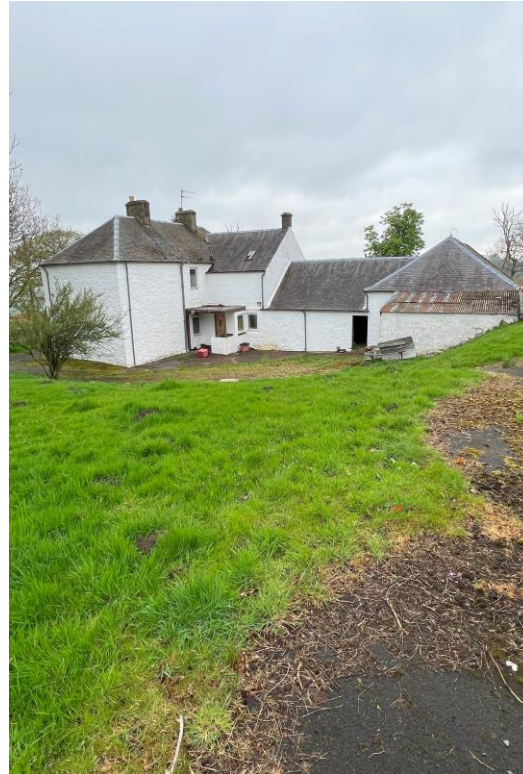
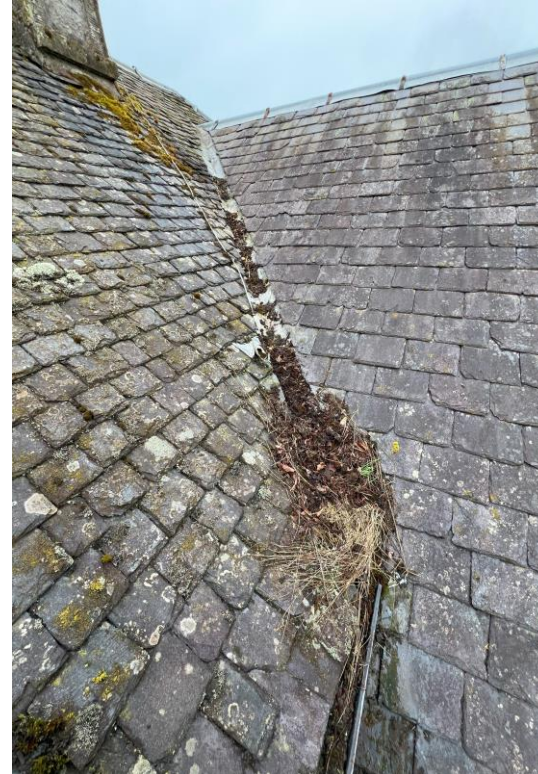
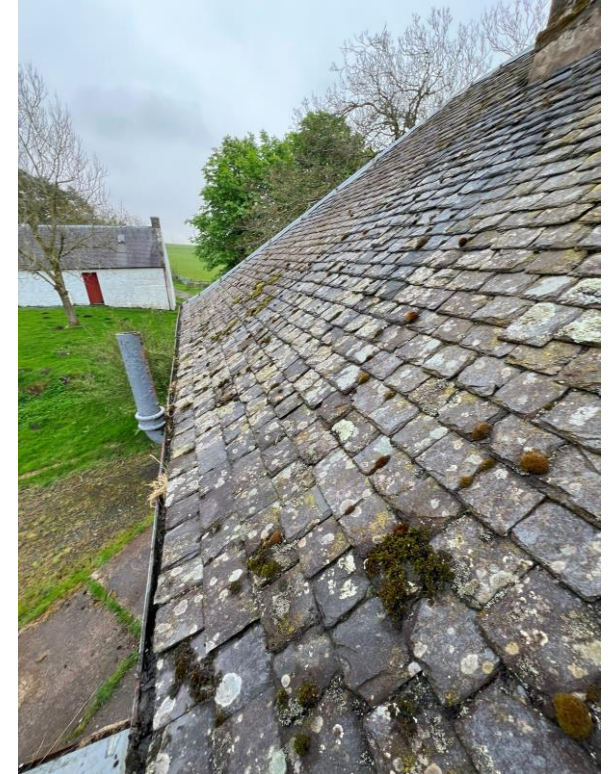
## Roof 1

**Main house roof has been slated using a random scotch slate, considering roofs age it was found to be in a fair condition with nail heads and slates still good only requiring general slate repair.**

**Lead valley gutters and cast-iron gutters were full of vegetation and require cleaning.**

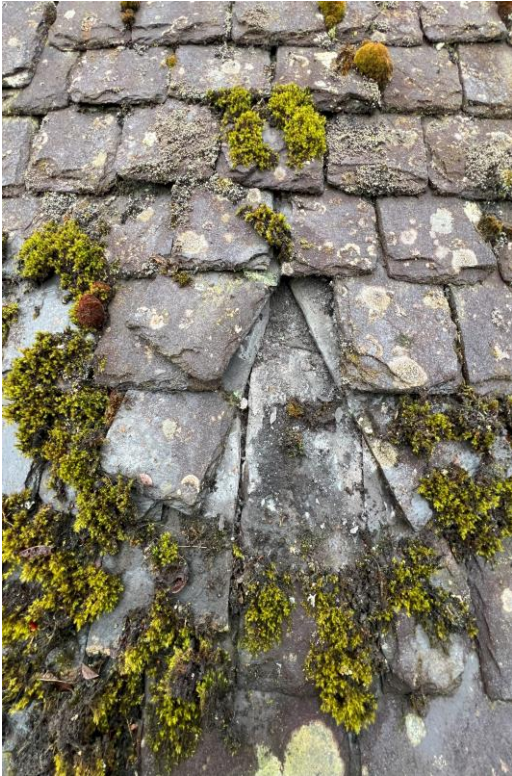
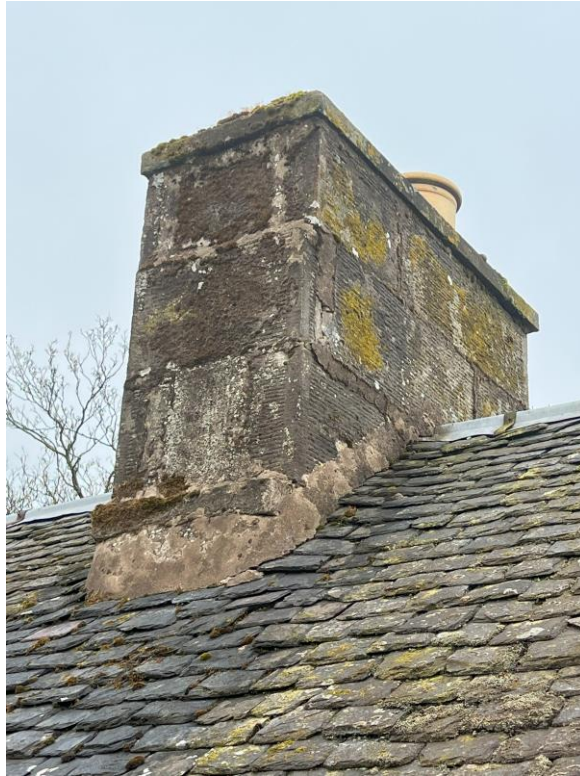
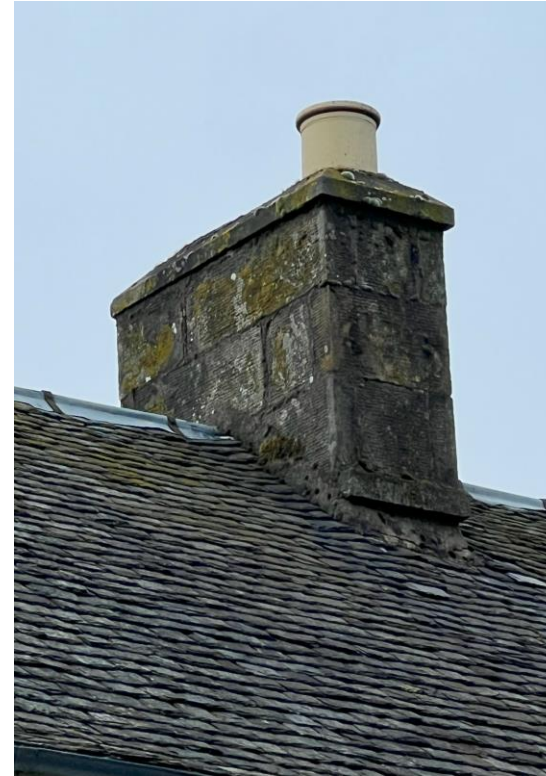
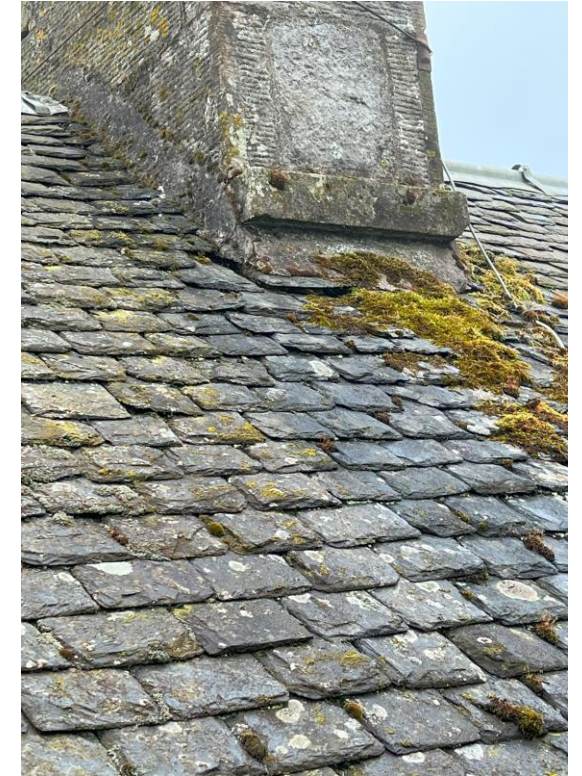
# Roof 1

**Slates turned on main roof to expose nail heads which were found to be in a good condition, considering age of roof.**

**No felt is present under slating.**

**Chimney stacks require raking out of joints in sandstone and repointing using lime mortar mix.**

**I would suggest also that chimney pot were also capped.**

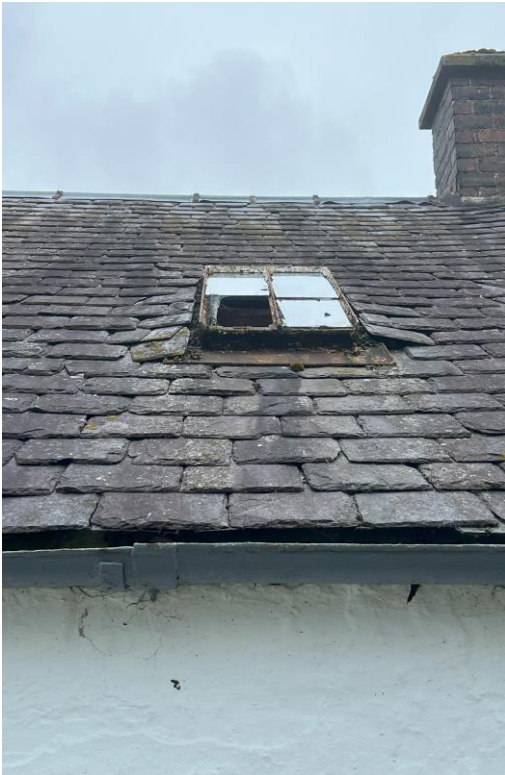
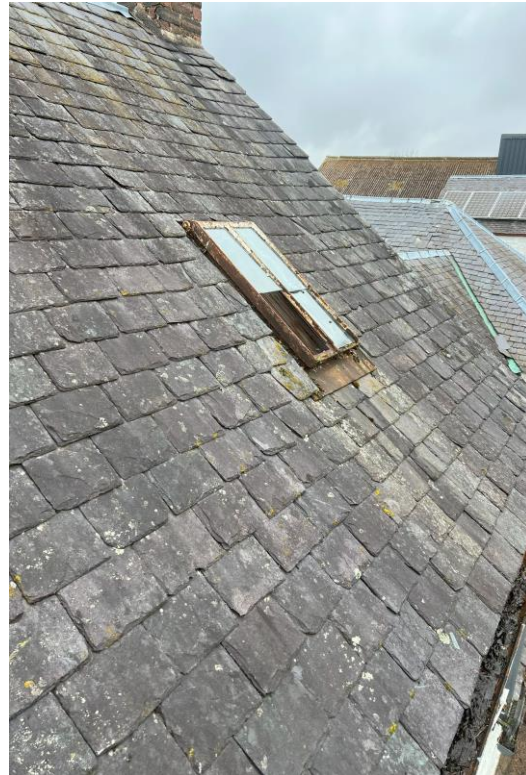
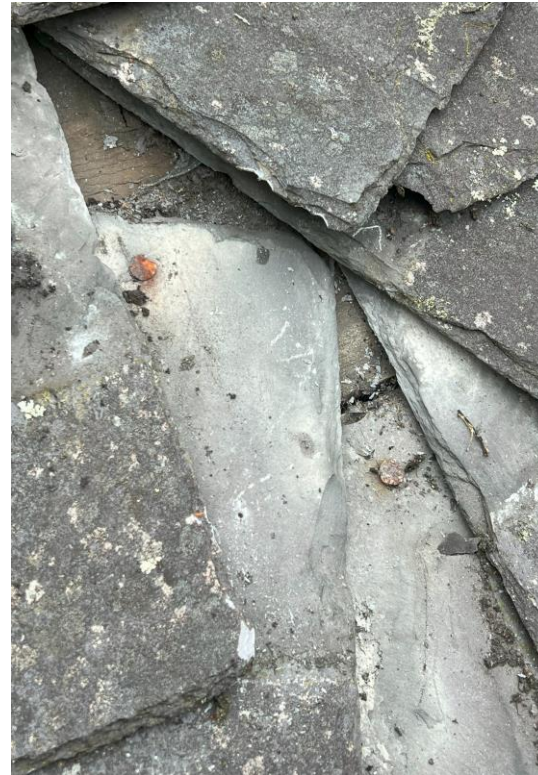
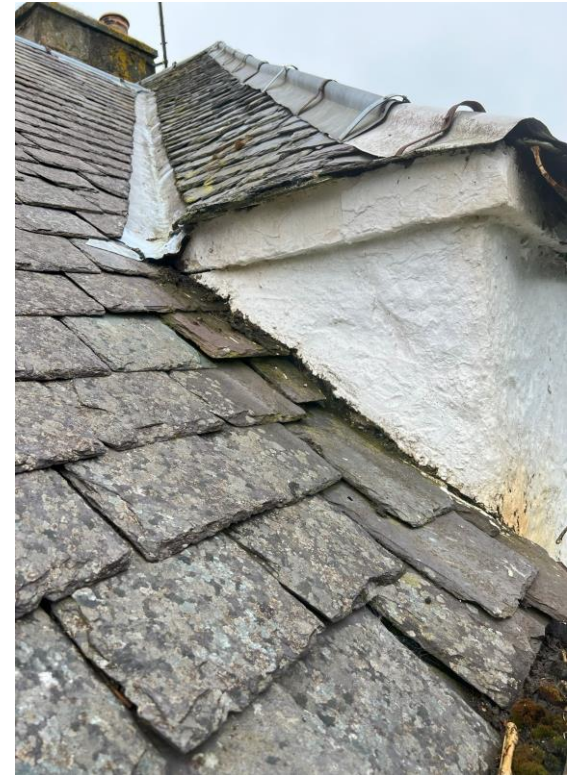
**Cement skew at junction to main building requires hacking of and renewal.**

**Chimney to gable requires repointing, new chimney pot and cowl fitted.**

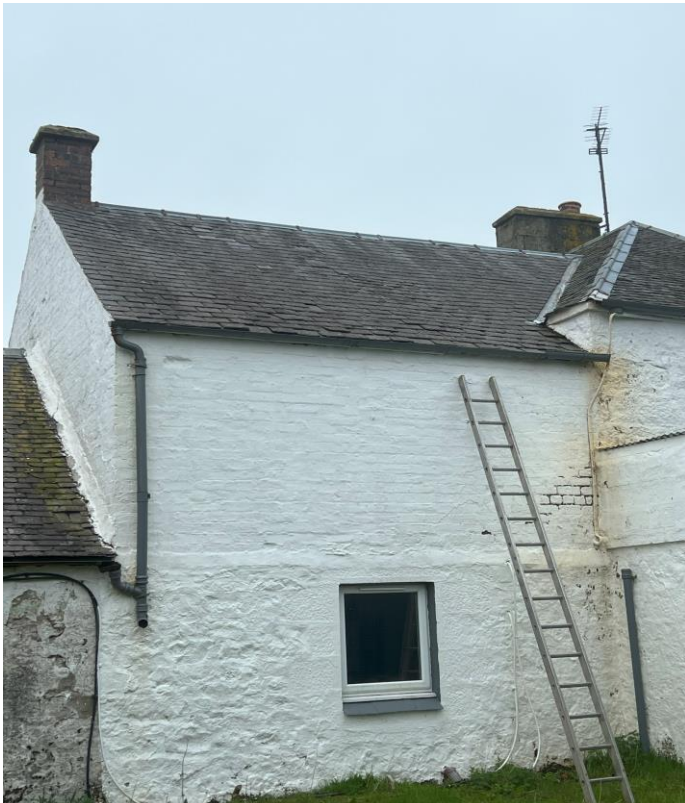
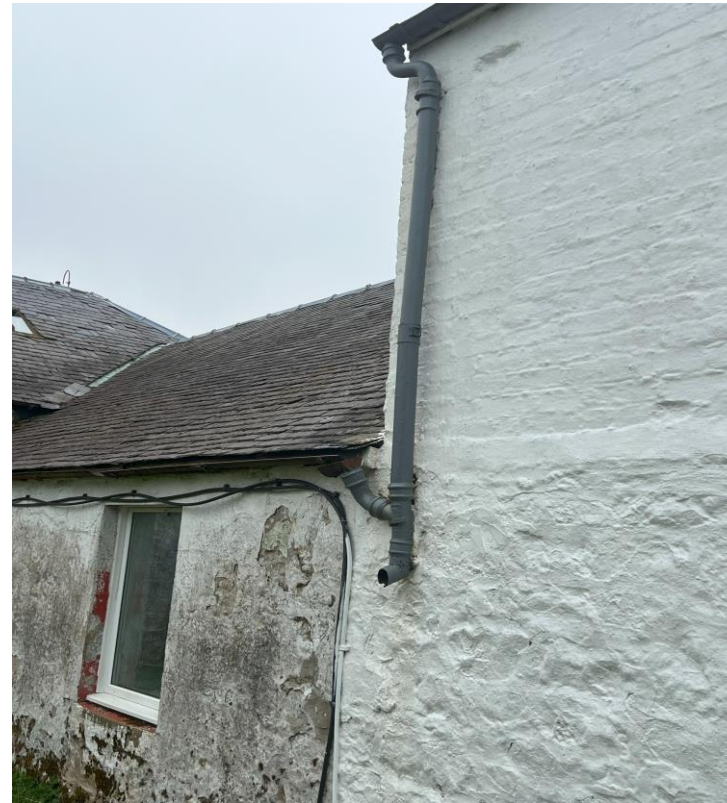
Roof 2 ,  
Section of cast down requires renewal  
to bottom of run.  
Total estimated costing for identified issues to  
roof 2:- £780.00 +Vat

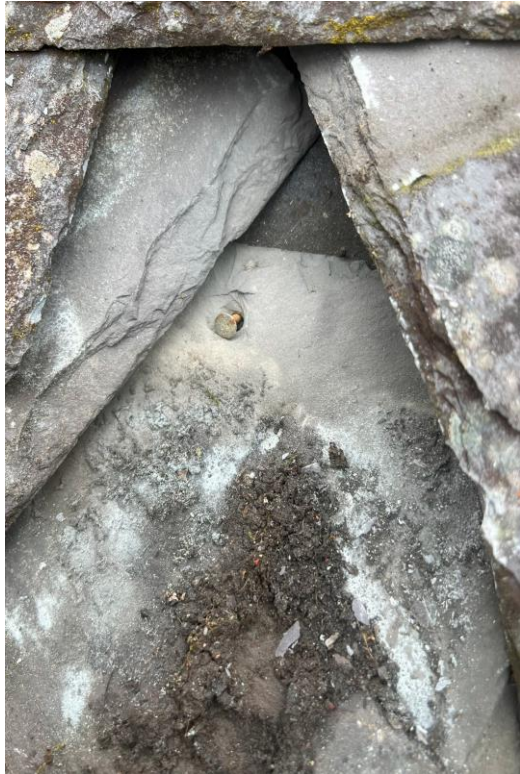
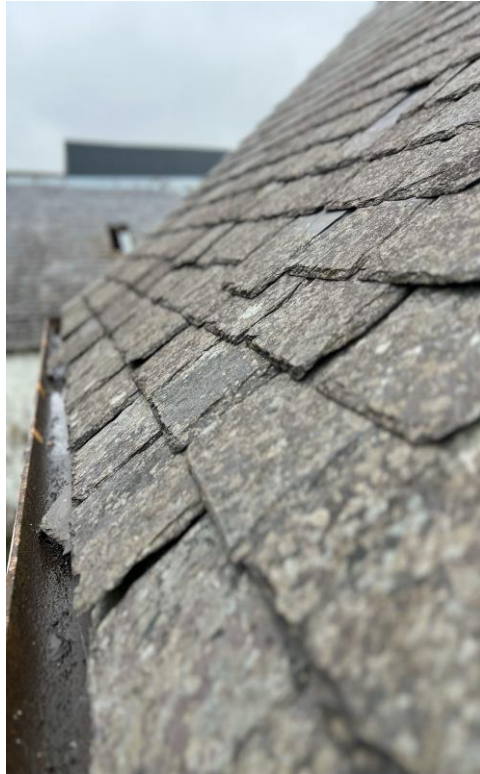
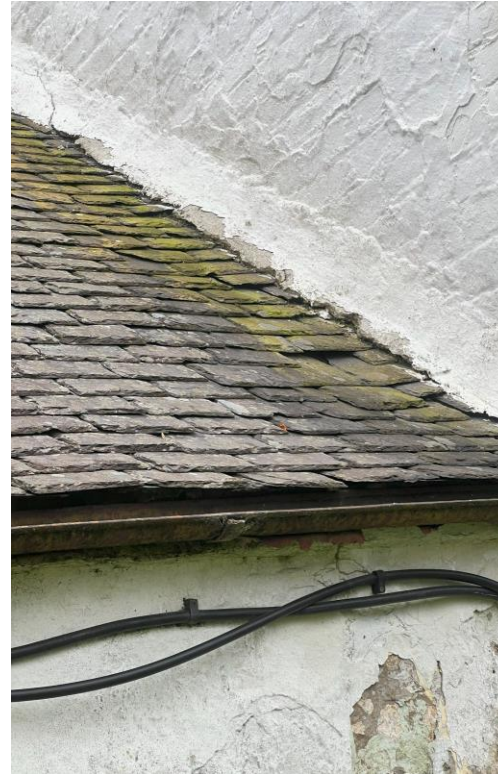
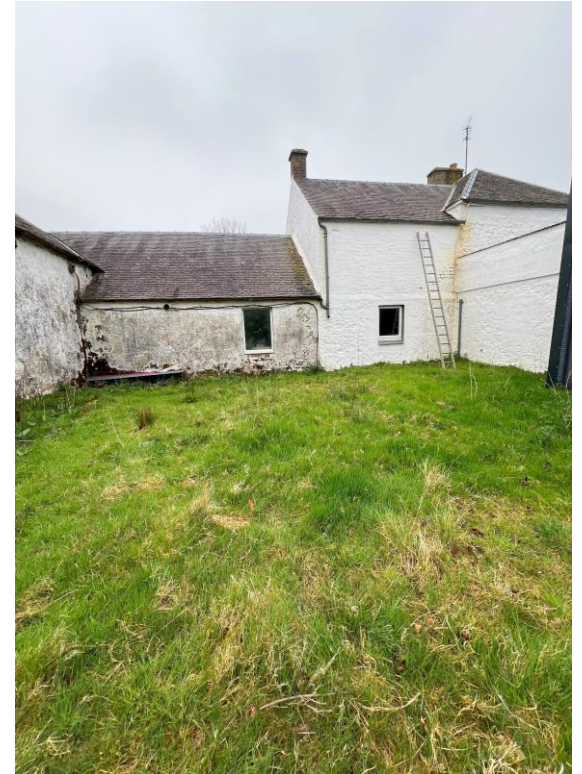
# Roof 3

Roof has been re slated at some point and has a non breathable felt to underside unfortunately it has been re slated with wrong type of nail, nails are to short and to thin.

This roof should be re slated.

Estimated costing of works to roof 3:- £8,500.00

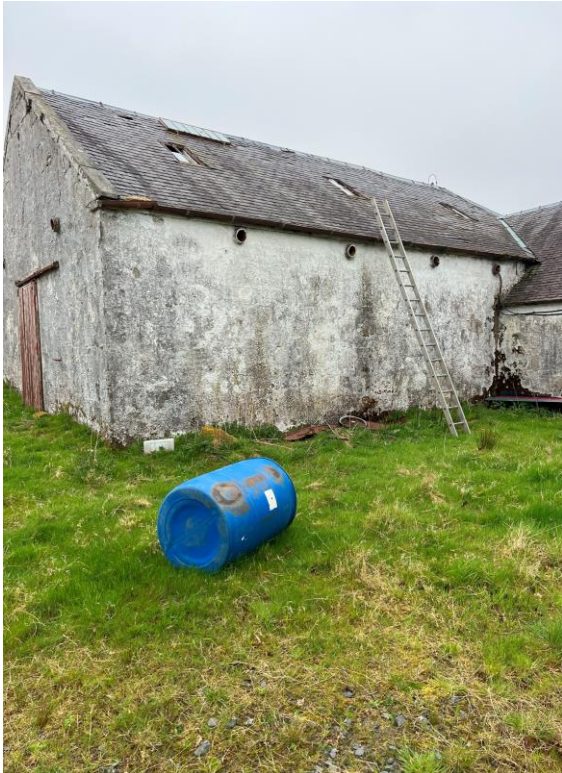
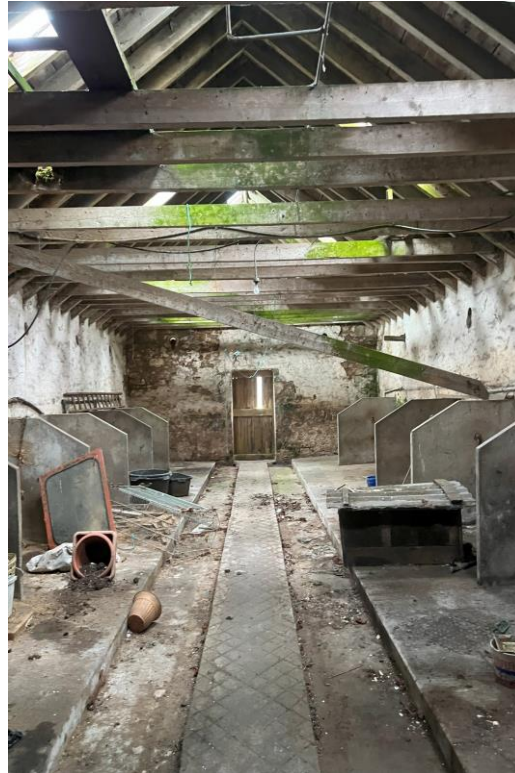
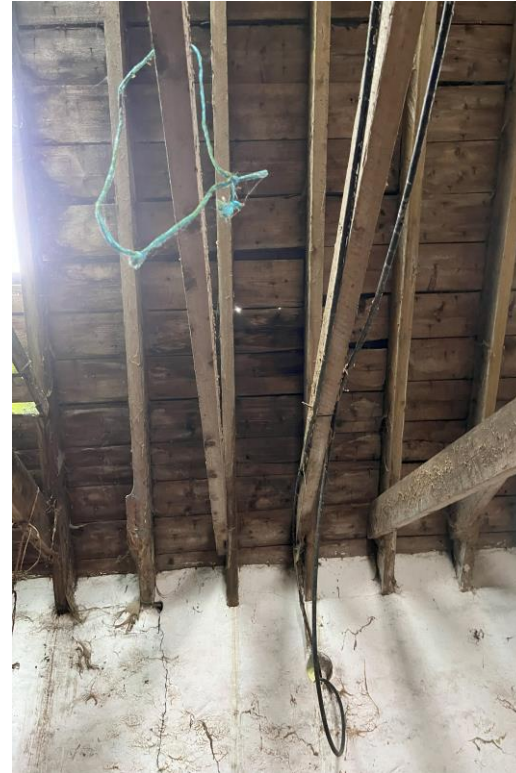
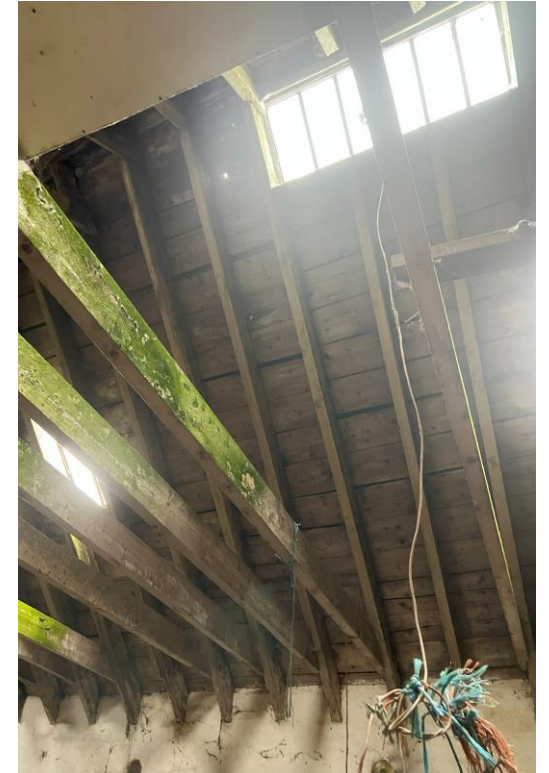
# Roof 4

**Timber sarking as can be seen from inside of byre at roof 4 is starting to slip due to nail fatigue .This roof requires re slating.**

**Estimated costing to reslate £19,500.00 + Vat.**

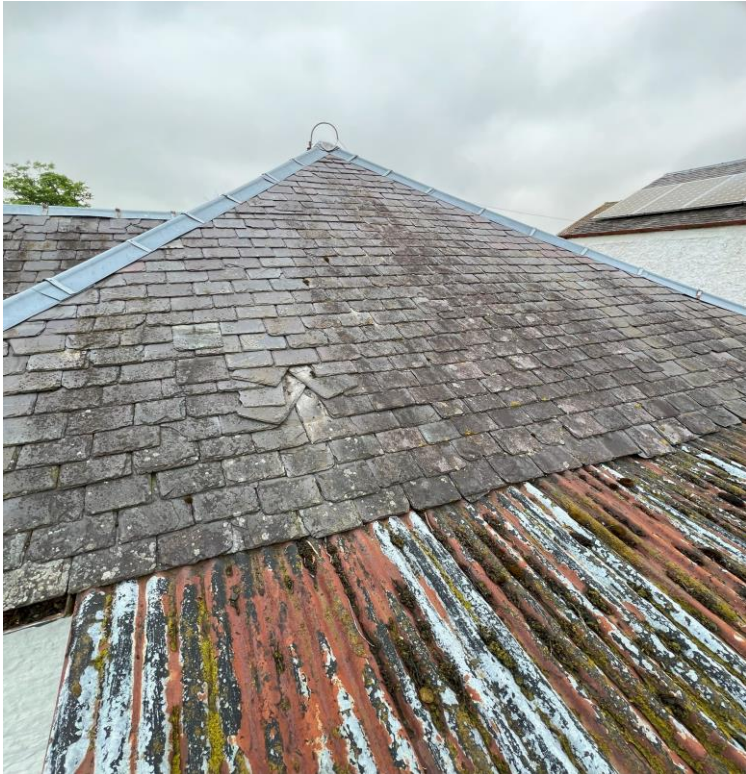
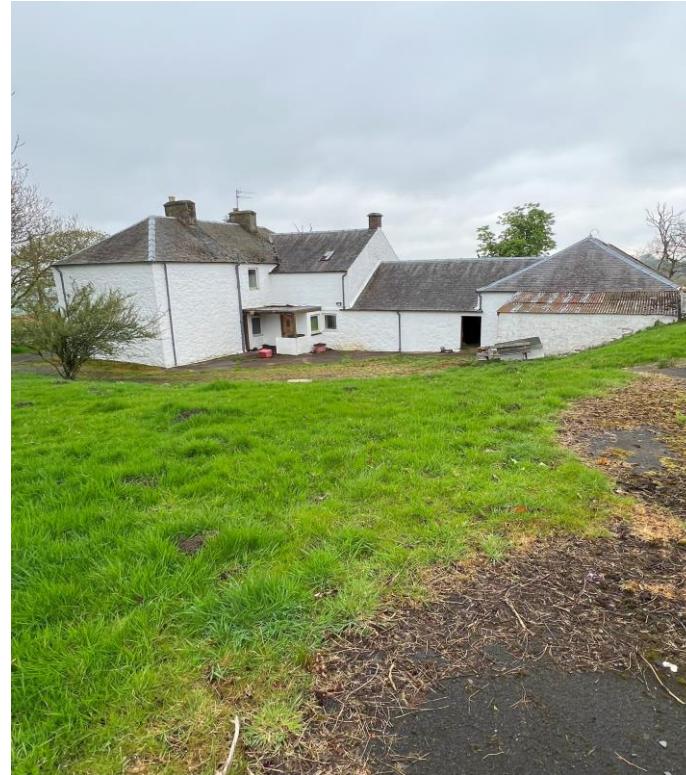
# Roof 5

**This is a corrugated iron which although is unsightly , It still has a bit of life left in it yet.**

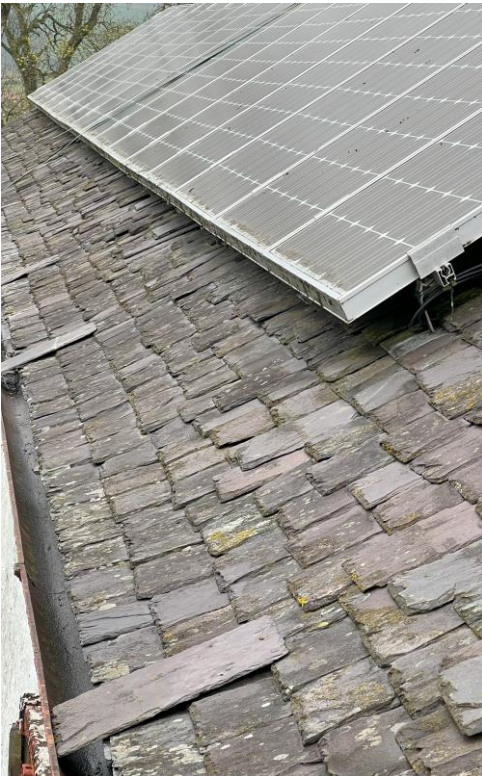
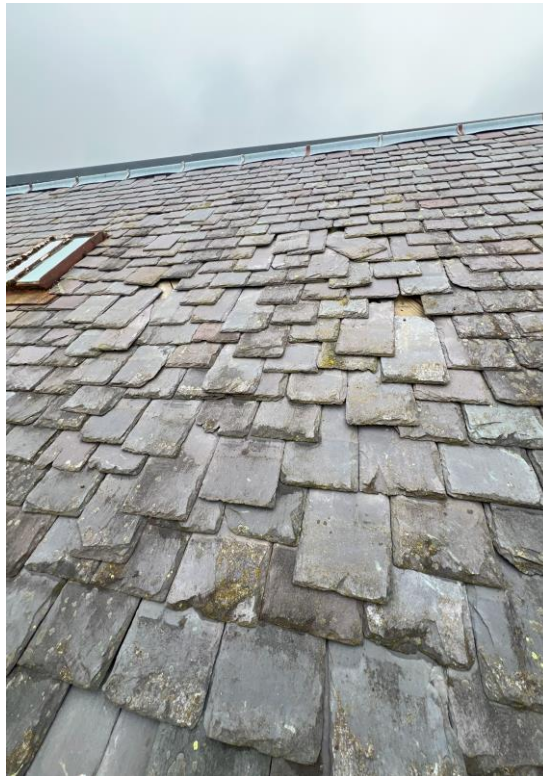
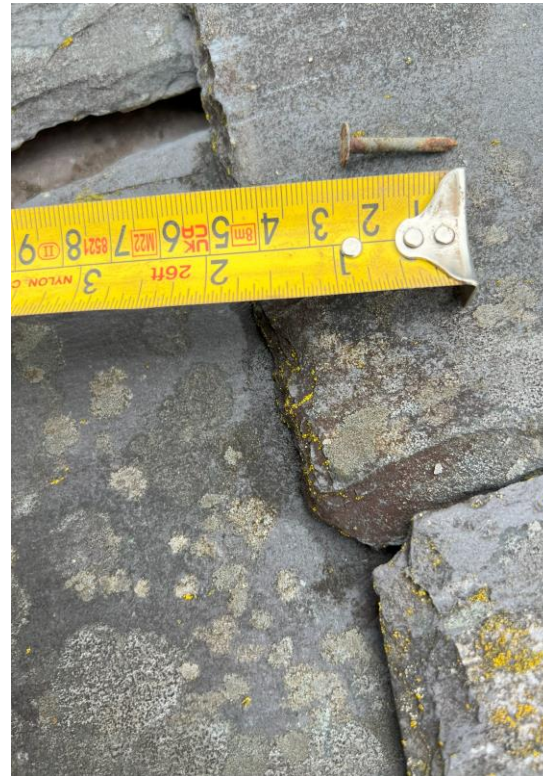
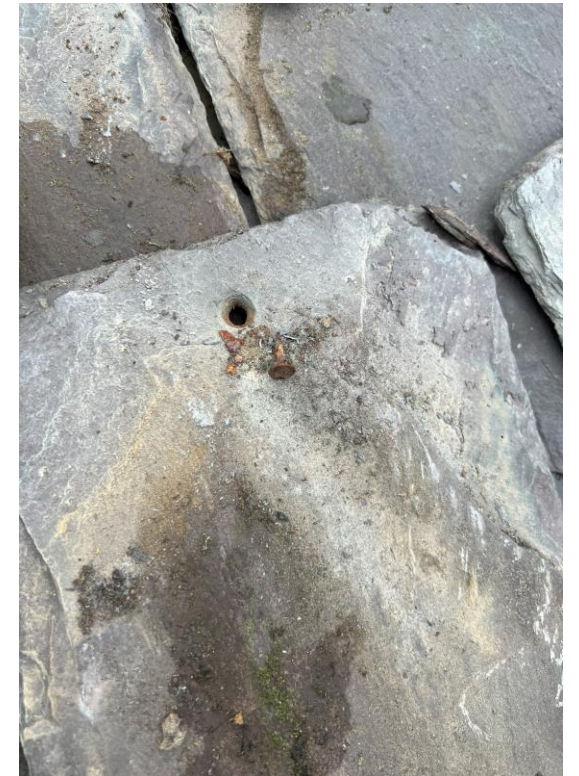
# Roof 6

**This roof as with roof 4 has been slated using wrong nails .  
These nails are just over 20mm when in fact they should  
be a minimum of 40mm with a 3.35mm shank.**

**This roof has failed and requires to be reslated both sides.  
Total estimated costing £ 22,500.00**

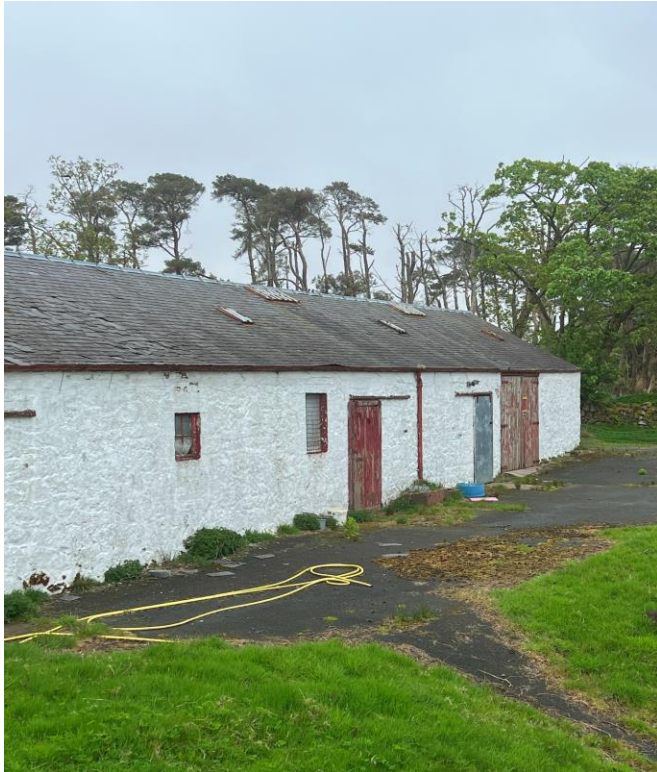
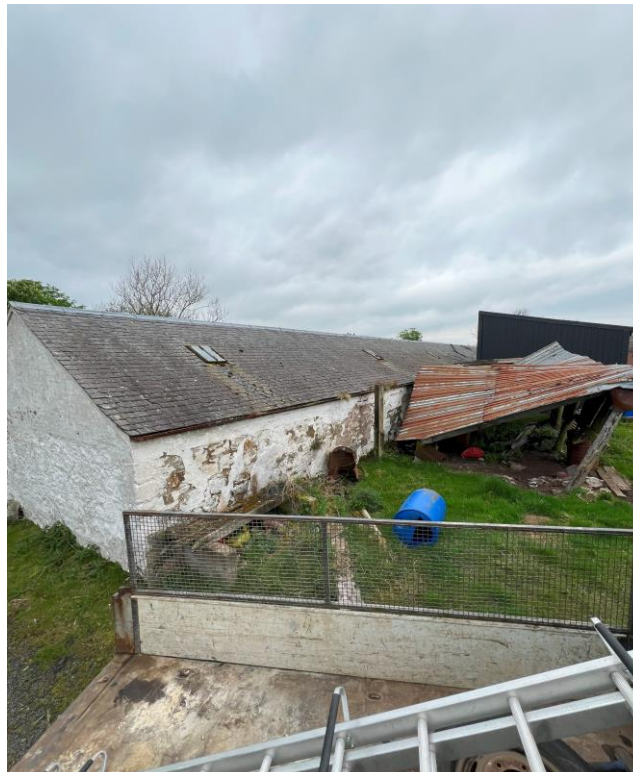
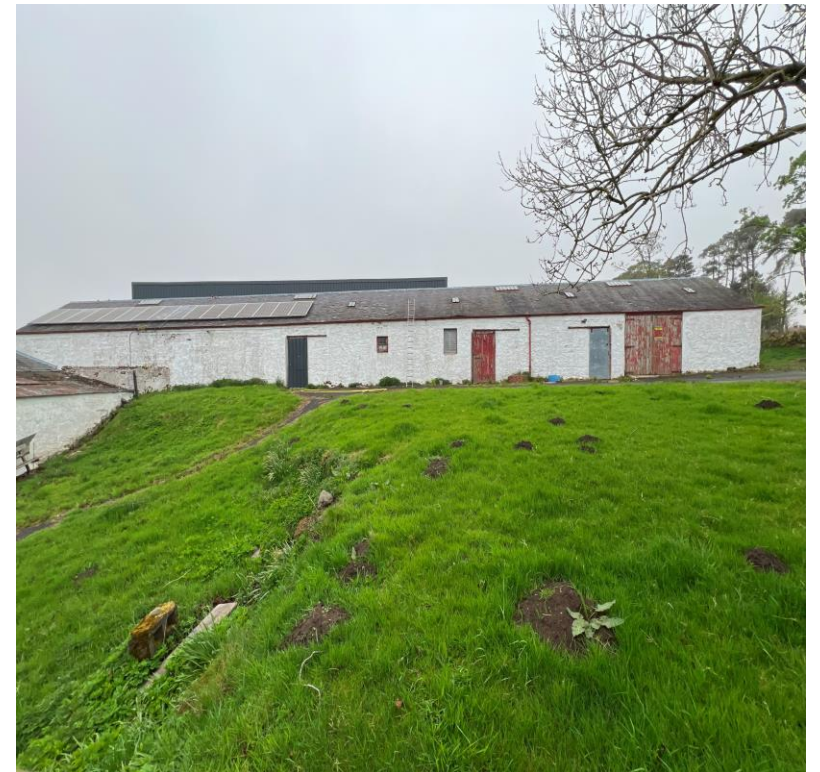
# Roof 7

**Roof 7 is the other half of roof 6, this has been re slated at a different time with the correct nails and only requires a slate repair and some gutter repairs.**

**Estimated costing for roof 7:- £850.00 + Vat**

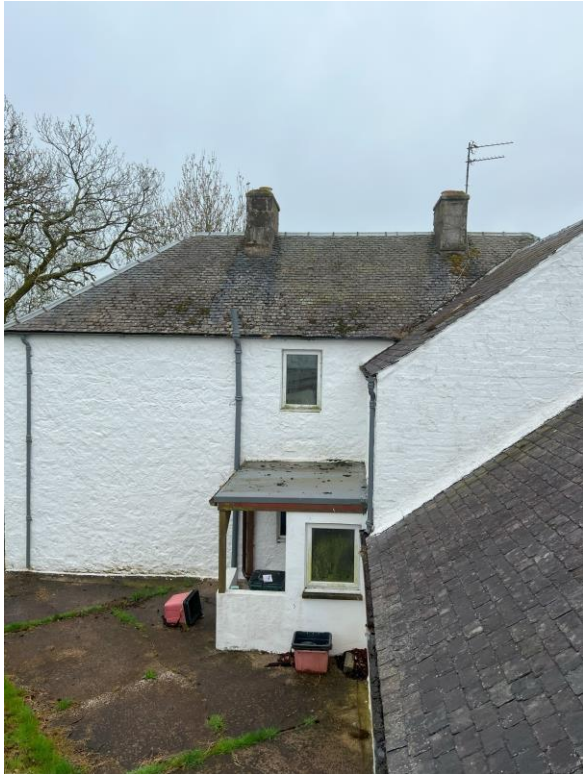
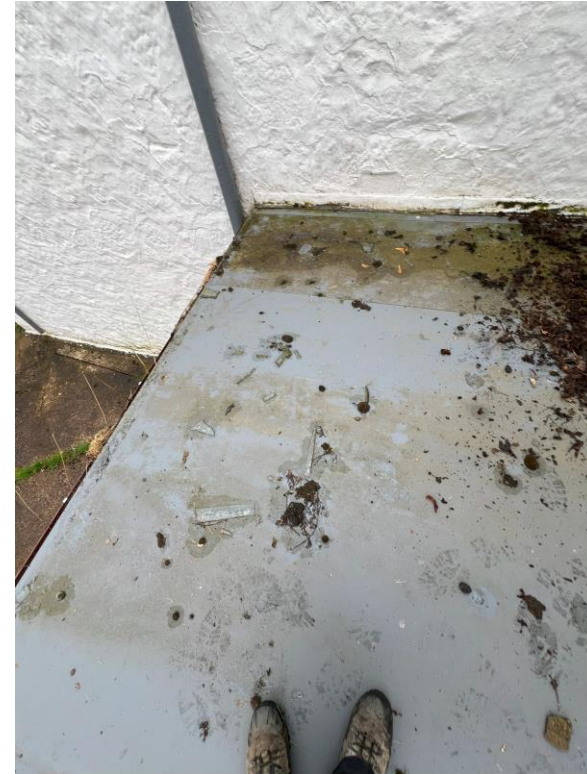
# Roof 8

**Roof 8 is a single ply membrane roof on top of entrance porch and was found to be in a good condition just requiring a clean.**

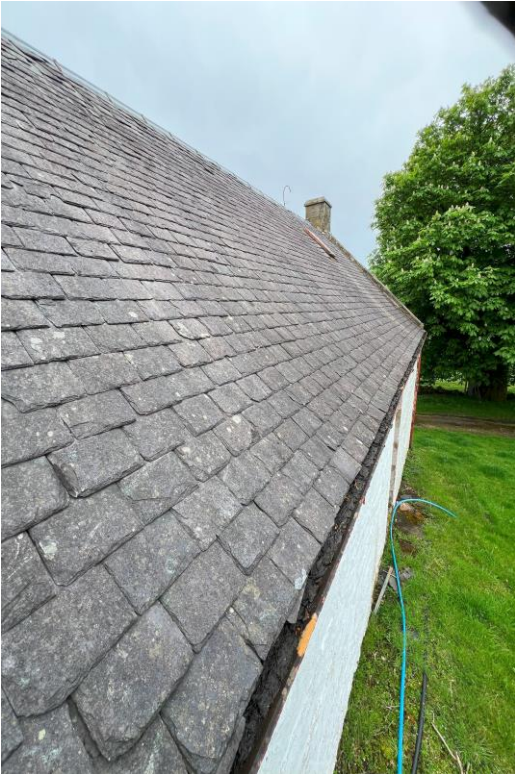
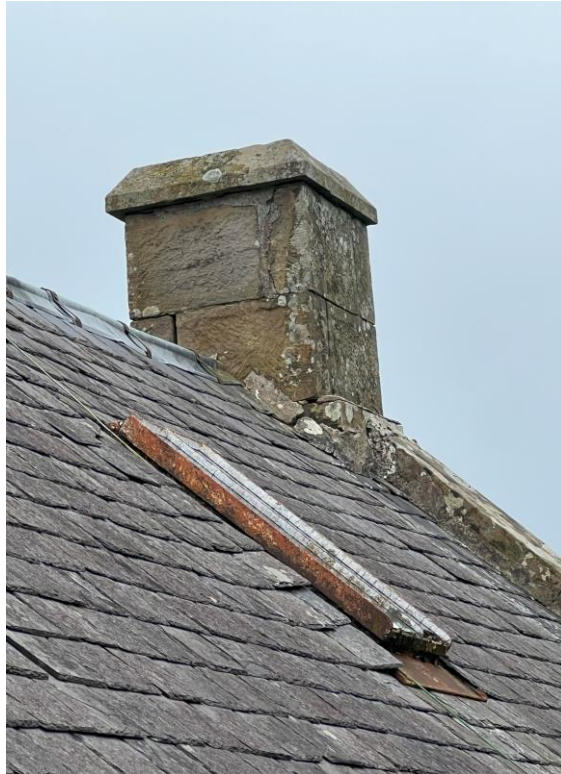
# Roof 9

**This roof was found to be in a decent condition with nail heads found to be good as can be seen.**

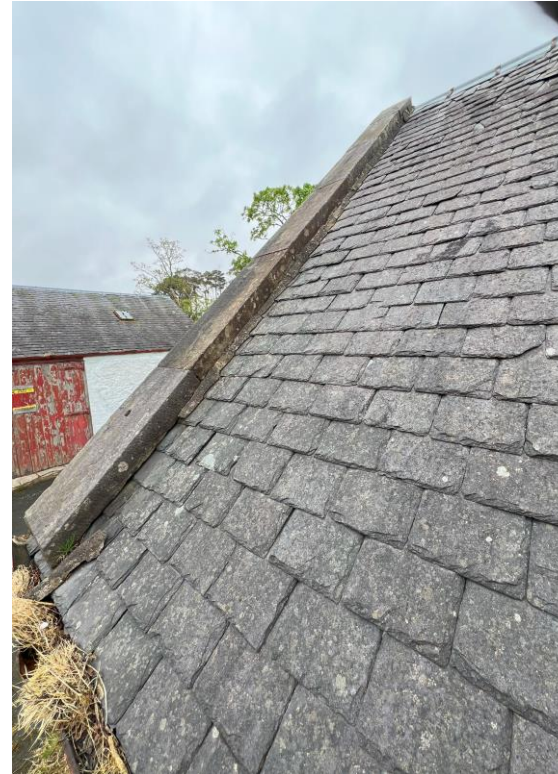
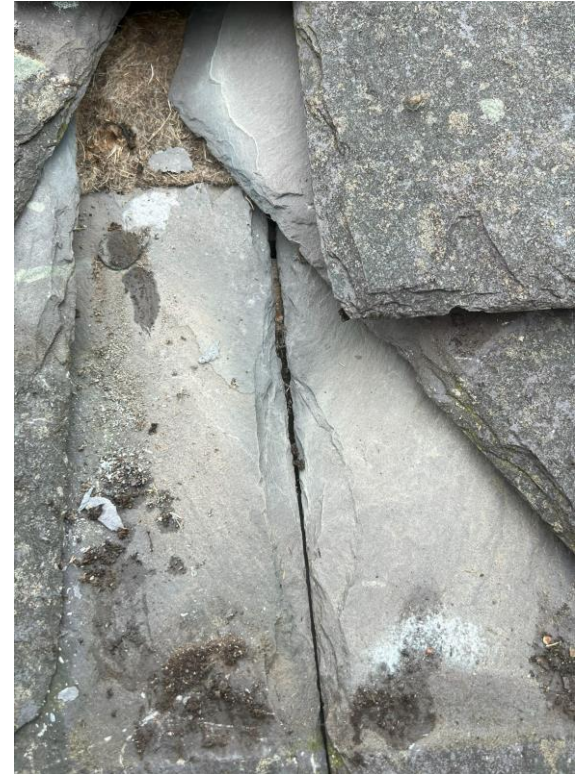
**Chimney stacks and skew stones require to be raked out at joints and repointed using a lime mortar mix.**

**Chimney's should also be capped.**

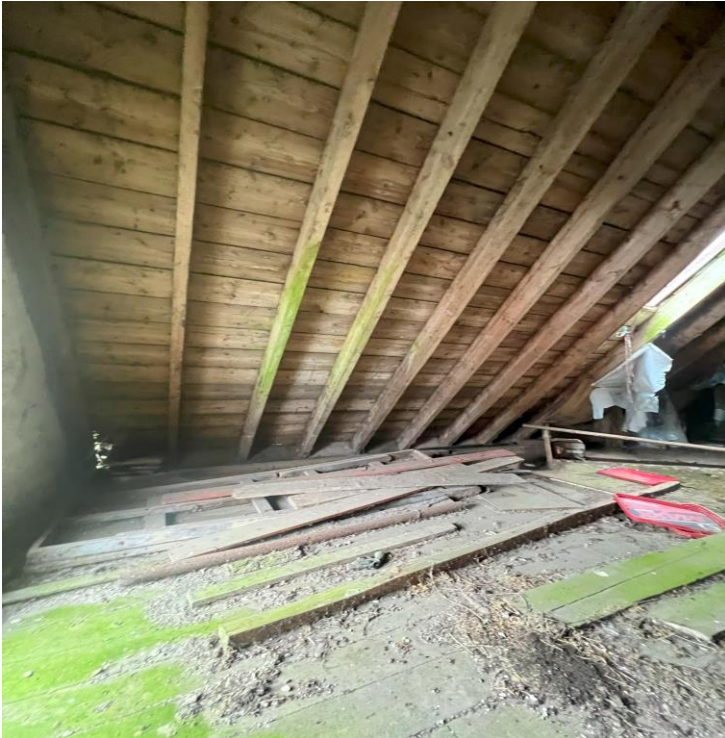
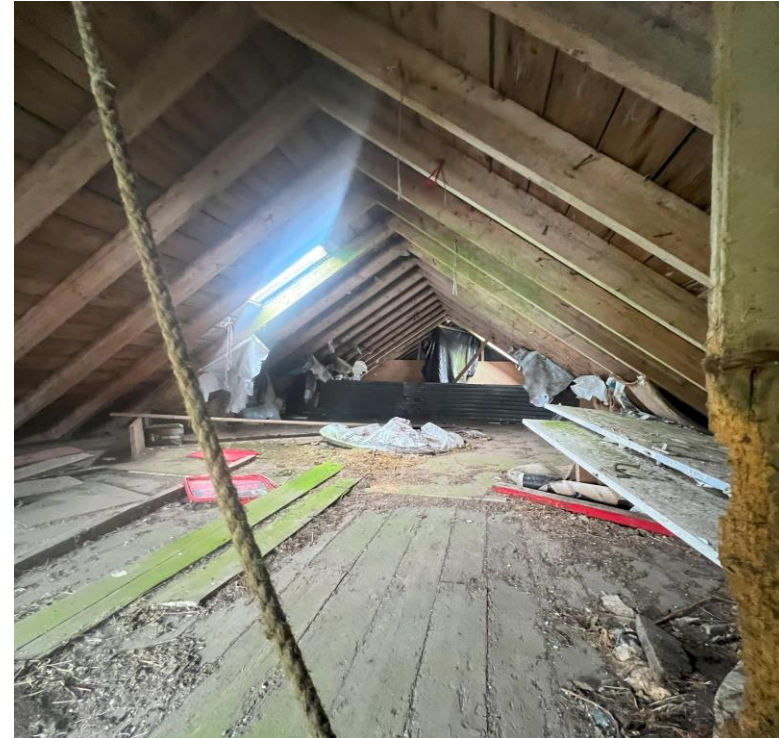
# Roof 9

**Main timbers inside roof 9, still look in good condition although slight signs of woodworm were present but don't look active.**

**Estimated costing to rectify roof 9 :- £2,800.00  
+ Vat**

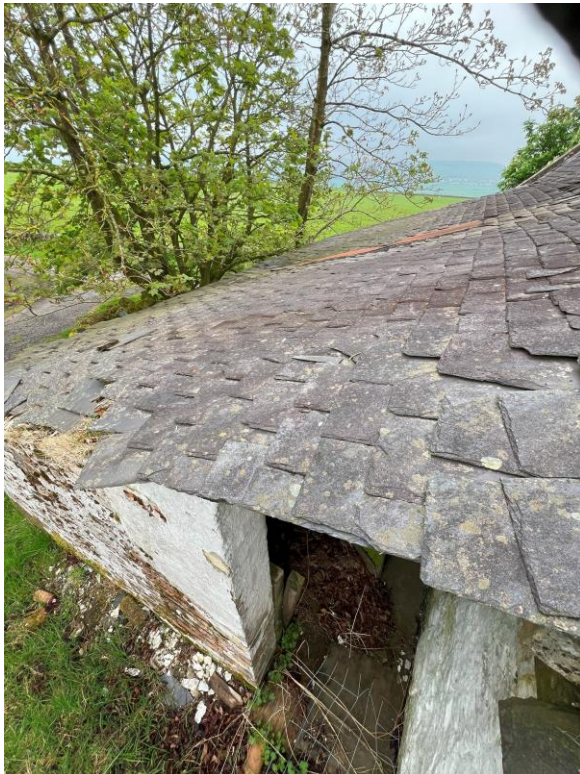
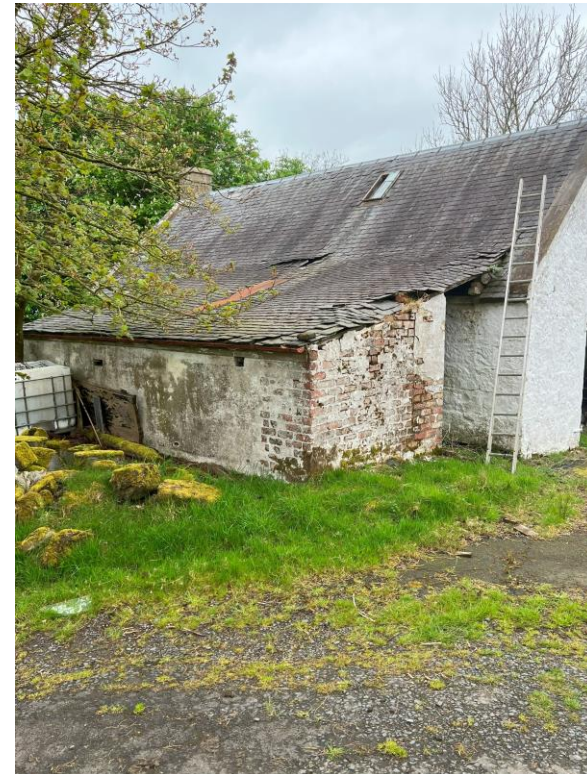
# Roof 10

**This roof is attached to Roof 9 , this lean to slated roof has failed due to being slated using wrong size of slate,**

**I would suggest this building and roof are removed and bottom section of roof 9 slated into main main part of roof and a new gutter fitted.**

**Total costing for suggested works £ 4,900.00 + Vat**

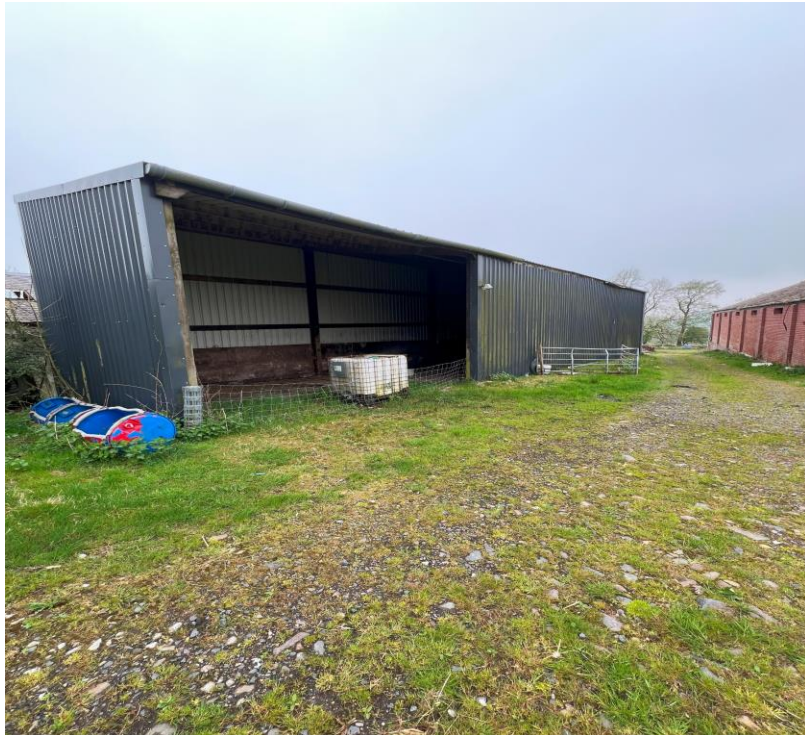
# Roof 11

**This lean-to box profile tin roof was found to be in a decent condition only requiring guttering repairs**

**Costing to carry out 6" pvc guttering repairs:- £1,200.00**

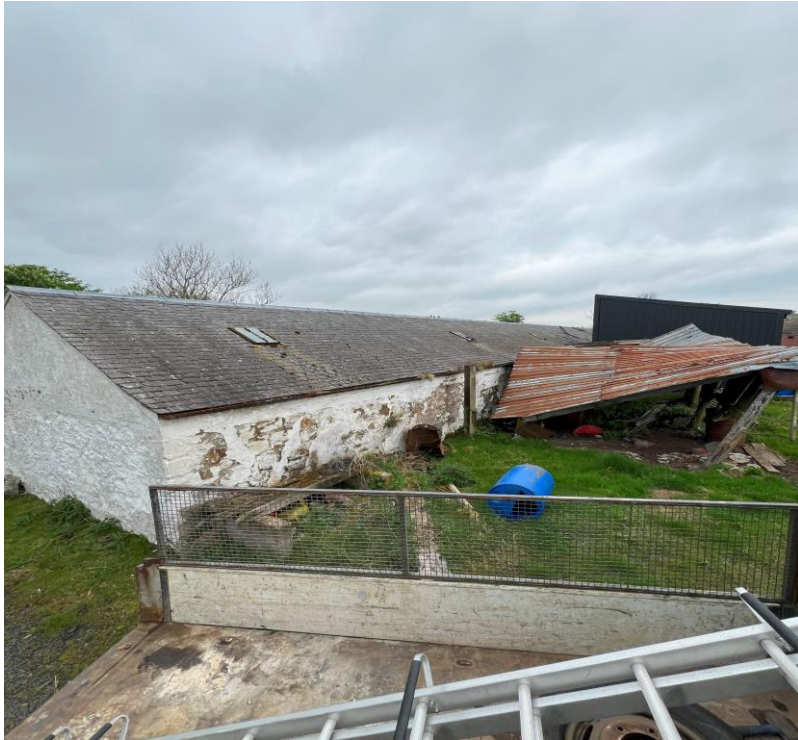
# Roof 12

**This Corrugated tin sheet building is derelict and require removal.**

**Estimated costing to dispose of:- £  
£2,300.00 + Vat**

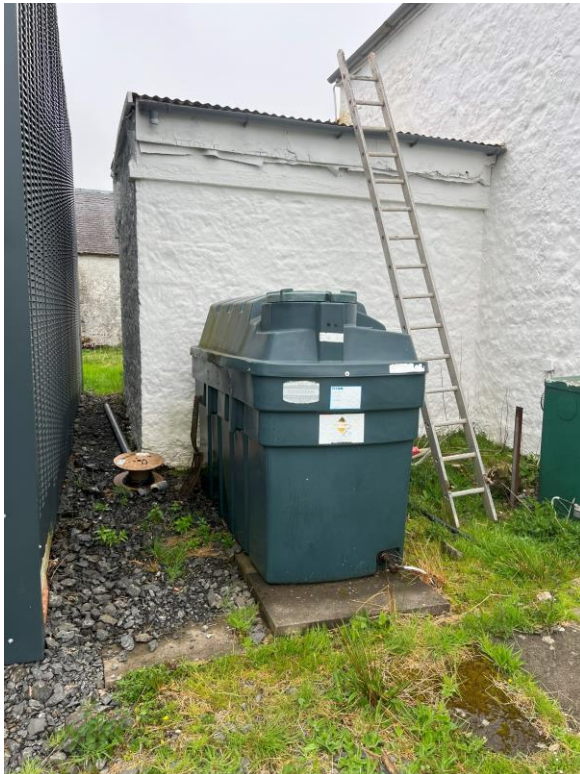
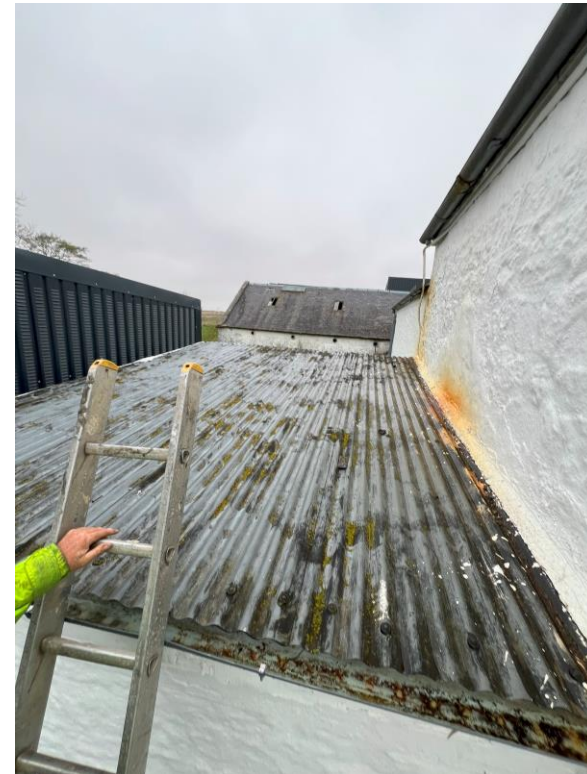
# Roof 13

**This corrugated tin roof is in a fair condition , fascia & rainwatercdown pipe required.**

**Estimated costing :- £620.00**

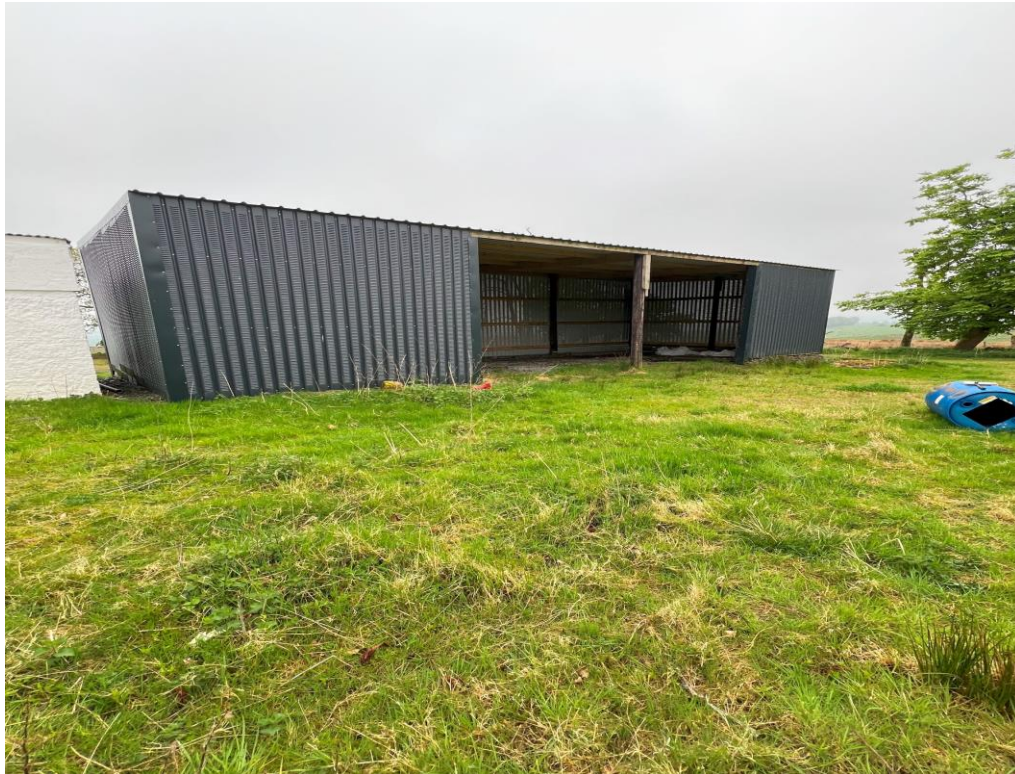
# Roof 14

**This is a box profile tin shed no works required.**
