# Home Report

Property address	Roughside Farm New Cumnock Cumnock KA18 4NT
Customer	Eli Banberger
Customer address	Roughside Farm New Cumnock Cumnock KA18 4NT
Prepared by	Shepherd Chartered Surveyors
Date of inspection	27/05/2025

Roofing report and  
associated estimated  
costings to bring roofs into a  
good state of repair.

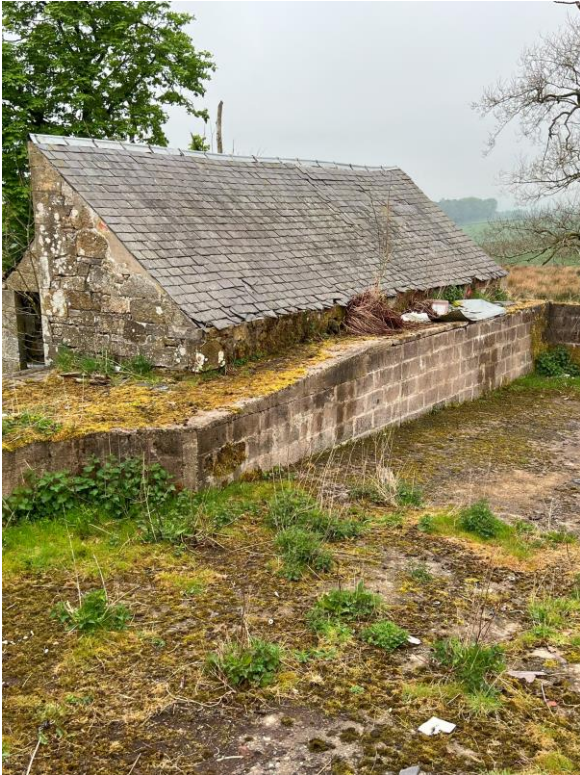
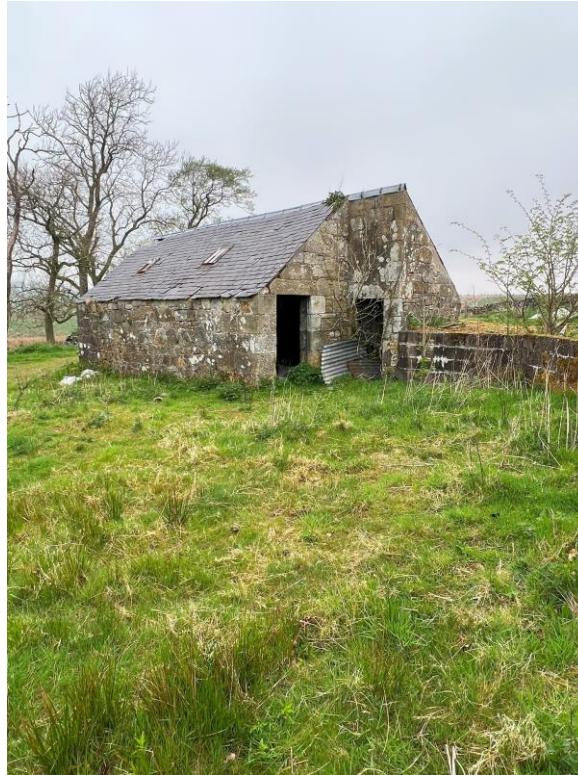
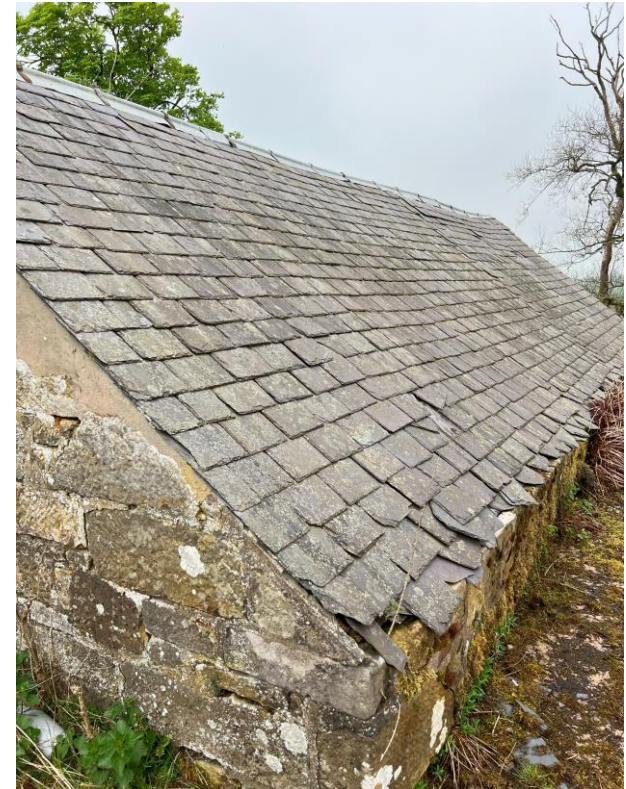
# Roof 15

**This old building was being used for lambs of late.**

**Roof was found to be nail sick and requires renewal.**

**Total costing to reinstate :- £ 8,700.00**

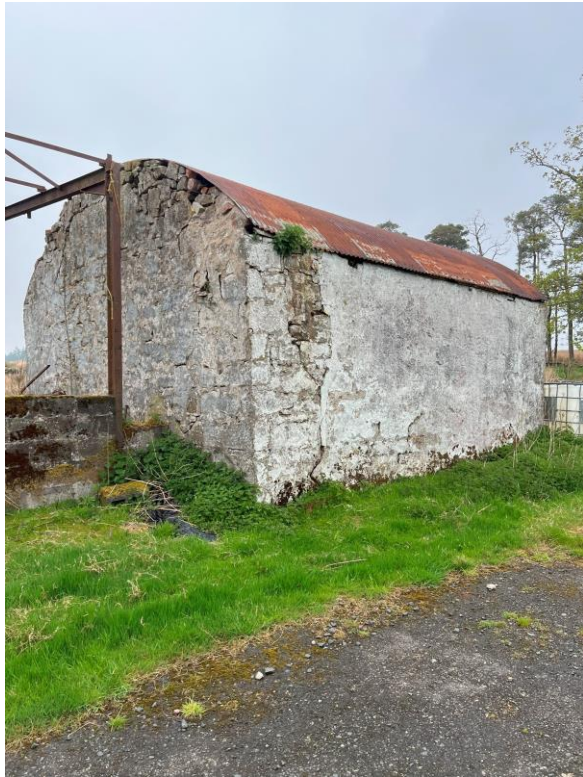
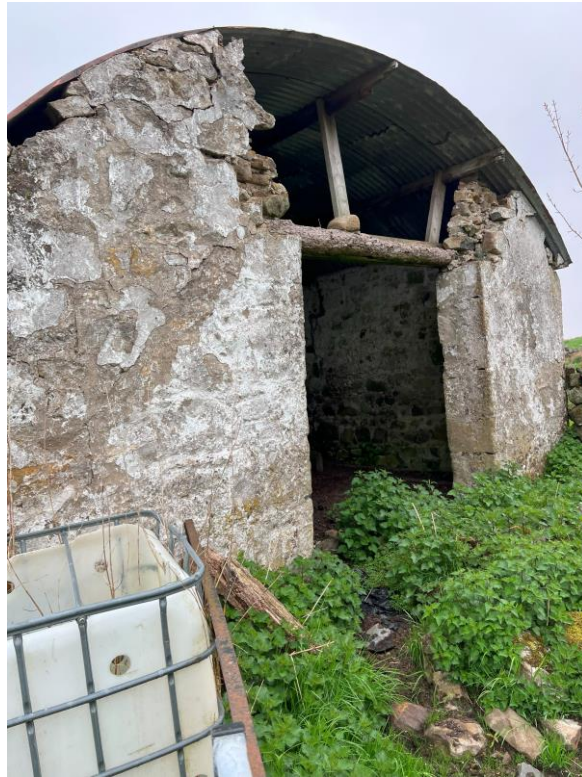
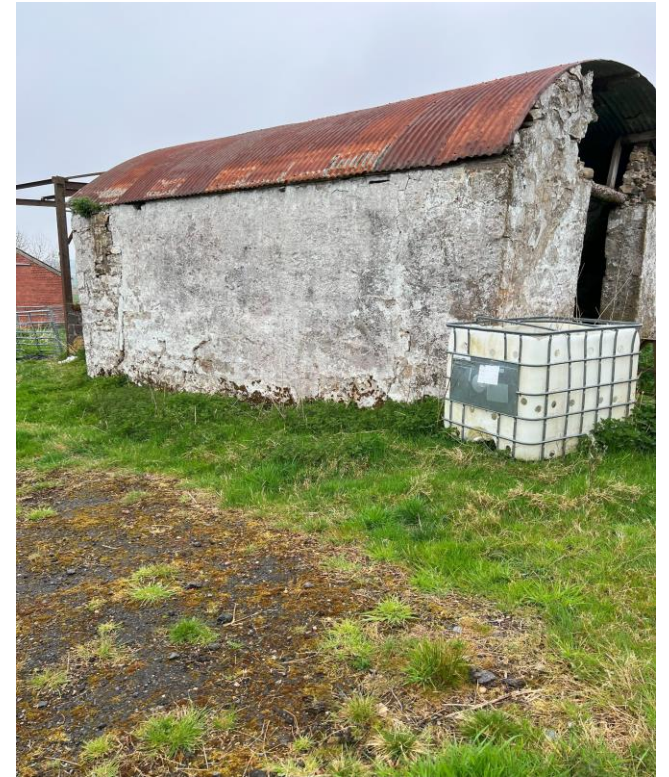
# Roof 16

**This old Dutch barn style stone-built shed is in a poor condition and should be demolished.**

**Estimate costing to demolish and remove £ 4,500.00**
