1 Toreduff Farm Cottages,  
Forres,  
Morayshire,  
IV36 2RA

# Home Report

# Single Survey

| <b>Reference</b> | 1412857 |

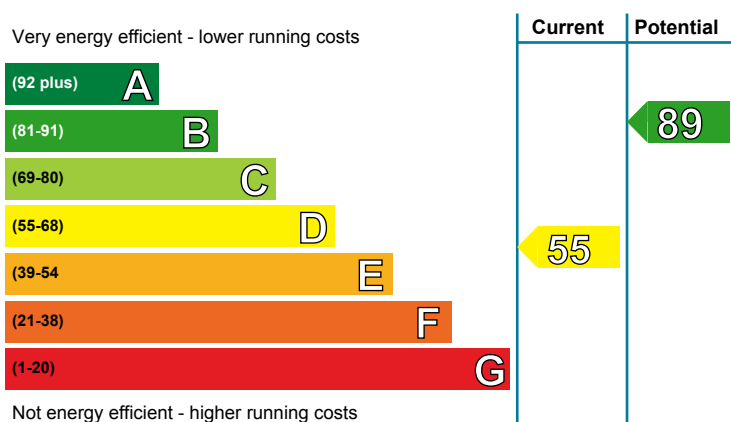
## Energy Efficiency Rating

Your current rating is **band D (55)**. The average rating for EPCs in Scotland is **band D (61)**.
