Home Report

Property address	Balorrin Aultgowrie Muir of Ord IV6 7XA
Customer	Mrs Freydis Campbell
Customer address	Balorrin Aultgowrie Muir of Ord IV6 7XA
Prepared by	Shepherd Chartered Surveyors
Date of inspection	15/12/2025

STRUCTURAL INSPECTION REPORT

Property	Balorrin, Aultgowrie, Muir of Ord, IV6 7XA
Client	Gillon Campbell
Project No	260103
Date of Inspection	13 January 2026
Prepared by	Martin Gillie FIStructE CEng

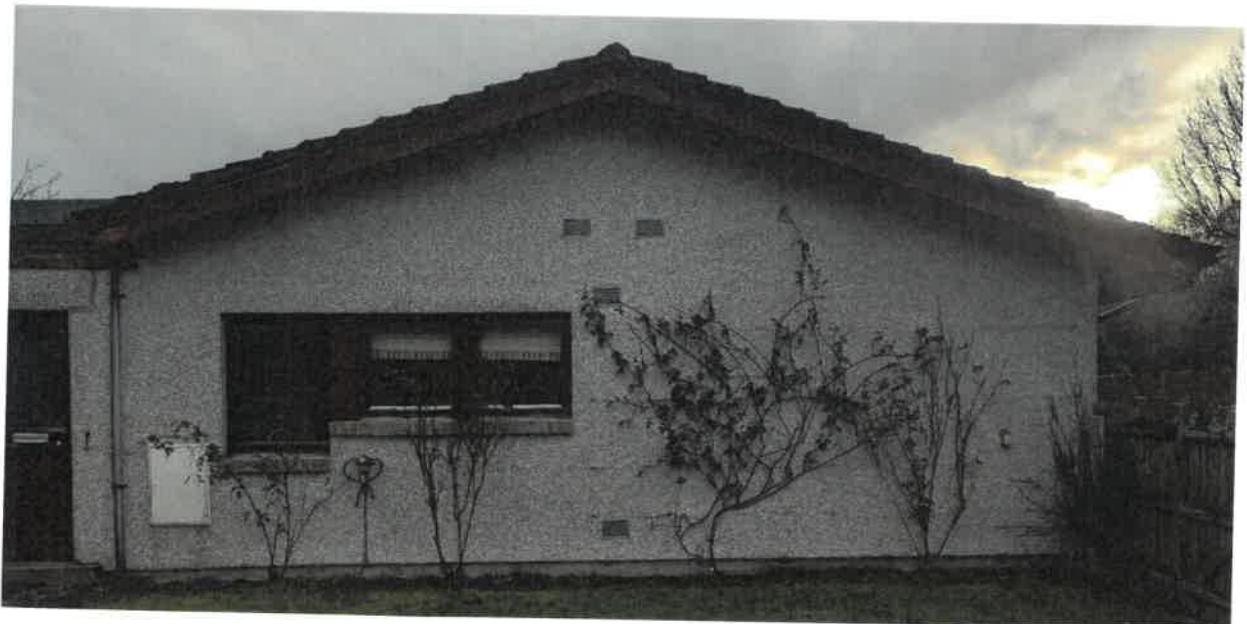
Figure 1 General view of the right gable wall. A filled crack above the doorway is visible and a diagonal crack running from the top-right of a vent to the roof line.

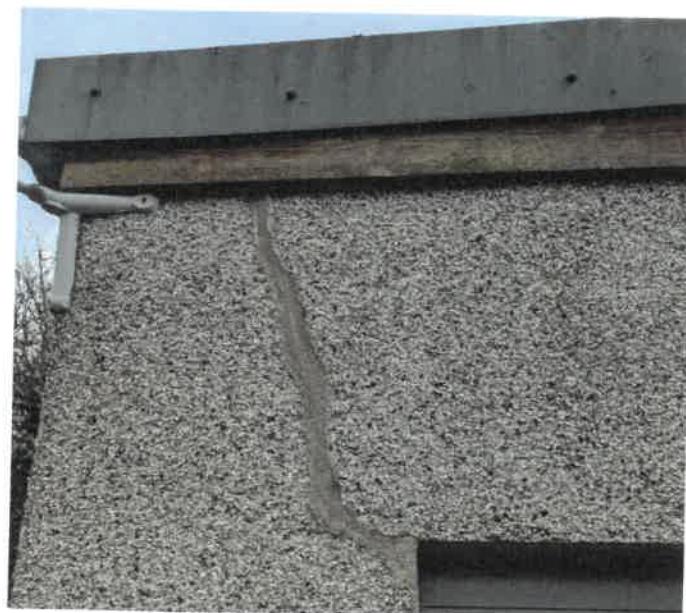
Figure 2 Filled crack above the left-hand garage door.

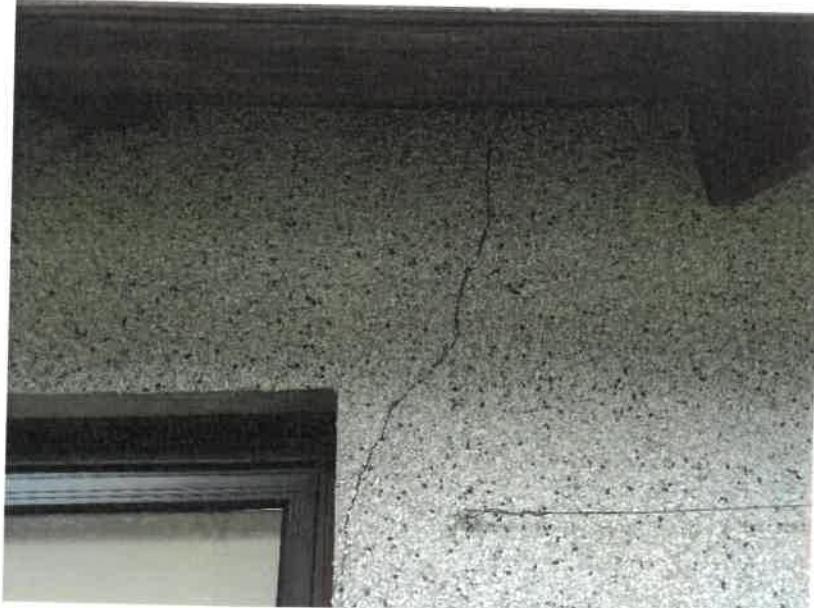
Figure 3 Crack to rear elevation. The crack fades to a hairline width below the area shown.

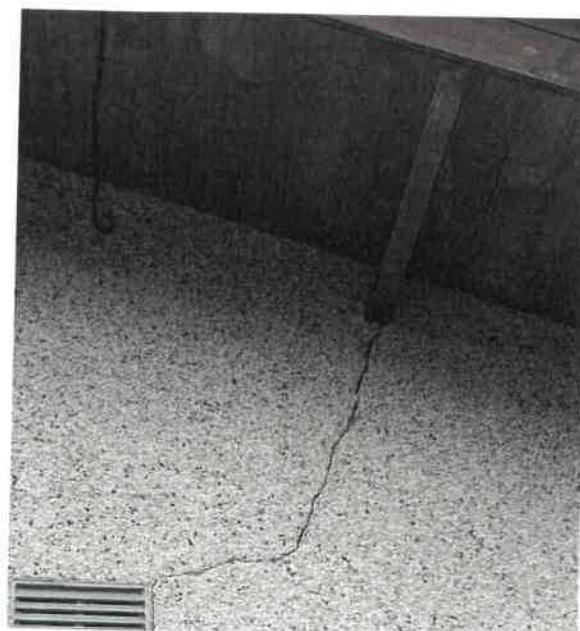
Figure 4 Diagonal crack to right gable wall

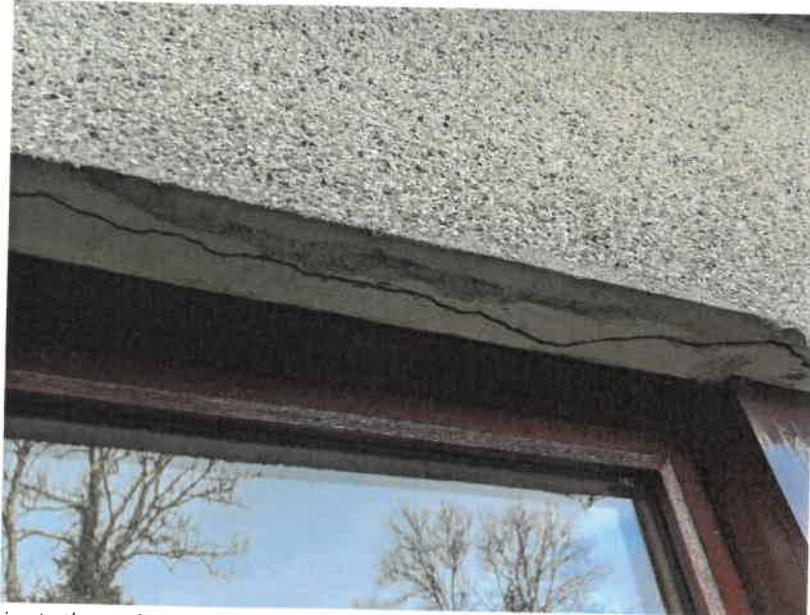
Figure 5 Cracking to the render on the underside of the window opening on the right gable wall. A further hairline horizontal crack is present about 200mm above the opening although not clearly visible in the image.

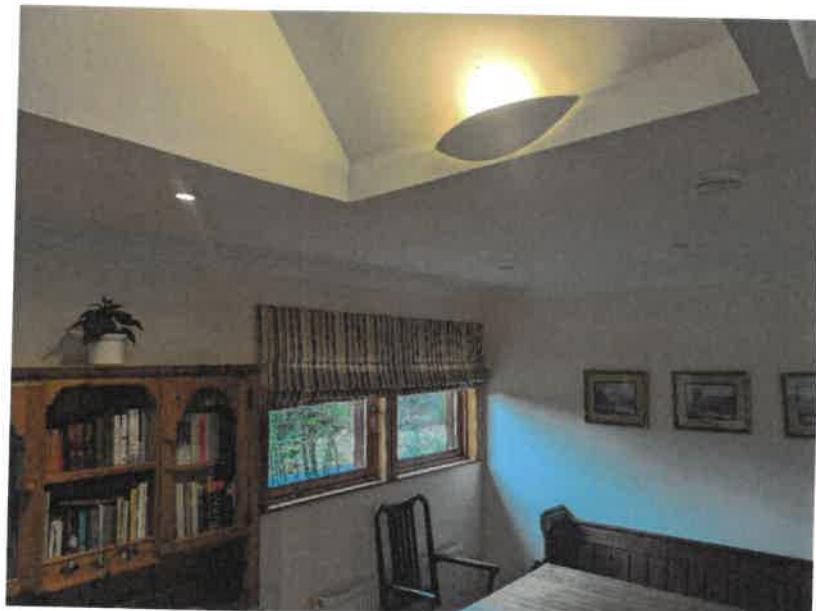
Figure 6 Typical internal view showing painted plasterboard finishes with no cracking. The left side of the image is the right gable wall of the property.
