# Home Report

<b>Property address</b>	Distillery Cottage 39 King Street Oldmeldrum Inverurie AB51 0EQ
<b>Customer</b>	Beam Suntory UK Ltd
<b>Customer address</b>	Distillery Cottage 39 King Street Oldmeldrum Inverurie AB51 0EQ
<b>Prepared by</b>	Shepherd Chartered Surveyors
<b>Date of inspection</b>	19/08/2025

## DISTILLERY COTTAGE, 39 KING STREET, OLDMELDRUM

### STRUCTURAL SURVEY REPORT

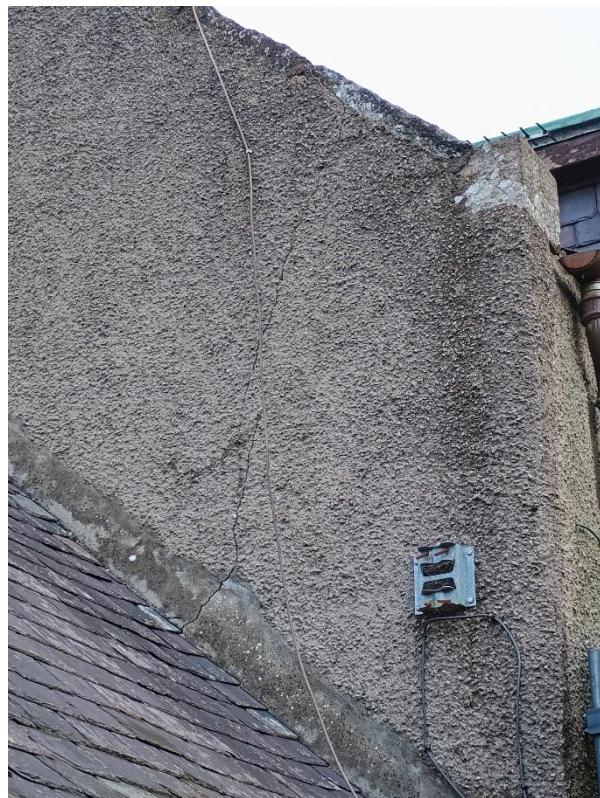
*Figure A1. Location of external crack on gable wall of the original building.*

4. Remedial repair works to the cracked masonry, as well as to the door and window frames, will need to be undertaken. However, these works should not commence until the underlying settlement and structural issues have been fully investigated, addressed, and confirmed as stable. Care should be taken to ensure that remedial works address the underlying structural issues and are not purely cosmetic; repairs are expected to involve crack stitching using stainless steel reinforcement bars and compatible grout or resin injection systems.

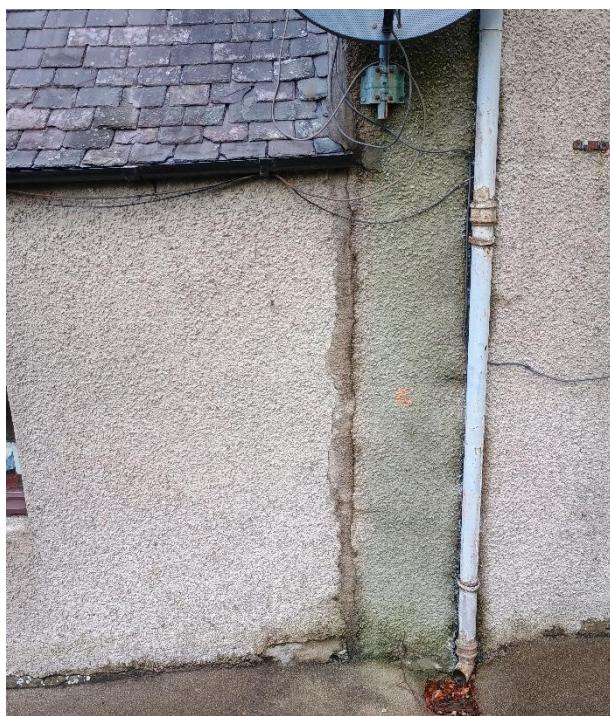
*Figure A2. Cracking at joint between extension and original building*

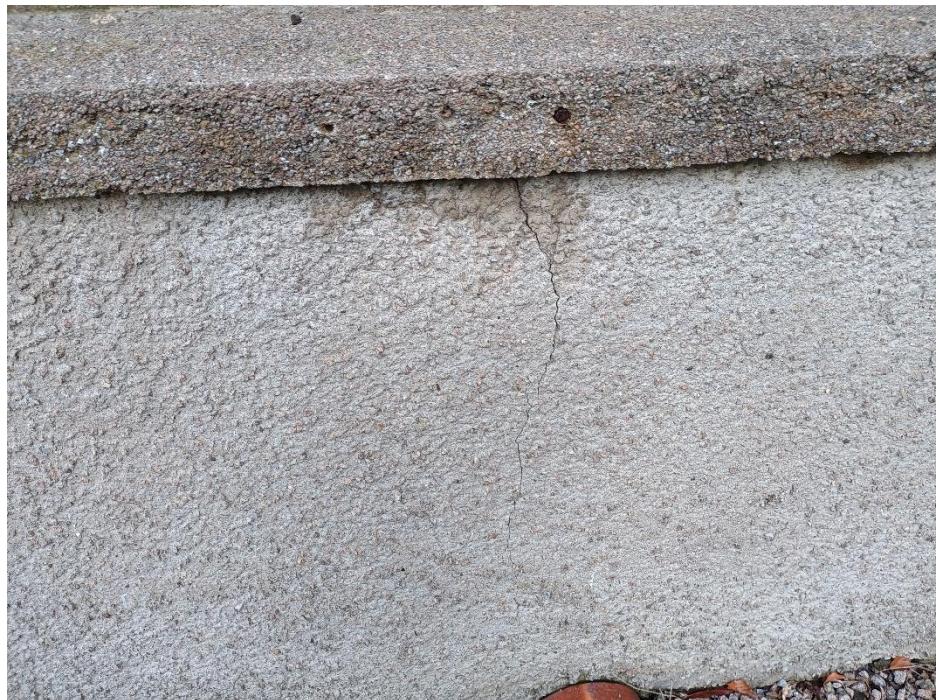
*Figure A3. Hairline to fine cracking below the sill of the window of the kitchen at the extension kitchen*

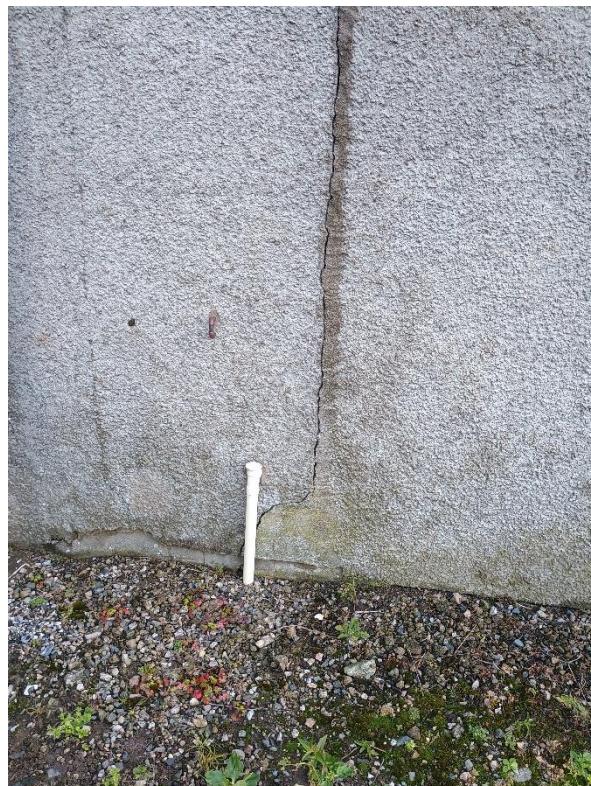
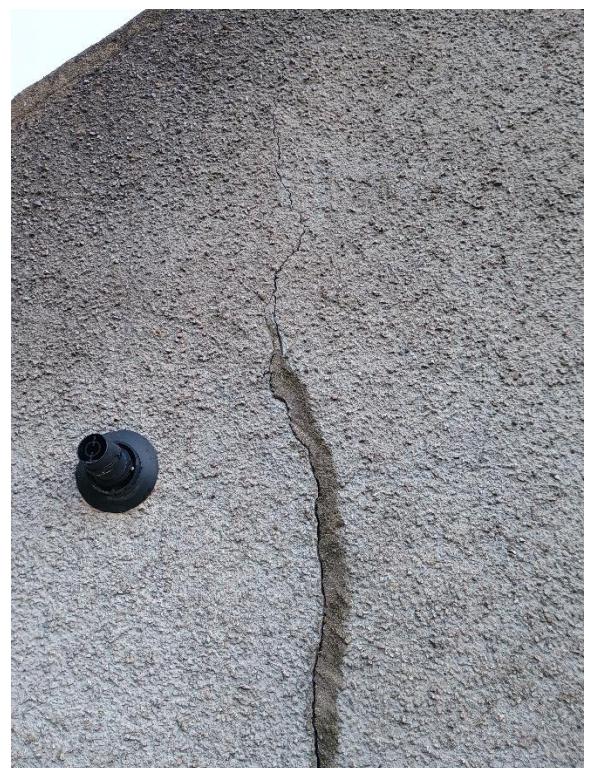
*Figure A4 & A5. Vertical crack on extension gable with signs of defective historic repair*

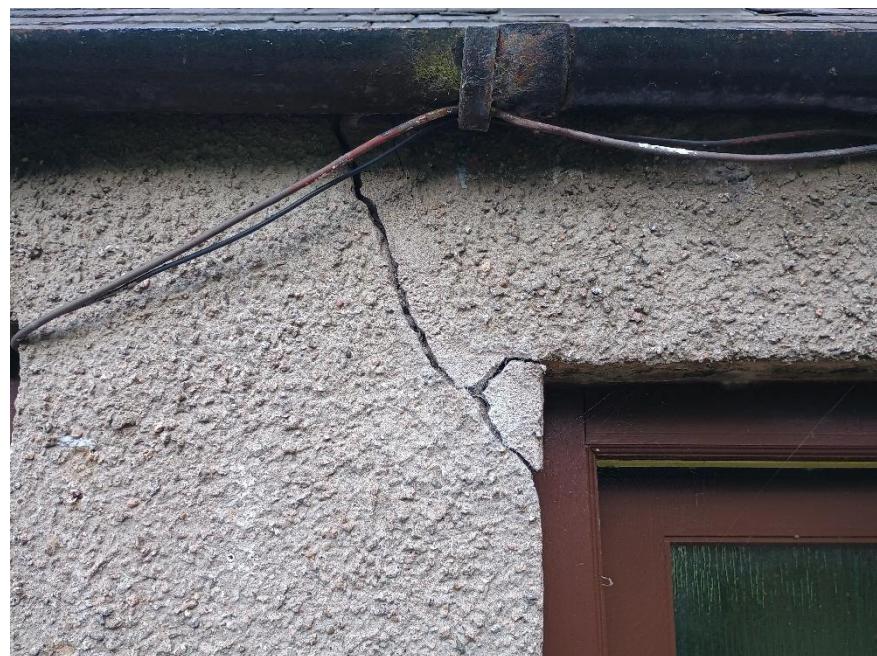
*Figure A6. Cracking at the extension door*

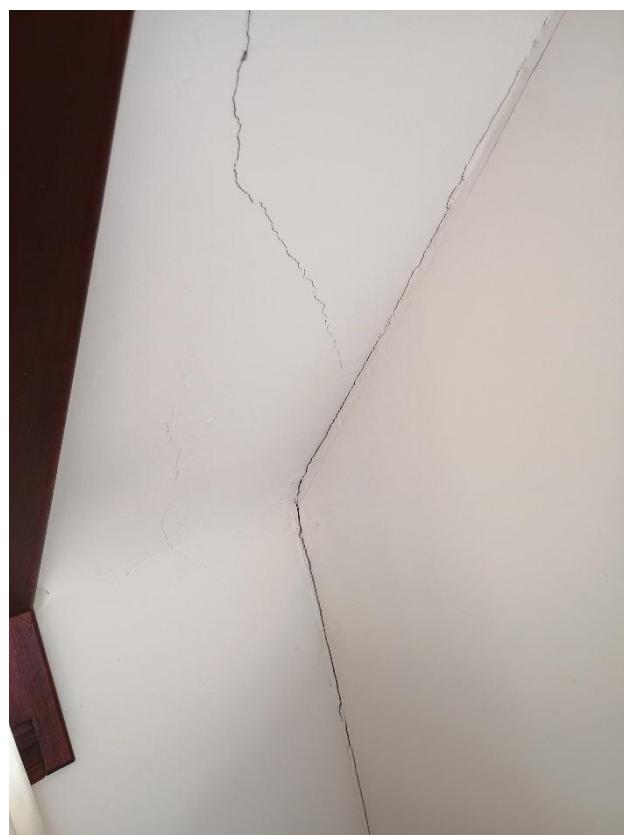
*Figure A7. Internal cracking at the corner of the first floor bedroom correlation with the external crack as indicated in Figure A1.*

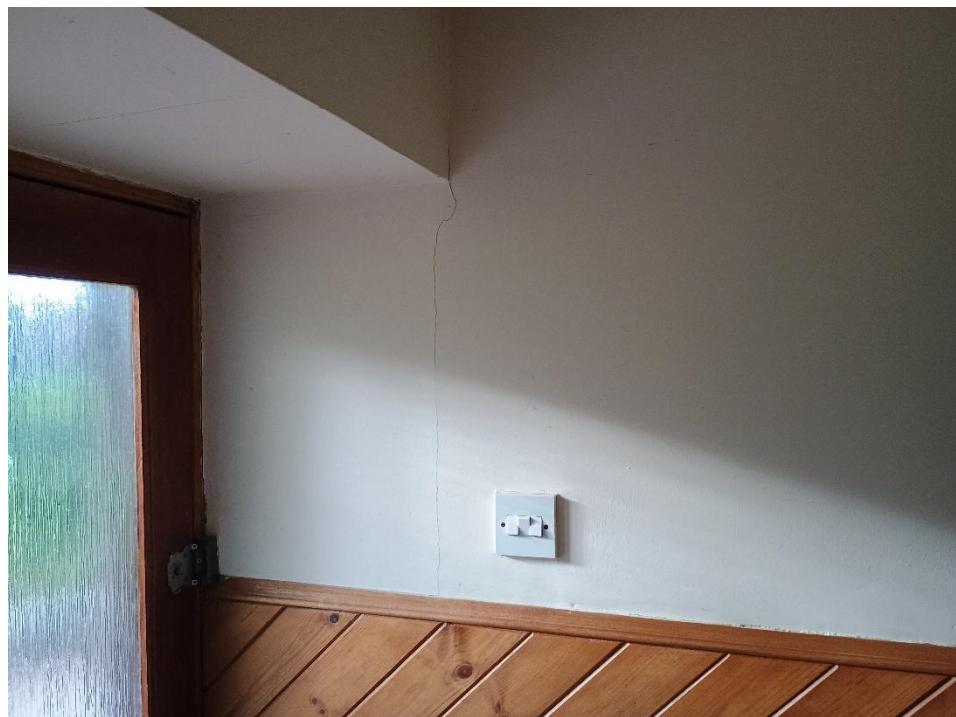
*Figure A8. Internal cracking observed at the extension door*

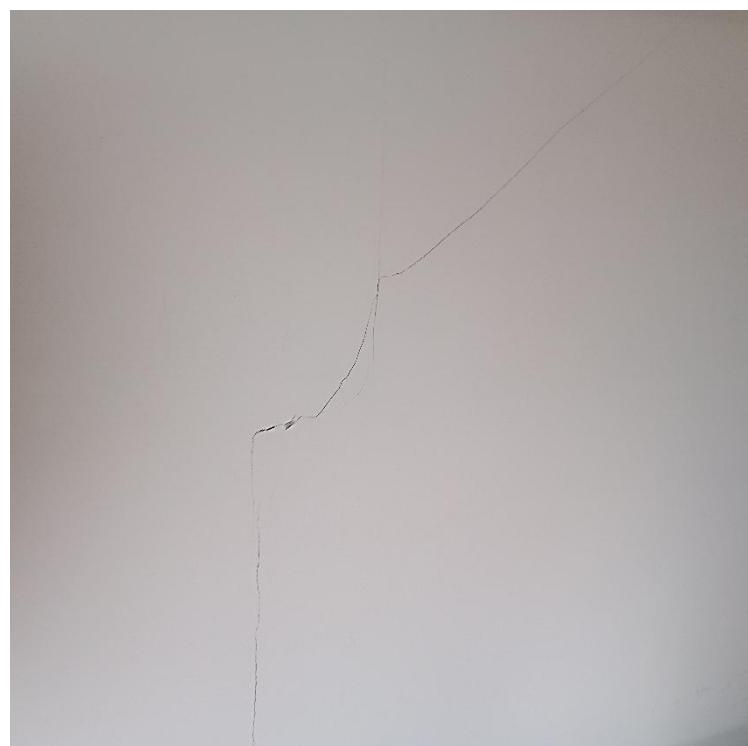
*Figure A9. Hairline to fine cracking as typically observed on internal wall finishes*
