Home Report

Single Survey

Property address	Bellevue House Church Street Cromarty IV11 8XA
Customer	Ms Mairi MacNeil & Mr William Alexander.
Customer address	
Prepared by	Shepherd Chartered Surveyors
Date of inspection	25/06/2024

SURVEY REPORT

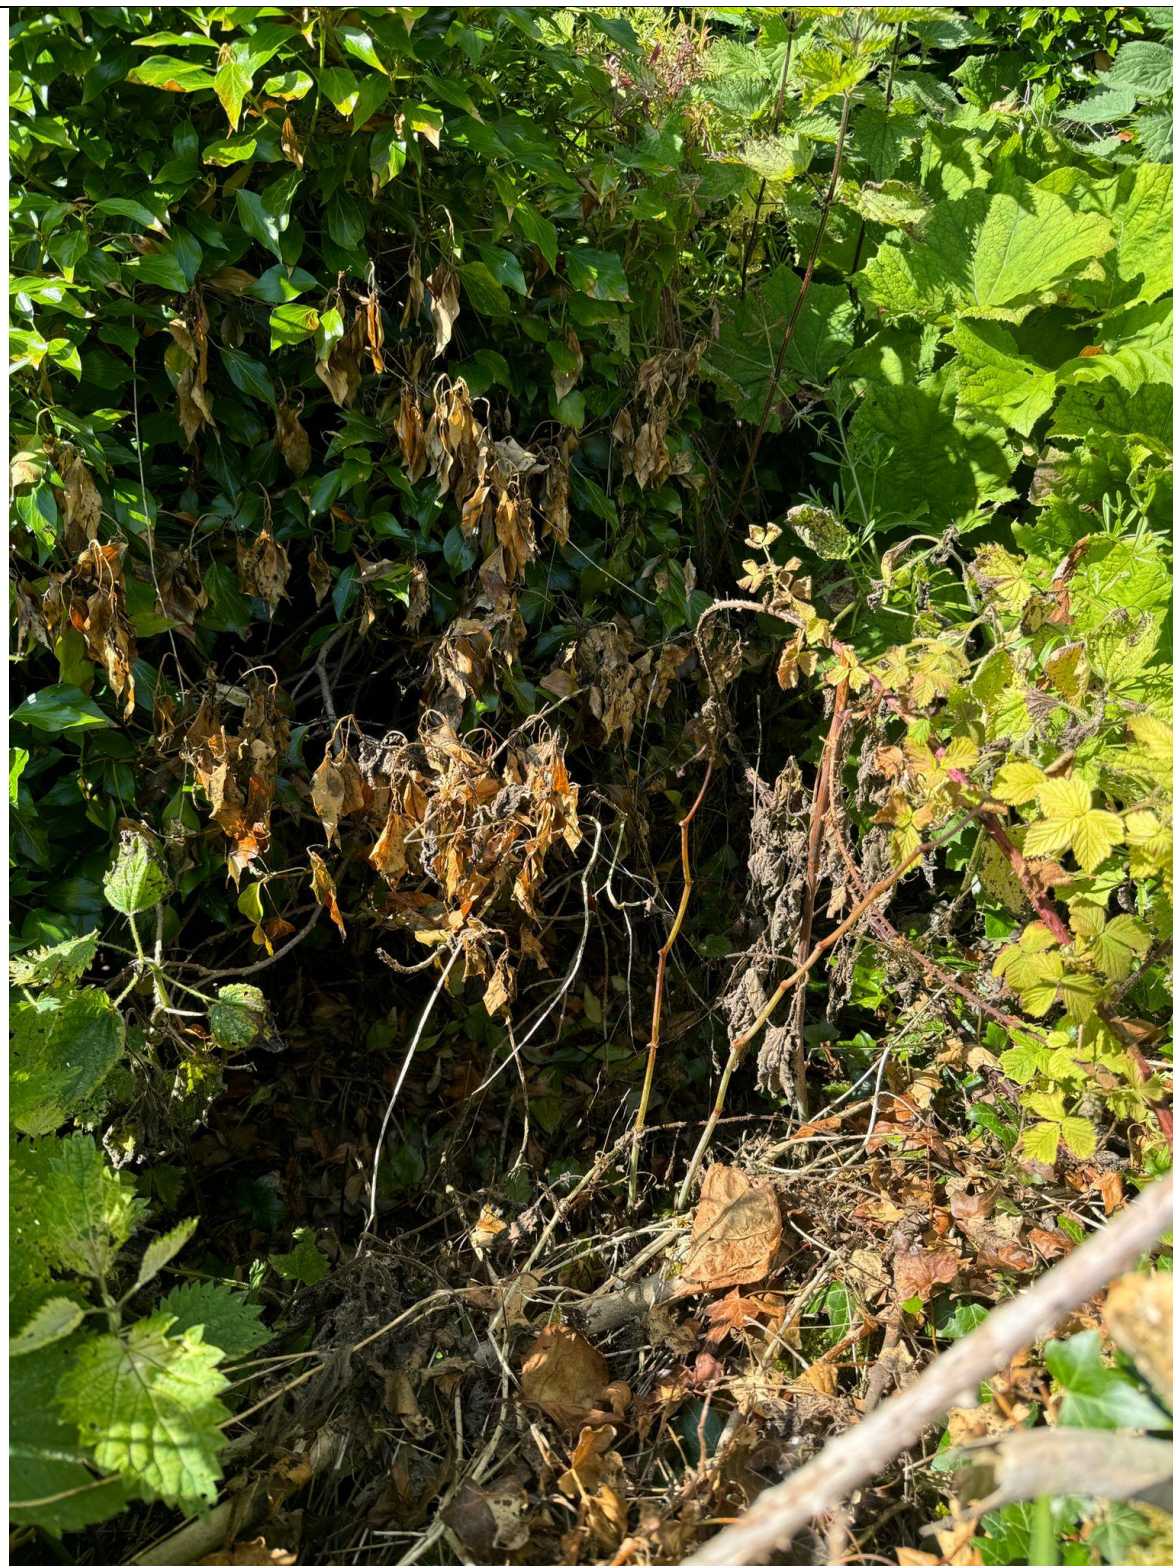
Evidence of dead canes and disturbed small growth underneath overgrown vegetation and weeds.

Img 3; dead Japanese Knotweed canes

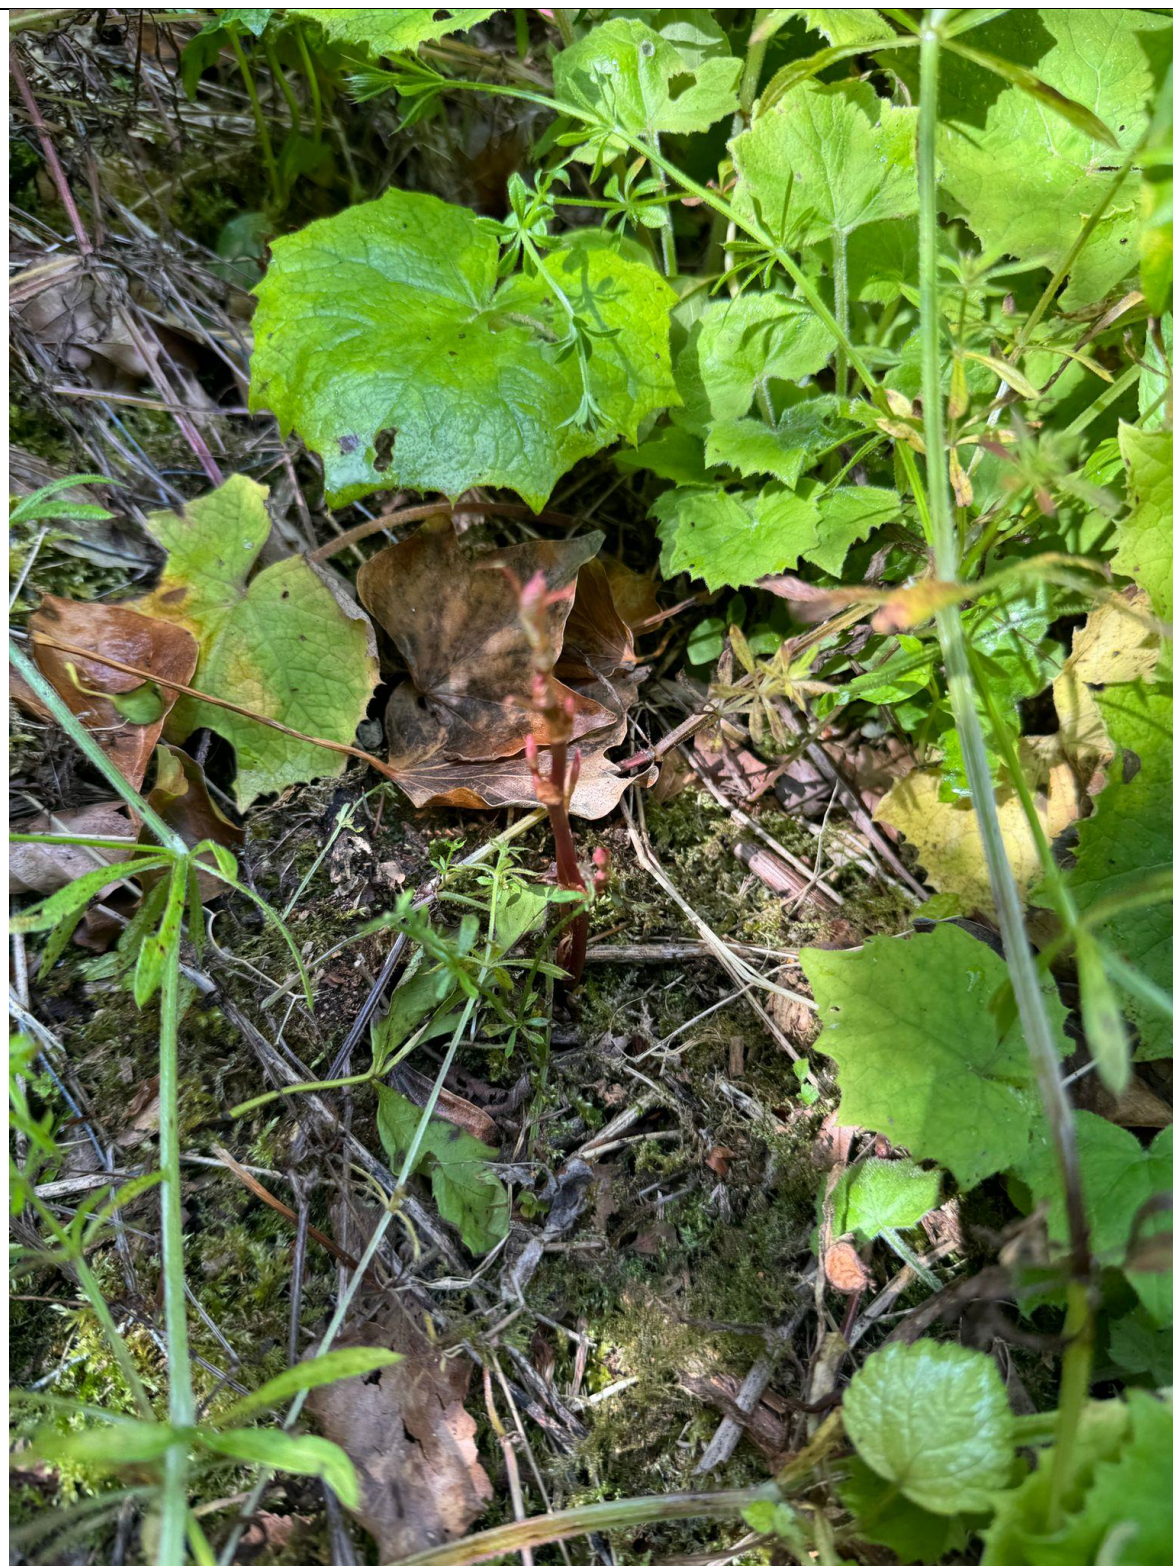
There is evidence of what appears to be Japanese Knotweed in the back garden. Japanese Knotweed is an invasive plant which can cause damage to its surroundings. Some mortgage providers may restrict or refuse loan facilities when Japanese Knotweed is present. It is understood that a full assessment has been undertaken by an experienced contractor and that this is now being treated. A copy of this report should be obtained.

Management Category C (Manage): Japanese knotweed is present but not causing damage or affecting amenity. It has minimal impact on property value, and remediation costs are at the owner's discretion.

Img 4; Japanese Knotweed regrowth
