Home Report

Keillor House Kettins PH13 9JT

single survey

survey report on:

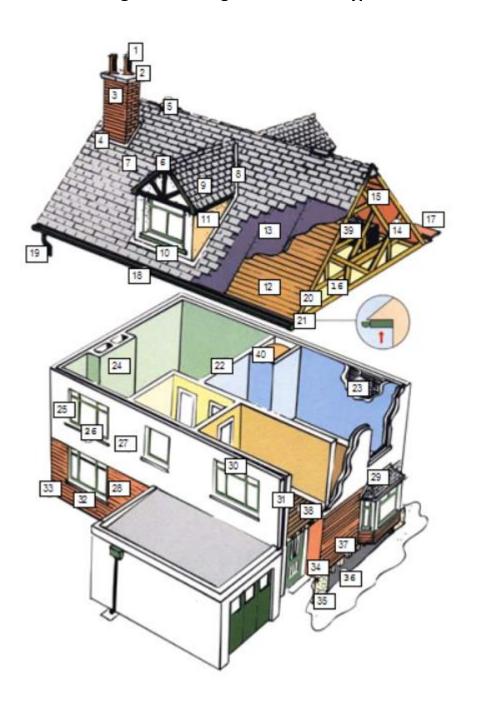
Sectional Diagram showing elements of a typical house

Chimney pots Coping stone 3 Chimney head **Flashing** Ridge ventilation Ridge board Slates/tiles Valley guttering Dormer projection 10 Dormer flashing 11 Dormer cheeks 12 Sarking 13 Roof felt 14 Trusses 15 Collar 16 Insulation 17 Parapet gutter 18 Eaves guttering 19 Rainwater downpipe 20 Verge boards / skews 21 Soffit boards 22 Partition wall 23 Lath / plaster 24 Chimney breast 25 Window pointing 26 Window sills 27 Rendering 28 Brickwork / pointing 29 Bay window 30 Lintels 31 Cavity walls / wall ties 32 Subfloor ventilator 33 Damp proof course 34 Base course 35 **Foundations** 36 Solum
