Home Report

Scottish Single Survey

Property address	Rowancliff Tradespark Road Nairn IV12 5NF
-------------------------	--

Prepared by	Shepherd Chartered Surveyors
--------------------	------------------------------

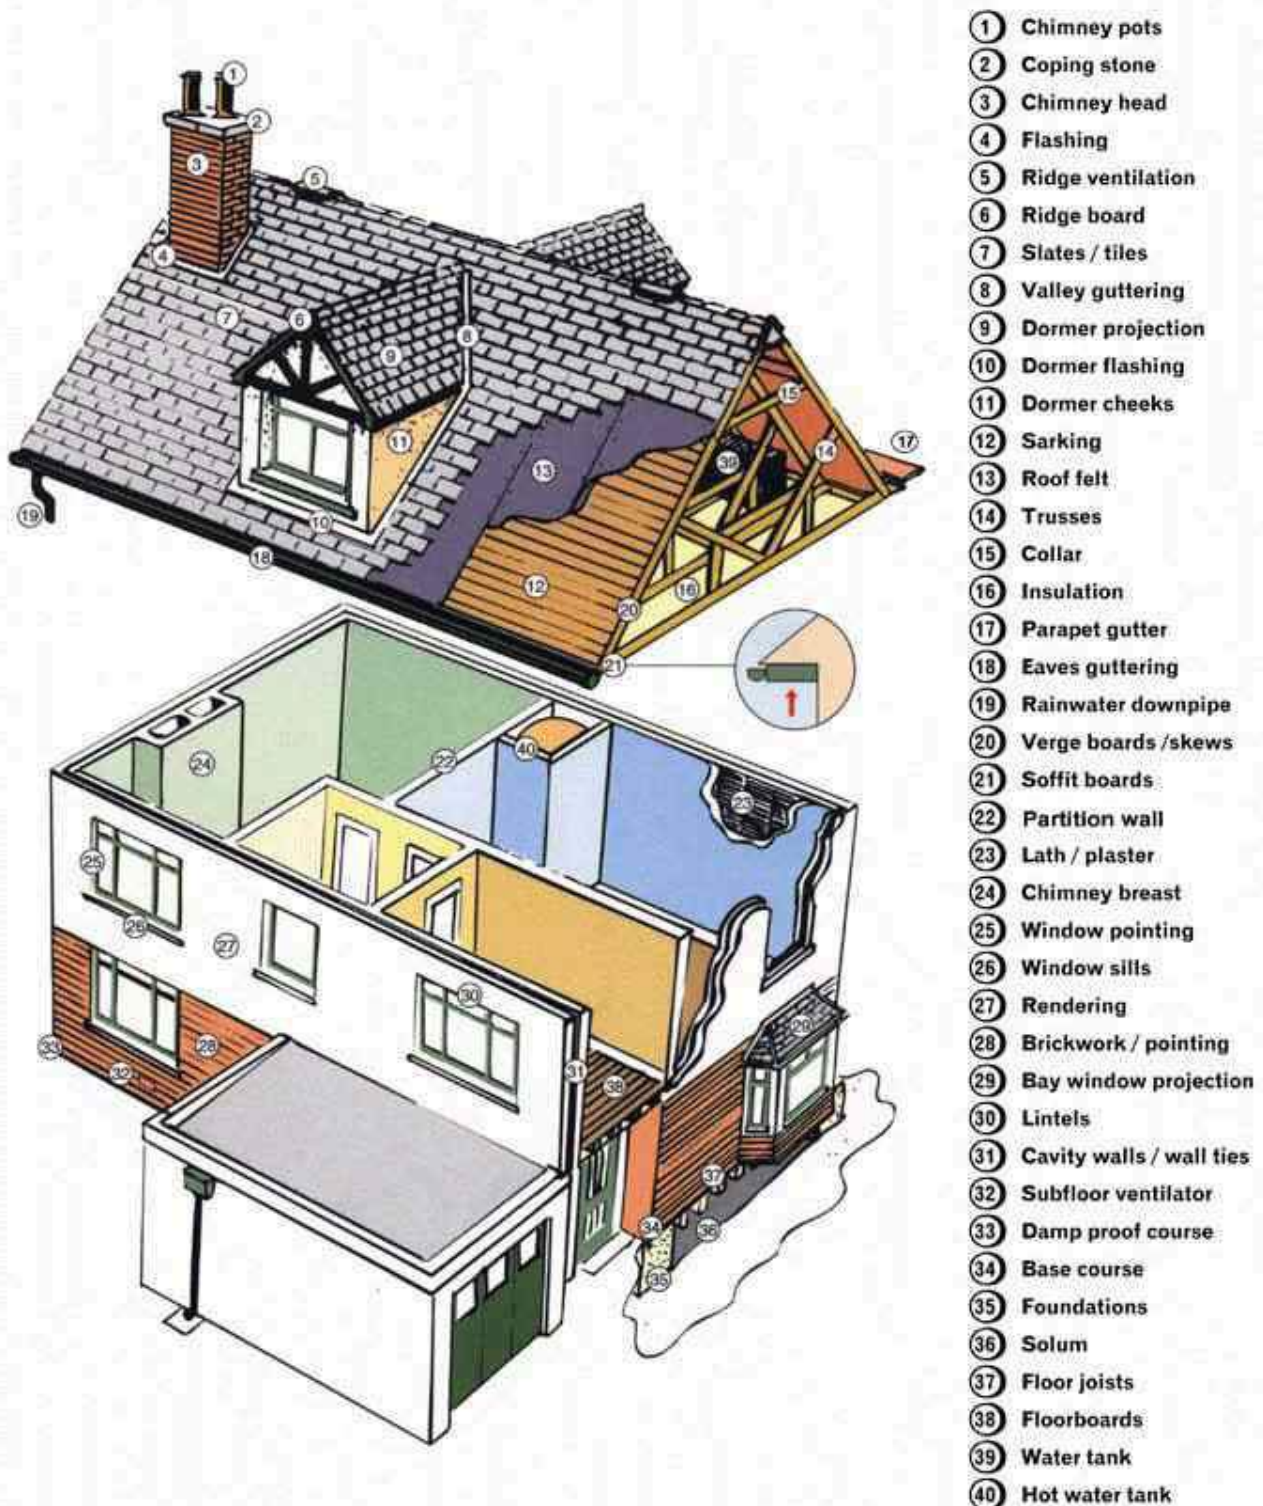
Sectional Diagram showing elements of a typical house

Reference may be made in this report to some or all of the above component parts of the property. This diagram may assist you in locating and understanding these items.

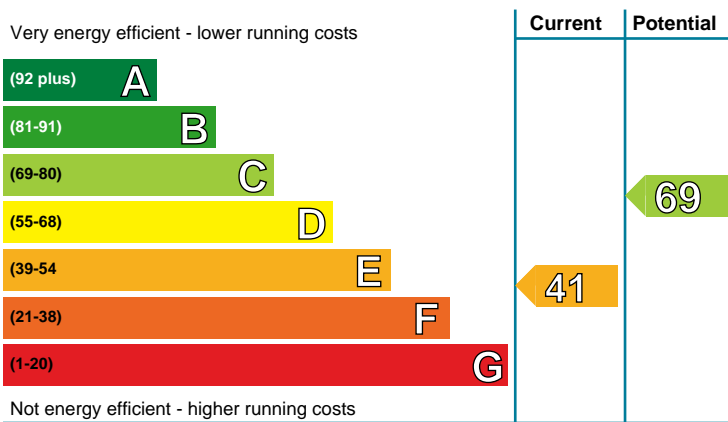
Energy Efficiency Rating

This graph shows the current efficiency of your home, taking into account both energy efficiency and fuel costs. The higher this rating, the lower your fuel bills are likely to be.

Your current rating is **band E (41)**. The average rating for EPCs in Scotland is **band D (61)**.

The potential rating shows the effect of undertaking all of the improvement measures listed within your recommendations report.

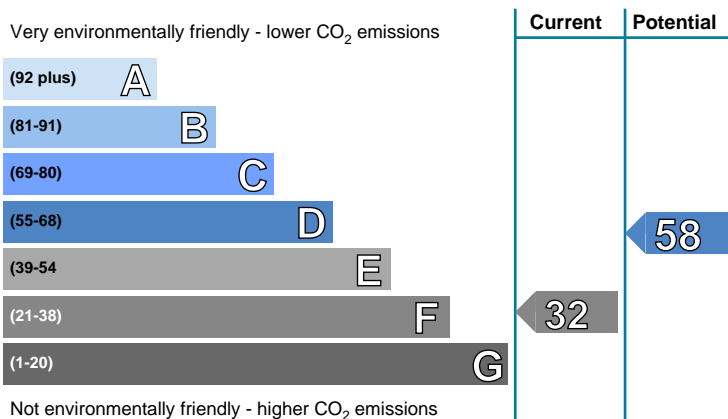
Environmental Impact (CO₂) Rating

This graph shows the effect of your home on the environment in terms of carbon dioxide (CO₂) emissions. The higher the rating, the less impact it has on the environment.
