HOME REPORT

HAZLIEBRAE FARM

LOCKERBIE
DG11 1LZ

Energy Performance Certificate (EPC)

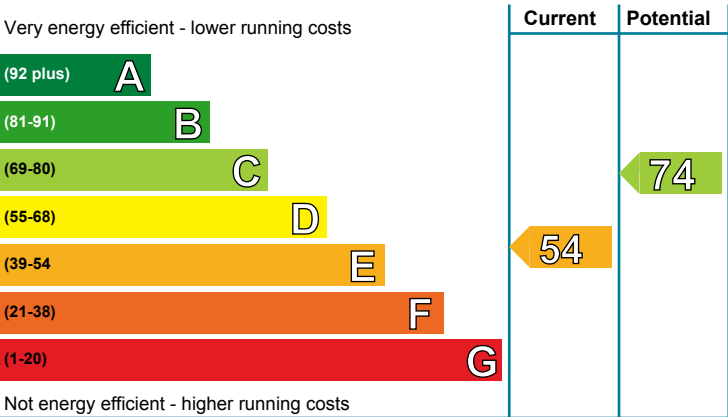
Energy Efficiency Rating

This graph shows the current efficiency of your home, taking into account both energy efficiency and fuel costs. The higher this rating, the lower your fuel bills are likely to be.

Your current rating is **band E (54)**. The average rating for EPCs in Scotland is **band D (61)**.

The potential rating shows the effect of undertaking all of the improvement measures listed within your recommendations report.

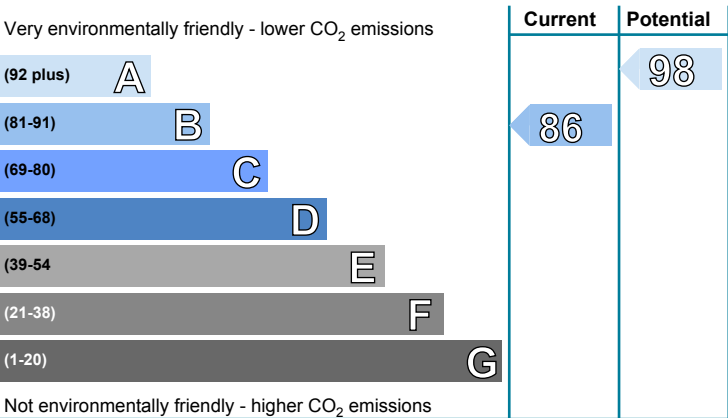
Environmental Impact (CO₂) Rating

This graph shows the effect of your home on the environment in terms of carbon dioxide (CO₂) emissions. The higher the rating, the less impact it has on the environment.

Your current rating is **band B (86)**. The average rating for EPCs in Scotland is **band D (59)**.

The potential rating shows the effect of undertaking all of the improvement measures listed within your recommendations report.
