# Single Survey

<b>Property Address</b>	Fieldside Mains of Tulloch St Katherines Inverurie AB51 8UB
<b>Customer</b>	Mr & Mrs S & J Thompson
<b>Date of Inspection</b>	15/01/2026
<b>Prepared by</b>	Ryan Stewart Walker Fraser Steele

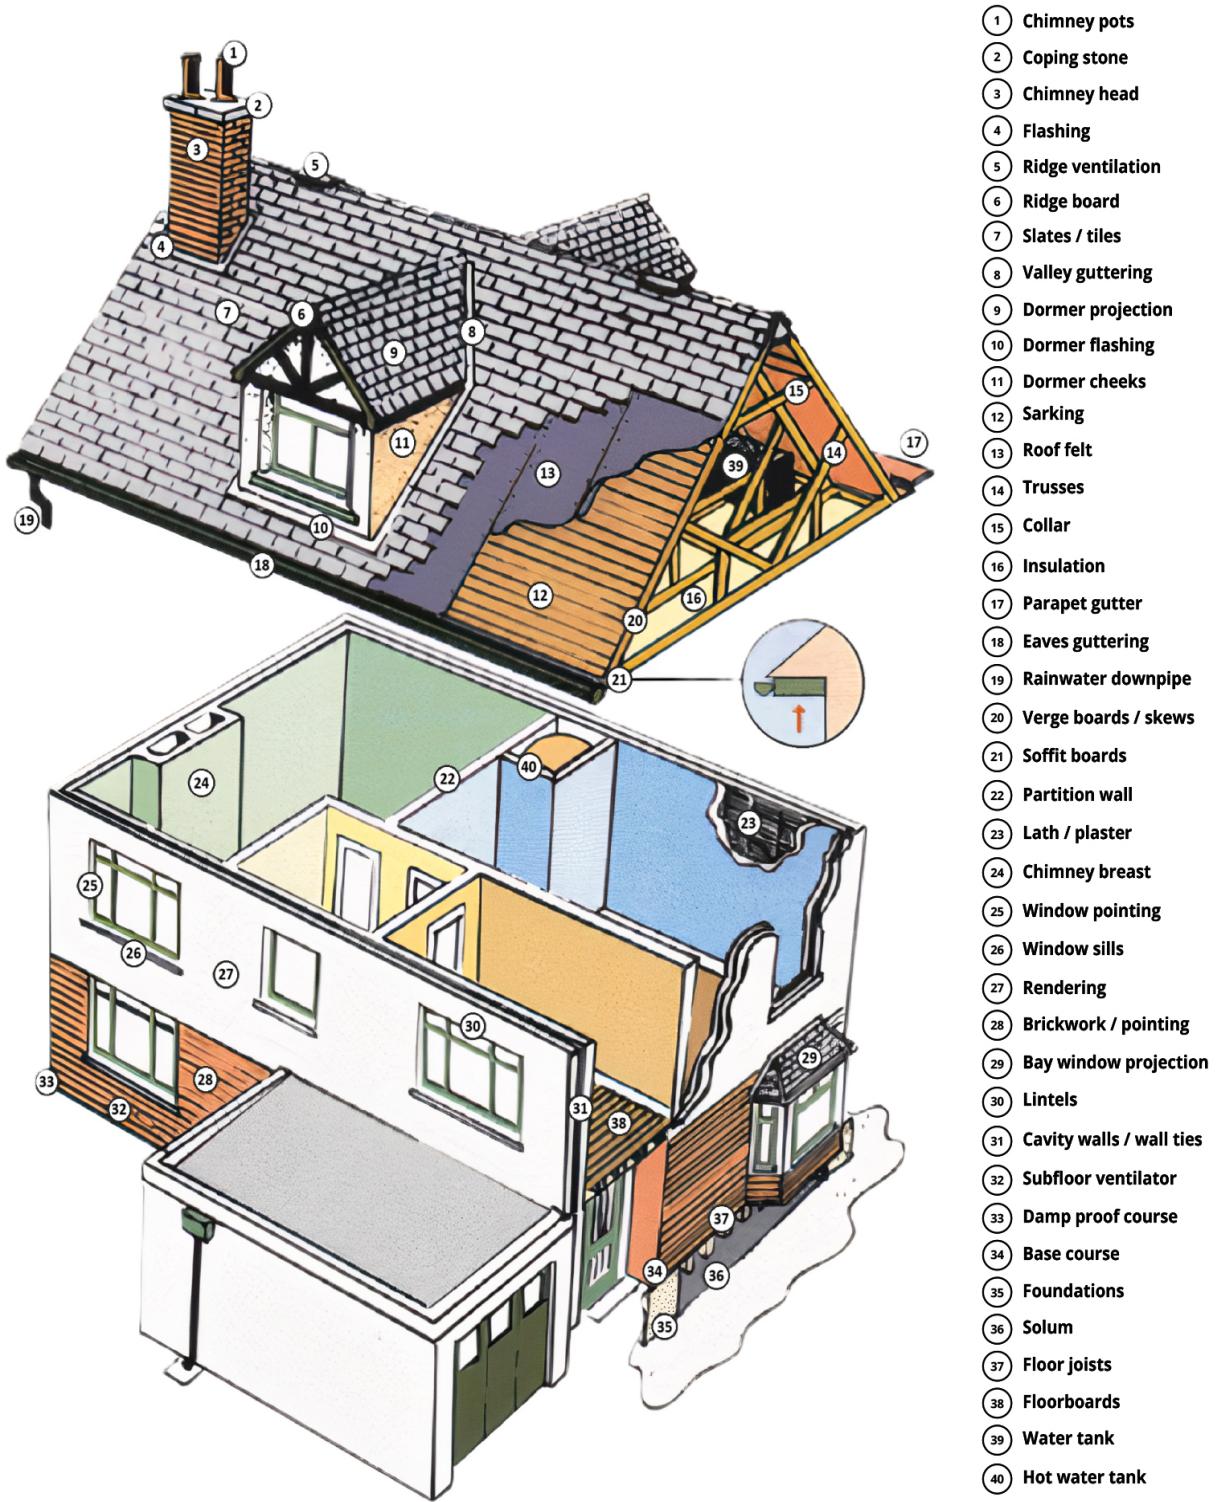
## Sectional Diagram showing elements of a typical house

Reference may be made in this report to some or all of the above component parts of the property. This diagram may assist you in locating and understanding these items.
