# Single Survey

<b>Property address</b>	"THE NEUK BOTHY" MEIKLE WARTLE INVERURIE ABERDEENSHIRE AB51 5BT
<b>Customer</b>	R. RAVENSHEAR
<b>Customer address</b>	"THE NEUK" MEIKLE WARTLE INVERURIE ABERDEENSHIRE AB51 5BT
<b>Prepared by</b>	Home Report Company
<b>Date of Inspection</b>	28 <sup>TH</sup> JUNE 2022

## 1. Information and scope of inspection

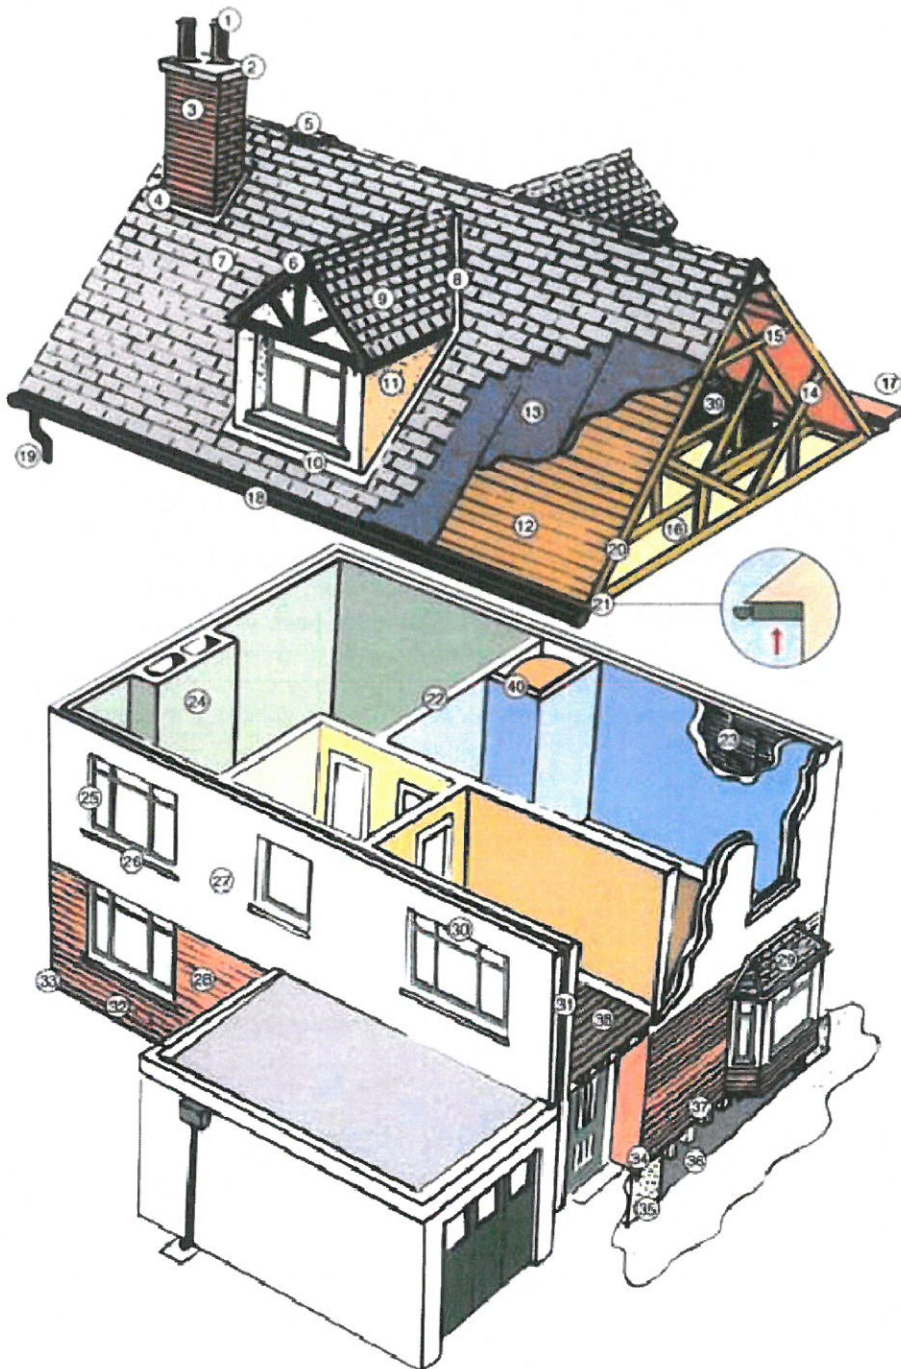
## Sectional Diagram showing elements of a typical house

- ① Chimney pots
- ② Coping stone
- ③ Chimney head
- ④ Flashing
- ⑤ Ridge ventilation
- ⑥ Ridge board
- ⑦ Slates / tiles
- ⑧ Valley guttering
- ⑨ Dormer projection
- ⑩ Dormer flashing
- ⑪ Dormer cheeks
- ⑫ Sarking
- ⑬ Roof felt
- ⑭ Trusses
- ⑮ Collar
- ⑯ Insulation
- ⑰ Parapet gutter
- ⑱ Eaves guttering
- ⑲ Rainwater downpipe
- ⑳ Verge boards /skews
- ㉑ Soffit boards
- ㉒ Partition wall
- ㉓ Lath / plaster
- ㉔ Chimney breast
- ㉕ Window pointing
- ㉖ Window sills
- ㉗ Rendering
- ㉘ Brickwork / pointing
- ㉙ Bay window projection
- ㉚ Lintels
- ㉛ Cavity walls / wall ties
- ㉜ Subfloor ventilator
- ㉝ Damp proof course
- ㉞ Base course
- ㉟ Foundations
- ㊱ Solum
- ㊲ Floor joists
- ㊳ Floorboards
- ㊴ Water tank
- ㊵ Hot water tank

Reference may be made in this report to some or all of the above component parts of the property. This diagram may assist you in locating and understanding these items.

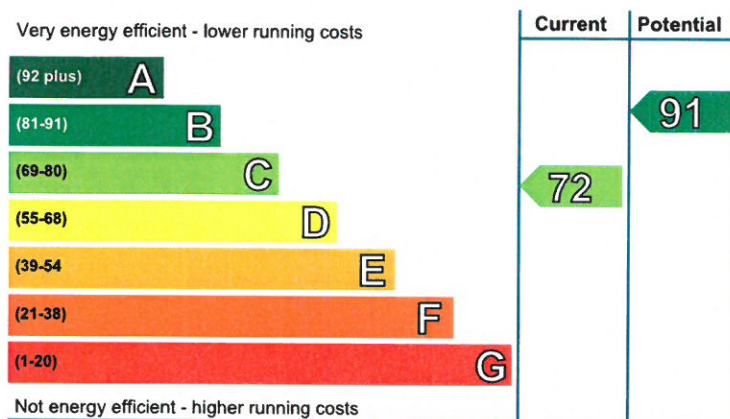
## Energy Efficiency Rating

This graph shows the current efficiency of your home, taking into account both energy efficiency and fuel costs. The higher this rating, the lower your fuel bills are likely to be.

Your current rating is **band C (72)**. The average rating for EPCs in Scotland is **band D (61)**.

The potential rating shows the effect of undertaking all of the improvement measures listed within your recommendations report.

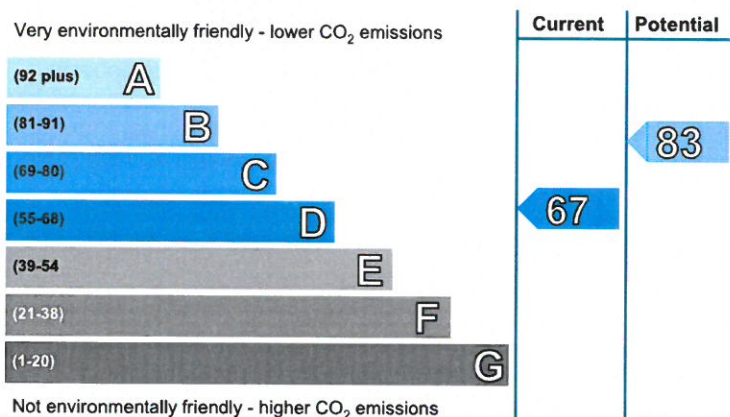
## Environmental Impact (CO<sub>2</sub>) Rating

This graph shows the effect of your home on the environment in terms of carbon dioxide (CO<sub>2</sub>) emissions. The higher the rating, the less impact it has on the environment.
