YOUR ONESURVEY
HOME REPORT

The Old Mill
Berryhillock
Deskford, Buckie
AB56 5YA

SINGLE SURVEY

Single Survey

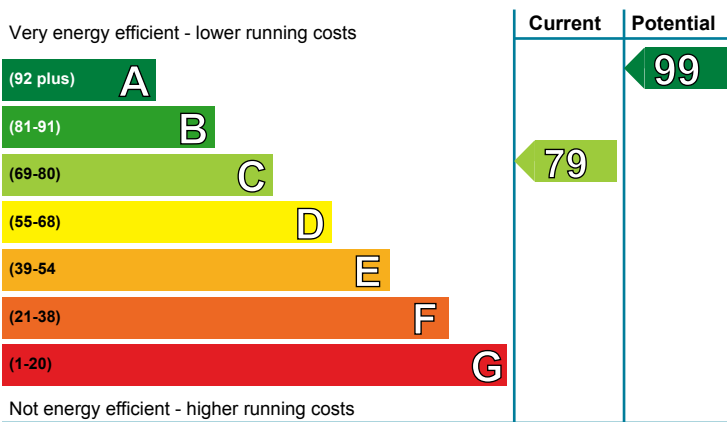
Energy Efficiency Rating

This graph shows the current efficiency of your home, taking into account both energy efficiency and fuel costs. The higher this rating, the lower your fuel bills are likely to be.

Your current rating is **band C (79)**. The average rating for EPCs in Scotland is **band D (61)**.

The potential rating shows the effect of undertaking all of the improvement measures listed within your recommendations report.

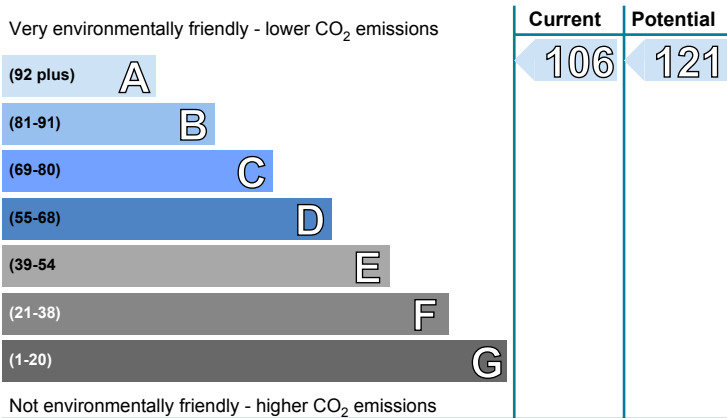
Environmental Impact (CO₂) Rating

This graph shows the effect of your home on the environment in terms of carbon dioxide (CO₂) emissions. The higher the rating, the less impact it has on the environment.
