# Home Report

# Single Survey

<b>Property address</b>	Corner Cottage Kingsford Stewarton Kilmarnock KA3 5JS
-------------------------	---

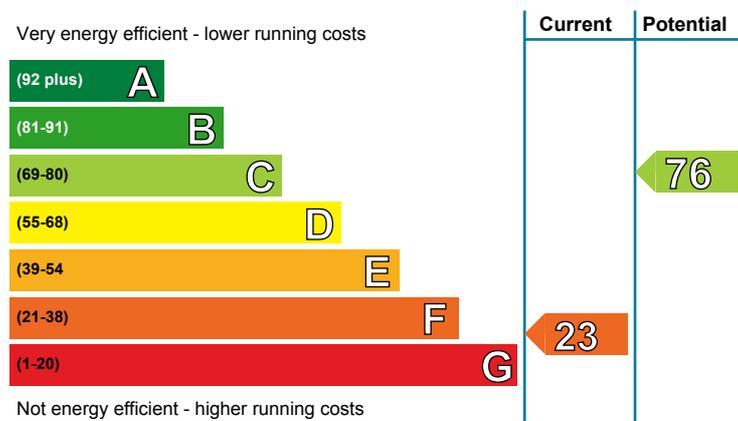
## Energy Efficiency Rating

This graph shows the current efficiency of your home, taking into account both energy efficiency and fuel costs. The higher this rating, the lower your fuel bills are likely to be.

Your current rating is **band F (23)**. The average rating for EPCs in Scotland is **band D (61)**.

The potential rating shows the effect of undertaking all of the improvement measures listed within your recommendations report.

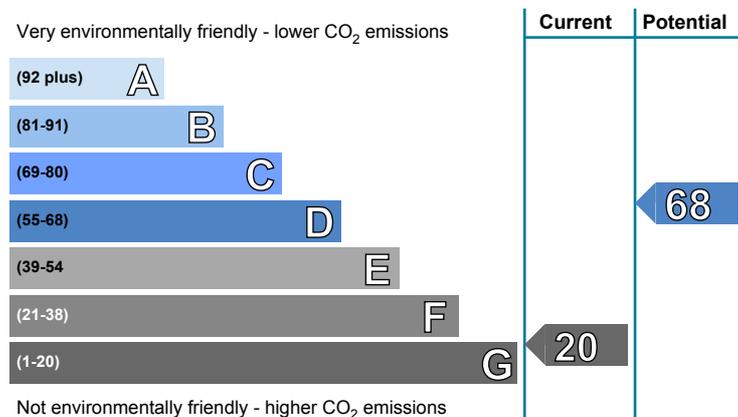
## Environmental Impact (CO<sub>2</sub>) Rating

This graph shows the effect of your home on the environment in terms of carbon dioxide (CO<sub>2</sub>) emissions. The higher the rating, the less impact it has on the environment.
