## Home Report

Creag Raineach Keltneyburn Aberfeldy PH15 2LQ

# single survey

Property address	Creag Raineach Keltneyburn
	Aberfeldy
	PH15 2LQ

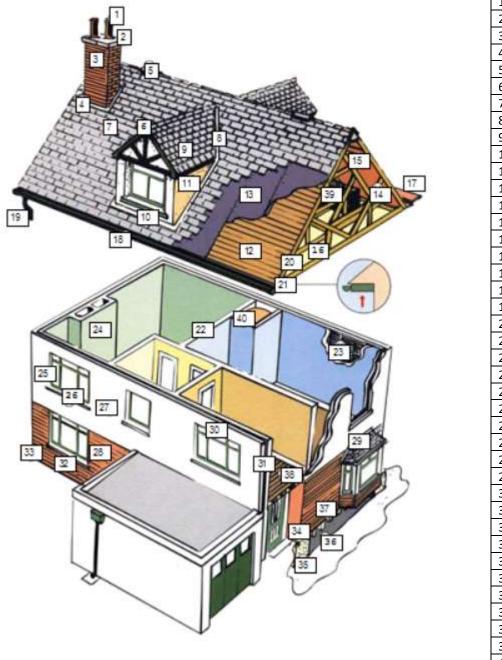
## Sectional Diagram showing elements of a typical house

Reference may be made in this report to some or all of the above component parts of the property. This diagram may assist you in locating and understanding these items.

1	Chimney pots
2	Coping stone
3	Chimney head
4	Flashing
5	Ridge ventilation
6	Ridge board
7	Slates/tiles
8	Valley guttering
9	Dormer projection
10	Dormer flashing
11	Dormer cheeks
12	Sarking
13	Roof felt
14	Trusses
15	Collar
16	Insulation
17	Parapet gutter
18	Eaves guttering
19	Rainwater downpipe
20	Verge boards / skews
21	Soffit boards
22	Partition wall
23	Lath / plaster
24	Chimney breast
25	Window pointing
26	Window sills
27	Rendering
28	Brickwork / pointing
29	Bay window
30	Lintels
31	Cavity walls / wall ties
32	Subfloor ventilator
33	Damp proof course
34	Base course
35	Foundations
36	Solum
37	Floor joists
38	Floorboards
39	Water tank
40	Hot water tank
