# Home Report

Bridge of Cally PH10 7LQ

# single survey

Property address	Inner Persie
	Bridge of Cally PH10 7LQ
	·
Customer	Mr + Mrs Smith

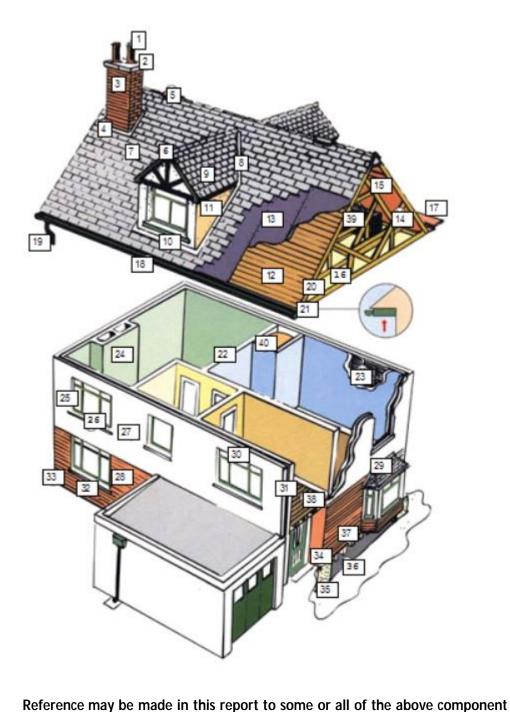
# Sectional Diagram showing elements of a typical house

Chimney pots 1 2 Coping stone 3 Chimney head Flashing 4 Ridge ventilation 5 Ridge board 6 7 Slates/tiles 8 Valley guttering 9 Dormer projection Dormer flashing 10 Dormer cheeks 11 12 Sarking Roof felt 13 Trusses 14 15 Collar 16 Insulation 17 Parapet gutter Eaves guttering 18 Rainwater downpipe 19 20 Verge boards / skews 21 Soffit boards 22 Partition wall Lath / plaster 23 24 Chimney breast 25 Window pointing Window sills 26 Rendering 27 Brickwork / pointing 28 Bay window 29 30 Lintels 31 Cavity walls / wall ties Subfloor ventilator 32 33 Damp proof course 34 Base course 35 Foundations Solum 36 37 Floor joists Floorboards 38 Water tank 39 40 Hot water tank parts of the property. This diagram may assist you in locating and understanding
