YOUR ONESURVEY HOME REPORT

Erin View
Slockmill
Drummore, Stranraer
DG9 9HG

SINGLE SURVEY

Customer	Mr & Mrs. George & Shirley Sephton
Selling address	Erin View Slockmill Drummore, Stranraer DG9 9HG
Date of Inspection	23/06/2025
Prepared by	Scott Morton, BSc (Hons) MRICS Dumfries - Allied Surveyors Scotland Ltd

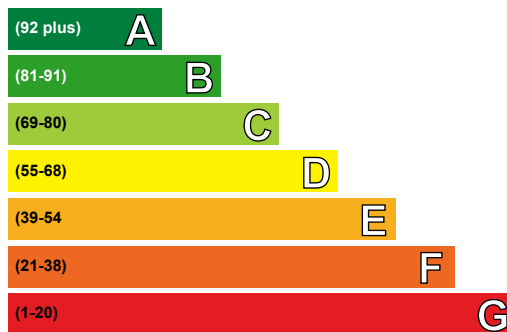
* based upon the cost of energy for heating, hot water, lighting and ventilation, calculated using standard assumptions

Very energy efficient - lower running costs

Not energy efficient - higher running costs

Current	Potential
52	81

The potential rating shows the effect of undertaking all of the improvement measures listed within your recommendations report.
