# Home Report

# Single Survey

Property address	Deadwaters Farm Lesmahagow Lanark ML11 0JH
Customer	Malcolm MacIntyre
Customer address	Deadwaters Farm Lesmahagow Lanark ML11 0JH
Prepared by	Shepherd Chartered Surveyors
Date of inspection	09/07/2025

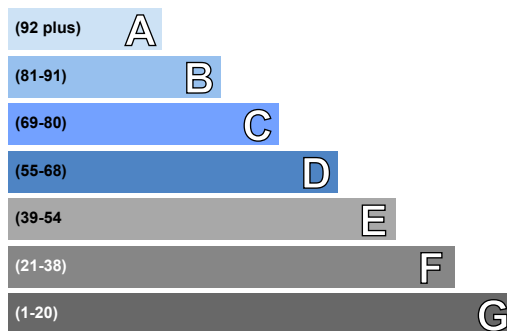
## Environmental Impact (CO<sub>2</sub>) Rating

Current	Potential
35	58
