Home Report

Scottish Single Survey

Single Survey

Property address	South Thorn Aiket Road Dunlop Kilmarnock KA3 4BP
Customer	Mrs M Justice
Customer address	South Thorn Aiket Road Dunlop Kilmarnock KA3 4BP
Prepared by	Shepherd Chartered Surveyors
Date of inspection	18/05/2026

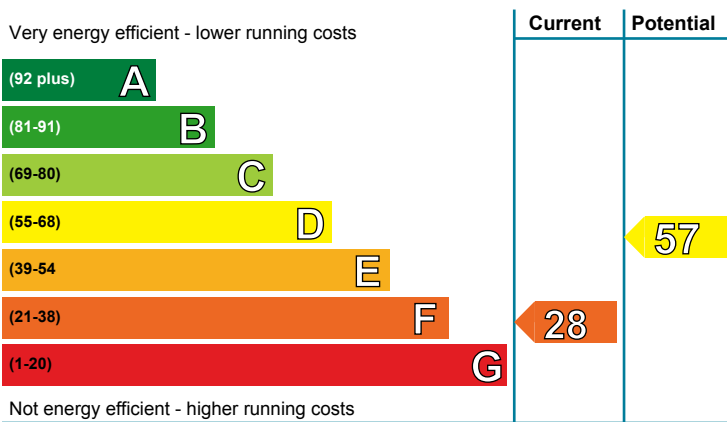
Energy Efficiency Rating

This graph shows the current efficiency of your home, taking into account both energy efficiency and fuel costs. The higher this rating, the lower your fuel bills are likely to be.

Your current rating is **band F (28)**. The average rating for EPCs in Scotland is **band D (61)**.

The potential rating shows the effect of undertaking all of the improvement measures listed within your recommendations report.
