# Home Report

# Single Survey

<b>Property address</b>	Bellevue House Church Street Cromarty IV11 8XA
<b>Customer</b>	Ms Mairi MacNeil & Mr William Alexander.
<b>Customer address</b>	Bellevue House Church Street Cromarty IV11 8XA
<b>Prepared by</b>	Shepherd Chartered Surveyors
<b>Date of inspection</b>	29/05/2023

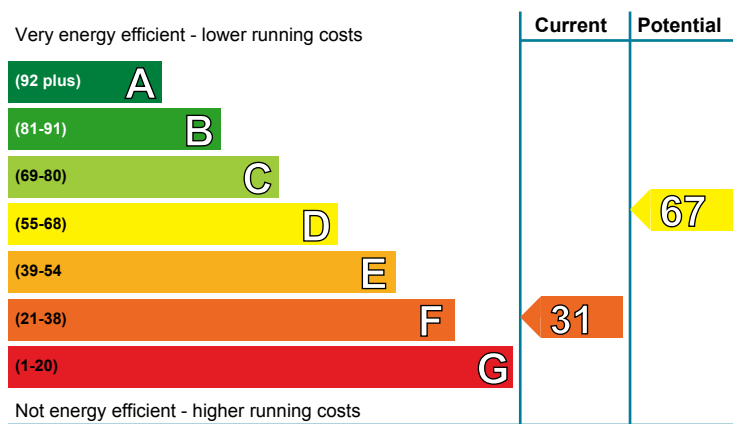
## Energy Efficiency Rating

This graph shows the current efficiency of your home, taking into account both energy efficiency and fuel costs. The higher this rating, the lower your fuel bills are likely to be.

Your current rating is **band F (31)**. The average rating for EPCs in Scotland is **band D (61)**.

The potential rating shows the effect of undertaking all of the improvement measures listed within your recommendations report.

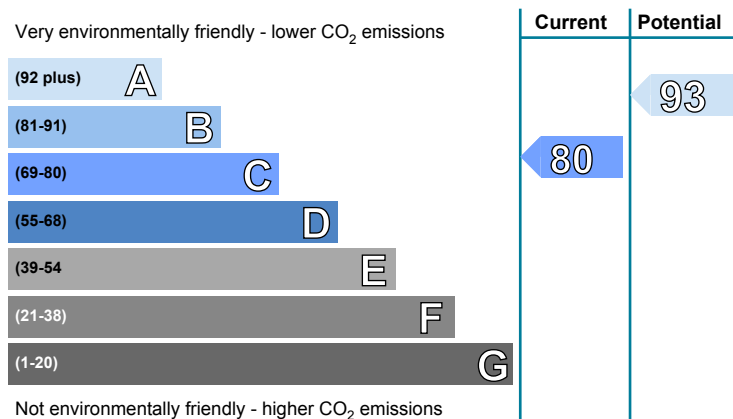
## Environmental Impact (CO<sub>2</sub>) Rating

This graph shows the effect of your home on the environment in terms of carbon dioxide (CO<sub>2</sub>) emissions. The higher the rating, the less impact it has on the environment.
