Home Report

The Bothy Camserney Farm Aberfeldy PH15 2JG

Property Address	The Bothy Camserney Farm Aberfeldy PH15 2JG
Customer	Ms Patricia Waite
Prepared by	Graham + Sibbald LLP
Date of Inspection	07/05/2025

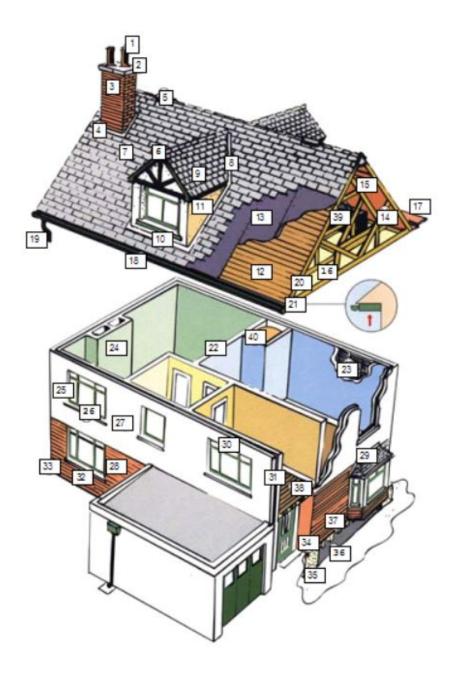
Sectional diagram showing elements of a typical house

_
1	Chimney pots
2	Coping stone
3	Chimney head
4	Flashing
5	Ridge ventilation
6	Ridge board
7	Slates / tiles
8	Valley guttering
9	Dormer projection
10	Dormer flashing
11	Dormer cheeks
12	Sarking
13	Roof felt
14	Trusses
15	Collar
16	Insulation
17	Parapet gutter
18	Eaves guttering
19	Rainwater downpipe
20	Verge boards / skews
21	Soffit boards
22	Partition wall
23	Lath / plaster
24	Chimney breast
25	Window pointing
26	Window sills
27	Rendering
28	Brickwork / pointing
29	Bay window projection
30	Lintels
31	Cavity walls / wall ties
32	Subfloor ventilator
33	Damp proof course
34	Base course
35	Foundations
36	Solum
37	Floor joists
38	Floorboards
39	Water tank
40	Hot water tank

Reference may be made in this report to some or all of the above component parts of the property. This diagram may assist you in locating and understanding these items.
