Home Report

29 Island Bank Road
Inverness IV2 4QS

Single Survey

Property Address	29 Island Bank Road Inverness IV2 4QS
Customer	Tristan Macalister Hall
Prepared by	Graham + Sibbald LLP
Date of Inspection	03/02/2025

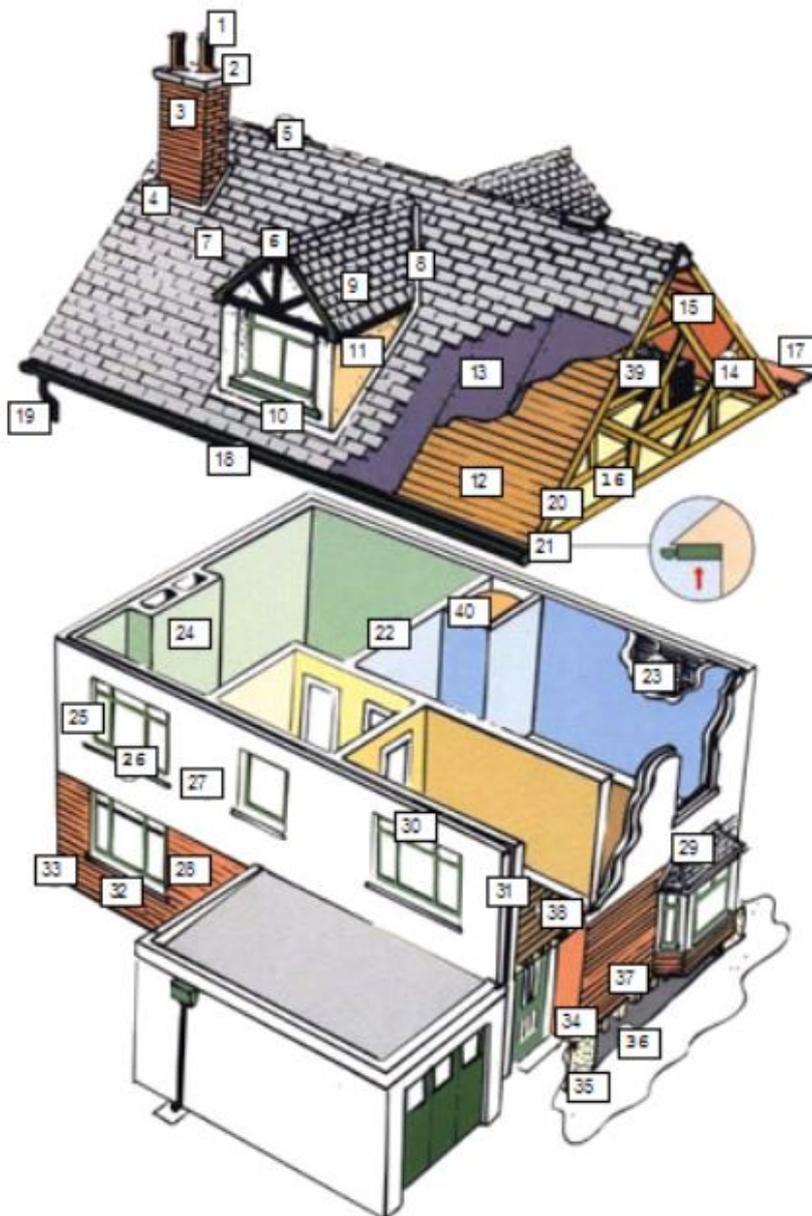
Sectional diagram showing elements of a typical house

1	Chimney pots
2	Coping stone
3	Chimney head
4	Flashing
5	Ridge ventilation
6	Ridge board
7	Slates / tiles
8	Valley guttering
9	Dormer projection
10	Dormer flashing
11	Dormer cheeks
12	Sarking
13	Roof felt
14	Trusses
15	Collar
16	Insulation
17	Parapet gutter
18	Eaves guttering
19	Rainwater downpipe
20	Verge boards / skews
21	Soffit boards
22	Partition wall
23	Lath / plaster
24	Chimney breast
25	Window pointing
26	Window sills
27	Rendering
28	Brickwork / pointing
29	Bay window projection
30	Lintels
31	Cavity walls / wall ties
32	Subfloor ventilator
33	Damp proof course
34	Base course
35	Foundations
36	Solum
37	Floor joists
38	Floorboards
39	Water tank
40	Hot water tank

Reference may be made in this report to some or all of the above component parts of the property. This diagram may assist you in locating and understanding these items.

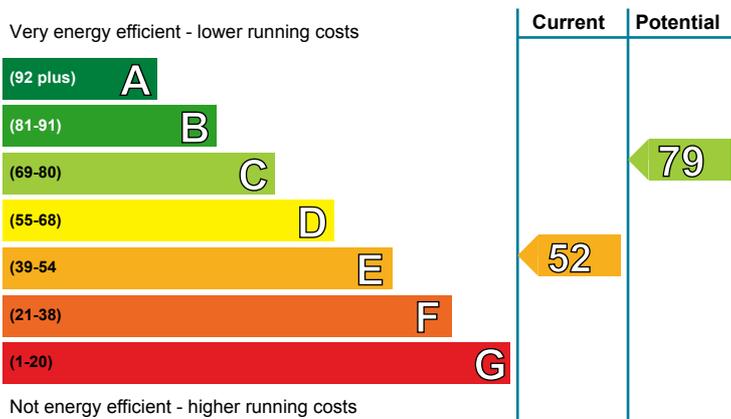
Energy Efficiency Rating

This graph shows the current efficiency of your home, taking into account both energy efficiency and fuel costs. The higher this rating, the lower your fuel bills are likely to be.

Your current rating is **band E (52)**. The average rating for EPCs in Scotland is **band D (61)**.

The potential rating shows the effect of undertaking all of the improvement measures listed within your recommendations report.
