# YOUR ONESURVEY HOME REPORT

No 1  
Easter Highgate  
Beith  
KA15 1HZ

# SINGLE SURVEY

# Single Survey

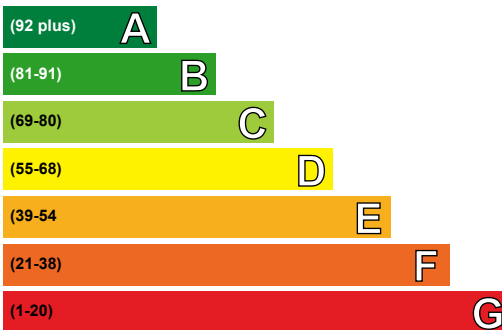
\* based upon the cost of energy for heating, hot water, lighting and ventilation, calculated using standard assumptions

Very energy efficient - lower running costs

Not energy efficient - higher running costs

The potential rating shows the effect of undertaking all of the improvement measures listed within your recommendations report.

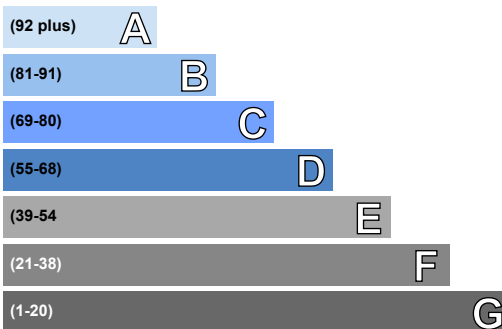
Very environmentally friendly - lower CO<sub>2</sub> emissions

Not environmentally friendly - higher CO<sub>2</sub> emissions
