Home Report

Scottish Single Survey

Single Survey

Property address	The Braes Upper Myrtlefield Inverness IV2 5BX
Customer	Mr & Mrs MacDonald
Customer address	The Braes Upper Myrtlefield Inverness IV2 5BX
Prepared by	Shepherd Chartered Surveyors
Date of inspection	26/02/2025

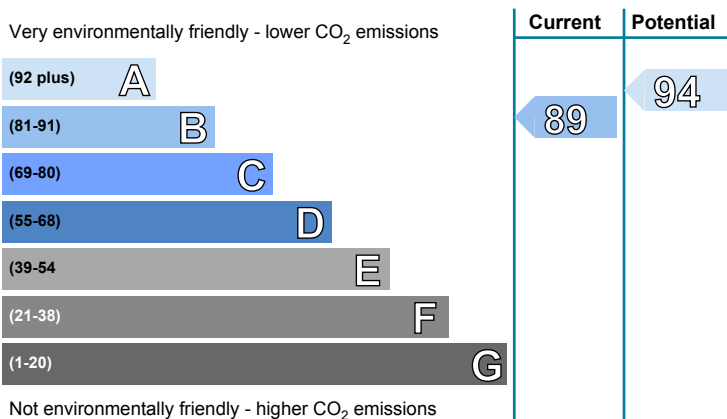
Environmental Impact (CO₂) Rating

This graph shows the effect of your home on the environment in terms of carbon dioxide (CO₂) emissions. The higher the rating, the less impact it has on the environment.
