Home Report

Scottish Single Survey

Property address	Parkfoot Farm Rosehall Road Shotts ML7 5BT
Customer	Janie Anderson
Customer address	Parkfoot Farm Rosehall Road Shotts ML7 5BT
Prepared by	Shepherd Chartered Surveyors
Date of inspection	12/05/2026

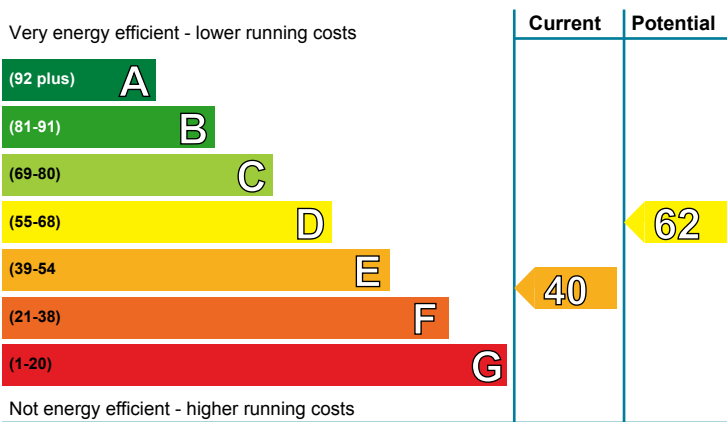
Energy Efficiency Rating

This graph shows the current efficiency of your home, taking into account both energy efficiency and fuel costs. The higher this rating, the lower your fuel bills are likely to be.

Your current rating is **band E (40)**. The average rating for EPCs in Scotland is **band D (61)**.

The potential rating shows the effect of undertaking all of the improvement measures listed within your recommendations report.

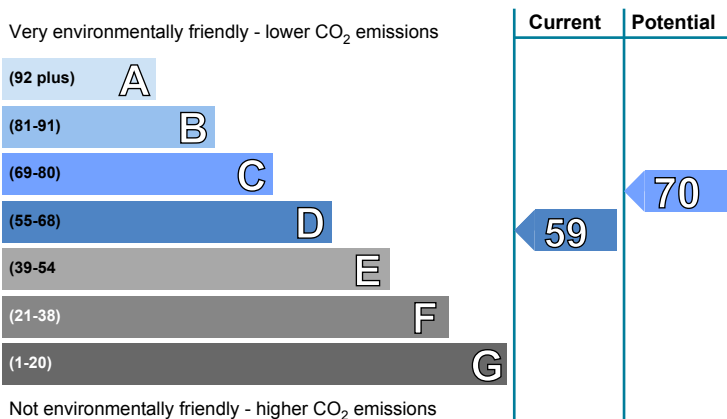
Environmental Impact (CO₂) Rating

This graph shows the effect of your home on the environment in terms of carbon dioxide (CO₂) emissions. The higher the rating, the less impact it has on the environment.
