YOUR ONESURVEY HOME REPORT

Cockmuir House
Longmorn, Elgin
IV30 8SL

SINGLE SURVEY

Single Survey

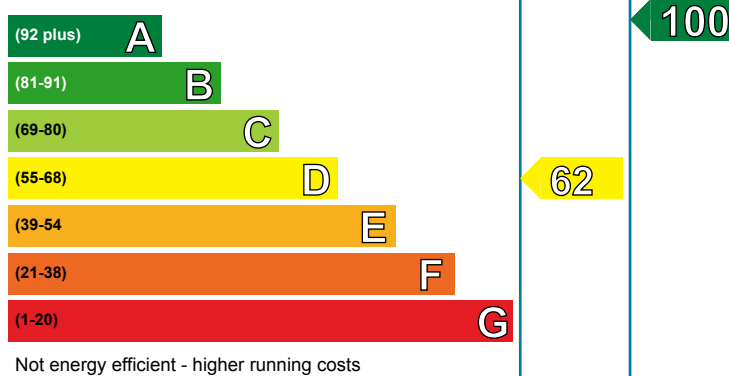
Energy Efficiency Rating

This graph shows the current efficiency of your home, taking into account both energy efficiency and fuel costs. The higher this rating, the lower your fuel bills are likely to be.

The potential rating shows the effect of undertaking all of the improvement measures listed within your recommendations report.

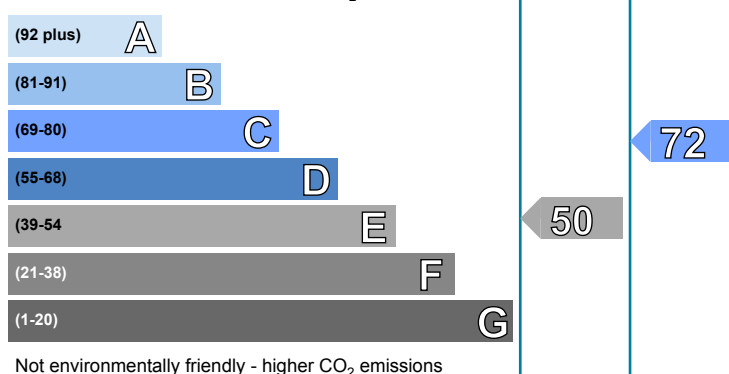
Environmental Impact (CO₂) Rating

This graph shows the effect of your home on the environment in terms of carbon dioxide (CO₂) emissions. The higher the rating, the less impact it has on the environment.
