# Home Report

Woodside  
Glenfarg  
PH2 9QJ

# single survey

Property address	Woodside Glenfarg PH2 9QJ
Customer	Mr Harris
Prepared by	Graham + Sibbald LLP

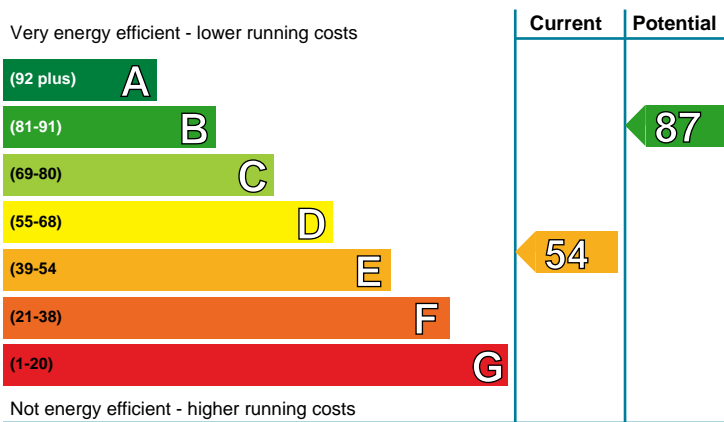
## Energy Efficiency Rating

This graph shows the current efficiency of your home, taking into account both energy efficiency and fuel costs. The higher this rating, the lower your fuel bills are likely to be.

Your current rating is **band E (54)**. The average rating for EPCs in Scotland is **band D (61)**.

The potential rating shows the effect of undertaking all of the improvement measures listed within your recommendations report.

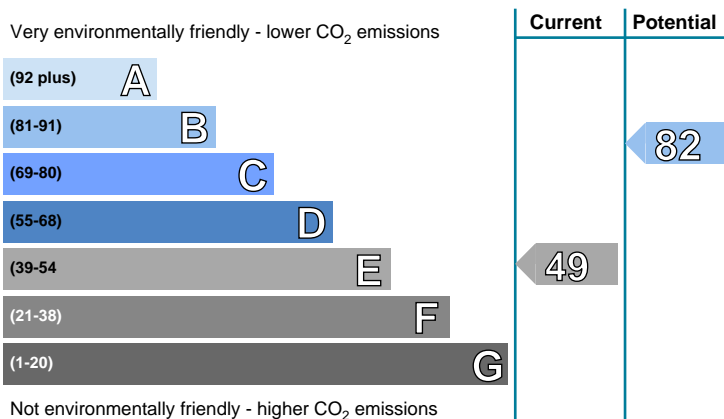
## Environmental Impact (CO<sub>2</sub>) Rating

This graph shows the effect of your home on the environment in terms of carbon dioxide (CO<sub>2</sub>) emissions. The higher the rating, the less impact it has on the environment.
