Energy Performance Certificate (EPC)

Scotland

Dwellings

TEMORA, 410 NORTH DEESIDE ROAD, CULTS, ABERDEEN, AB15 9TD

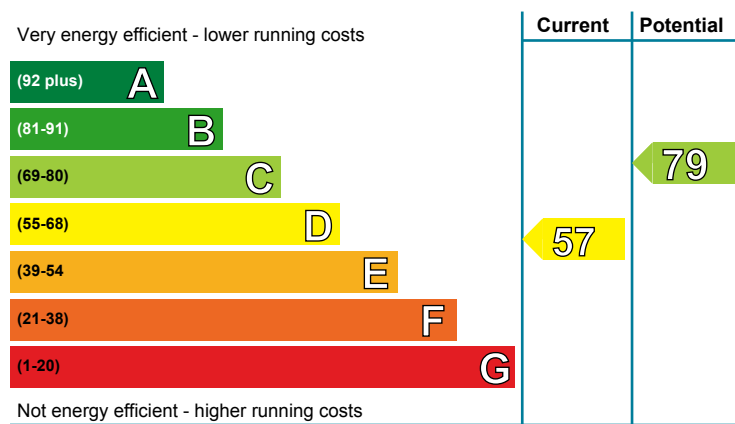
Energy Efficiency Rating

This graph shows the current efficiency of your home, taking into account both energy efficiency and fuel costs. The higher this rating, the lower your fuel bills are likely to be.

Your current rating is **band D (57)**. The average rating for EPCs in Scotland is **band D (61)**.

The potential rating shows the effect of undertaking all of the improvement measures listed within your recommendations report.

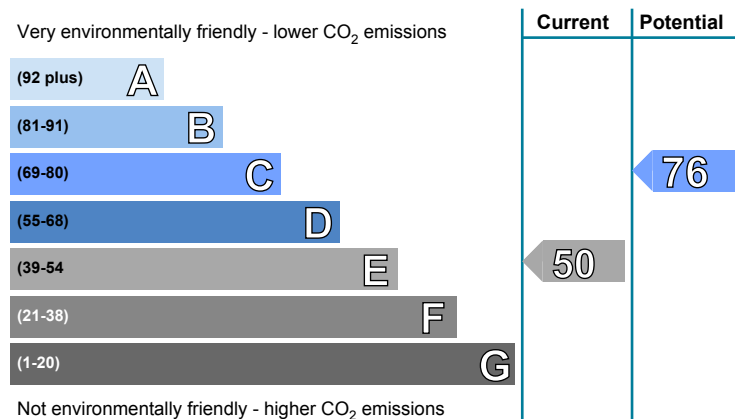
Environmental Impact (CO₂) Rating

This graph shows the effect of your home on the environment in terms of carbon dioxide (CO₂) emissions. The higher the rating, the less impact it has on the environment.

Your current rating is **band E (50)**. The average rating for EPCs in Scotland is **band D (59)**.

The potential rating shows the effect of undertaking all of the improvement measures listed within your recommendations report.
