HOME REPORT

CAMBUSMORE LODGE

DORNOCH
IV25 3JD

Energy Performance Certificate (EPC)

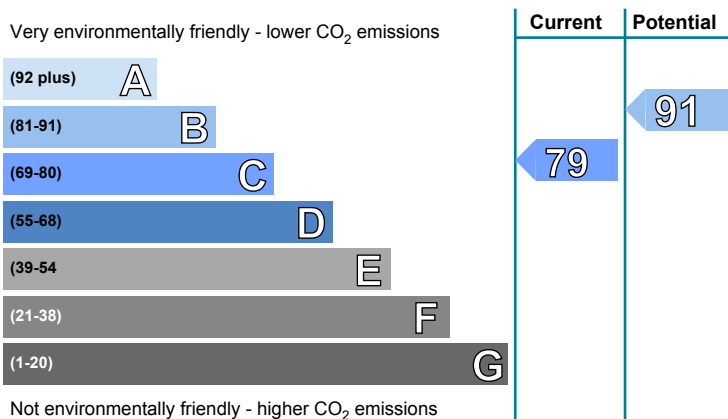
Environmental Impact (CO₂) Rating

This graph shows the effect of your home on the environment in terms of carbon dioxide (CO₂) emissions. The higher the rating, the less impact it has on the environment.

Your current rating is **band C (79)**. The average rating for EPCs in Scotland is **band D (59)**.

The potential rating shows the effect of undertaking all of the improvement measures listed within your recommendations report.
