**Walker Fraser Steele**  
**Chartered Surveyors**

HIGHFIELD  
19 ABBOTSHALL ROAD  
ABERDEEN  
AB15 9JX

# Energy Performance Certificate (EPC)

HIGHFIELD, 19 ABBOTSHALL ROAD, ABERDEEN, AB15 9JX

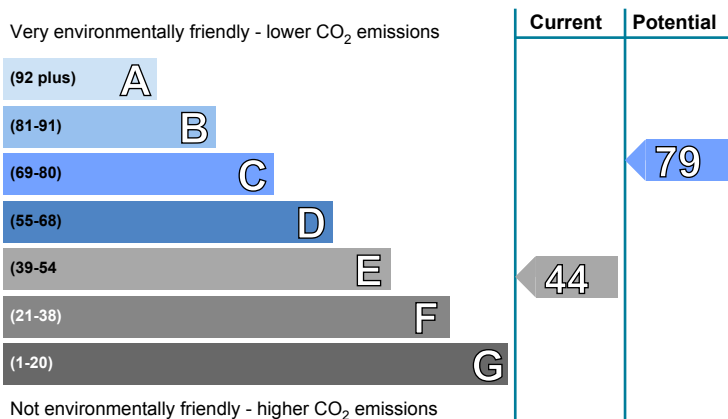
## Environmental Impact (CO<sub>2</sub>) Rating

This graph shows the effect of your home on the environment in terms of carbon dioxide (CO<sub>2</sub>) emissions. The higher the rating, the less impact it has on the environment.

Your current rating is **band E (44)**. The average rating for EPCs in Scotland is **band D (59)**.

The potential rating shows the effect of undertaking all of the improvement measures listed within your recommendations report.
