# Home Report

# Scottish Single Survey

Property address	Southfield Kelso TD5 8JW TD5 8JW
Customer	Mr Andrew Carter & Mrs Anna Carter
Customer address	Southfield Kelso TD5 8JW TD5 8JW
Prepared by	Shepherd Chartered Surveyors
Date of inspection	14/04/2025

# Energy Performance Certificate

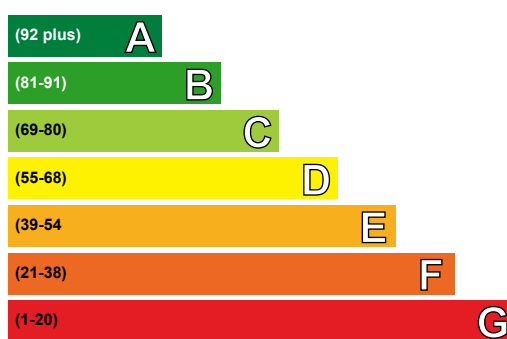
## Energy Efficiency Rating

Very energy efficient - lower running costs

Current	Potential
	99
68

The potential rating shows the effect of undertaking all of the improvement measures listed within your recommendations report.

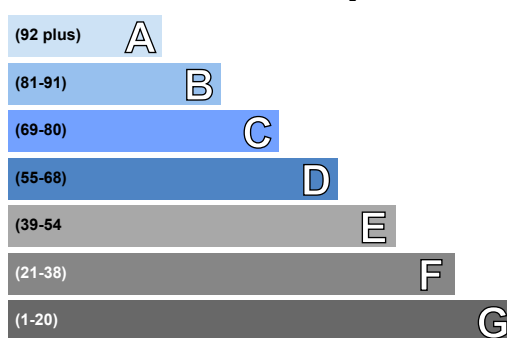
## Environmental Impact (CO<sub>2</sub>) Rating

Very environmentally friendly - lower CO<sub>2</sub> emissions

Current	Potential
	97
67
