# Home Report

# Single Survey

## Survey Report on:

<b>Property Address</b>	Killochries Fold, Kilmacolm, Renfrewshire, PA13 4TE
<b>Reference</b>	1327456
<b>Customer Name</b>	Iain & Sheena Graham
<b>Date of Inspection</b>	25th November 2025
<b>Surveyor's name, qualifications and office</b>	David Cree BSc, MRICS DM Hall LLP Chartered Surveyors 3 Centura Court, Hillington Park Glasgow G52 4PR  Tel: 0141 636 4141  email: glasgowresidential@dmhall.co.uk
<b>Prepared By</b>	DM Hall LLP

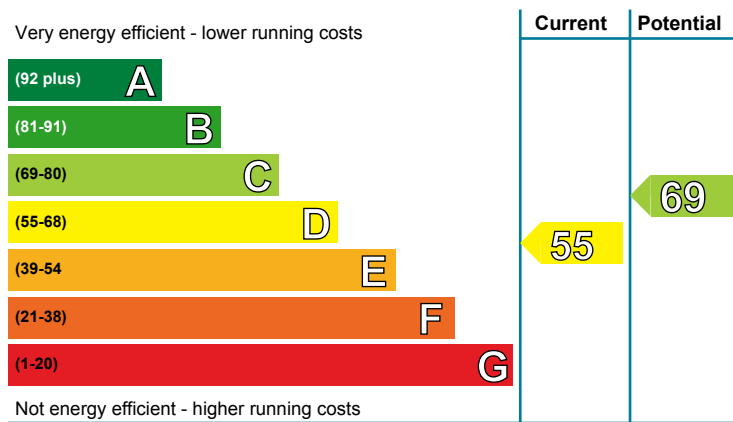
## Energy Efficiency Rating

This graph shows the current efficiency of your home, taking into account both energy efficiency and fuel costs. The higher this rating, the lower your fuel bills are likely to be.

Your current rating is **band D (55)**. The average rating for EPCs in Scotland is **band D (61)**.

The potential rating shows the effect of undertaking all of the improvement measures listed within your recommendations report.

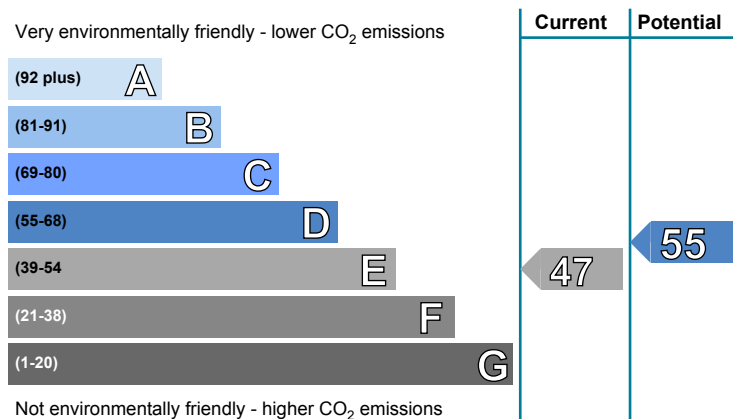
## Environmental Impact (CO<sub>2</sub>) Rating

This graph shows the effect of your home on the environment in terms of carbon dioxide (CO<sub>2</sub>) emissions. The higher the rating, the less impact it has on the environment.
