Home Report

Easter Skene House

single survey

Property address	Easter Skene House . Skene Westhill AB32 6YB
Customer	The Hon C A Pearson
Prepared by	Graham + Sibbald LLP

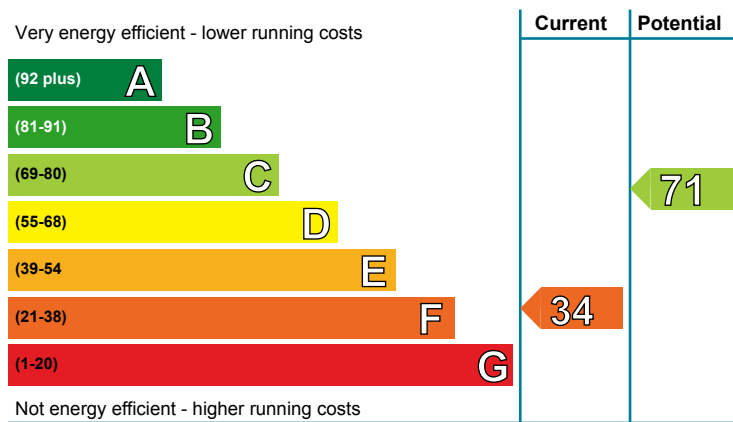
Energy Efficiency Rating

This graph shows the current efficiency of your home, taking into account both energy efficiency and fuel costs. The higher this rating, the lower your fuel bills are likely to be.

Your current rating is **band F (34)**. The average rating for EPCs in Scotland is **band D (61)**.

The potential rating shows the effect of undertaking all of the improvement measures listed within your recommendations report.

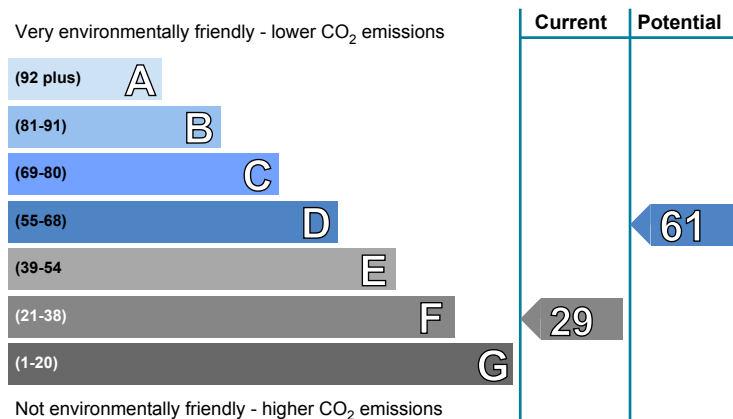
Environmental Impact (CO₂) Rating

This graph shows the effect of your home on the environment in terms of carbon dioxide (CO₂) emissions. The higher the rating, the less impact it has on the environment.
