# Home Report

# Energy Performance Certificate

## SUNFIELD COTTAGE, INCHMARLO, BANCHORY, AB31 4AT

**Dwelling type:** Detached house  
**Date of assessment:** 06 October 2023  
**Date of certificate:** 10 October 2023  
**Total floor area:** 221 m<sup>2</sup>  
**Primary Energy Indicator:** 292 kWh/m<sup>2</sup>/year

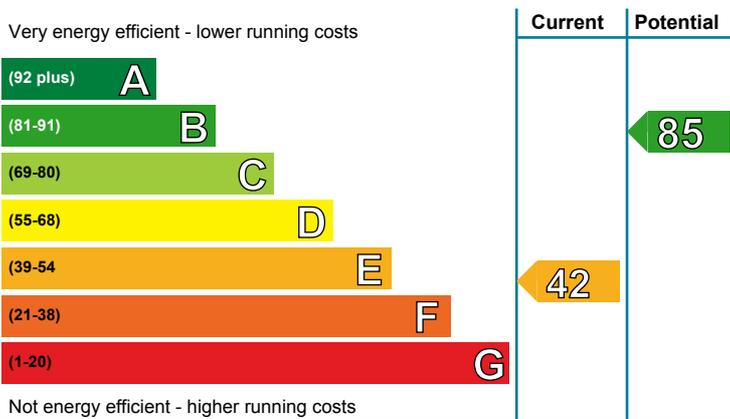
### Energy Efficiency Rating

This graph shows the current efficiency of your home, taking into account both energy efficiency and fuel costs. The higher this rating, the lower your fuel bills are likely to be.

Your current rating is **band E (42)**. The average rating for EPCs in Scotland is **band D (61)**.

The potential rating shows the effect of undertaking all of the improvement measures listed within your recommendations report.

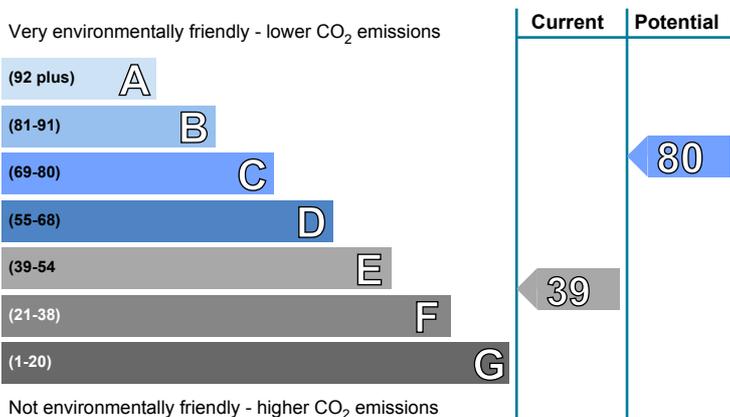
### Environmental Impact (CO<sub>2</sub>) Rating

This graph shows the effect of your home on the environment in terms of carbon dioxide (CO<sub>2</sub>) emissions. The higher the rating, the less impact it has on the environment.

Your current rating is **band E (39)**. The average rating for EPCs in Scotland is **band D (59)**.

The potential rating shows the effect of undertaking all of the improvement measures listed within your recommendations report.
