Energy Performance Certificate (EPC)

KNAPS, NEWMACHAR, ABERDEEN, AB21 0QJ

Single Survey

Property Address	Knaps, Newmachar, Aberdeen. AB21 0QJ
Customer	Mr and Mrs Harvie
Date of Inspection	17/09/2025
Prepared by	Ryan Stewart Walker Fraser Steele

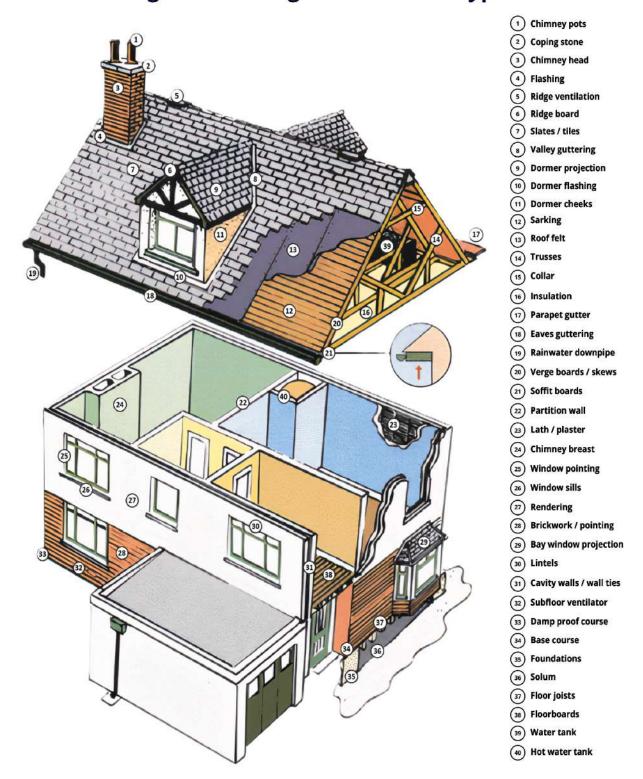
Sectional Diagram showing elements of a typical house

Reference may be made in this report to some or all of the above component parts of the property. This diagram may assist you in locating and understanding these items.
