YOUR ONESURVEY  
**HOME REPORT**

Sound View  
3 Ferrindonald  
Teangue, Isle of Skye  
IV44 8RF

# SINGLE SURVEY

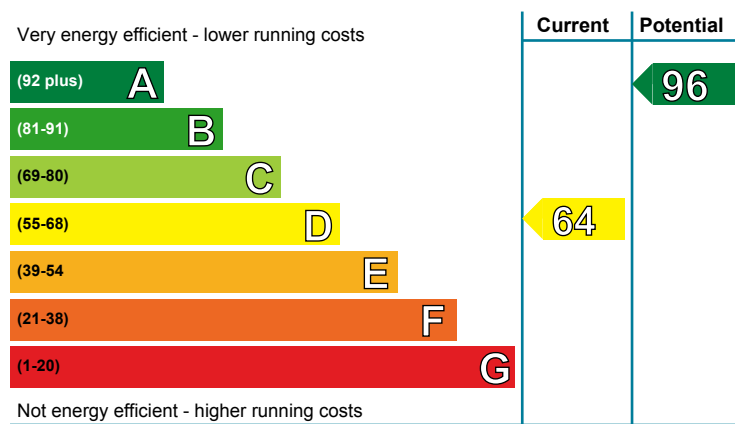
## Energy Efficiency Rating

This graph shows the current efficiency of your home, taking into account both energy efficiency and fuel costs. The higher this rating, the lower your fuel bills are likely to be.

Your current rating is **band D (64)**. The average rating for EPCs in Scotland is **band D (61)**.

The potential rating shows the effect of undertaking all of the improvement measures listed within your recommendations report.

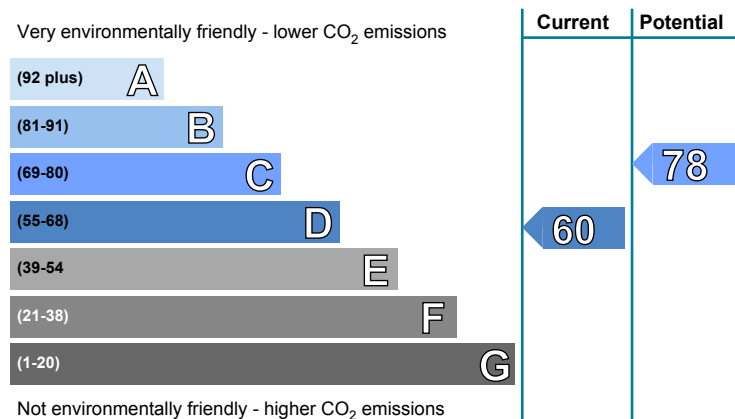
## Environmental Impact (CO<sub>2</sub>) Rating

This graph shows the effect of your home on the environment in terms of carbon dioxide (CO<sub>2</sub>) emissions. The higher the rating, the less impact it has on the environment.
