# Home Report

# Single Survey

| Property address | Newlands Farm<br>Grayshill<br>Cumbernauld<br>Glasgow<br>G68 9BA |
| Prepared by | Shepherd Chartered Surveyors |

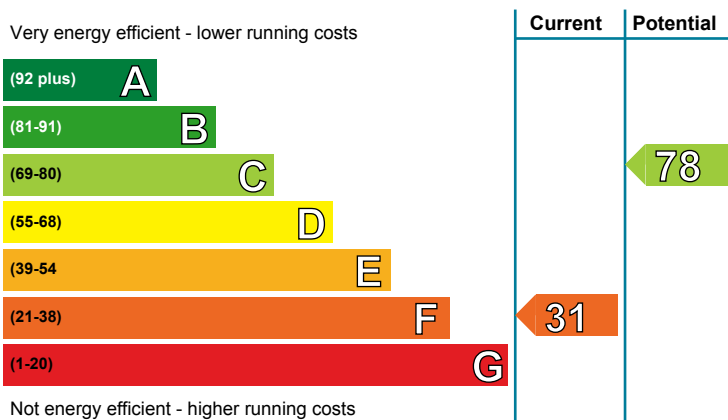
## Energy Efficiency Rating

This graph shows the current efficiency of your home, taking into account both energy efficiency and fuel costs. The higher this rating, the lower your fuel bills are likely to be.

Your current rating is **band F (31)**. The average rating for EPCs in Scotland is **band D (61)**.

The potential rating shows the effect of undertaking all of the improvement measures listed within your recommendations report.
