HOME REPORT

7 Ariundle Scotstown Strontian PH36 4JB

SINGLE SURVEY

Property address	7 Ariundle, Scotstown, Strontian, PH36 4JB
Customer	Ms Johanna Gunnell
Customer address	
Prepared by	DM Hall LLP
Date of inspection	19th March 2024

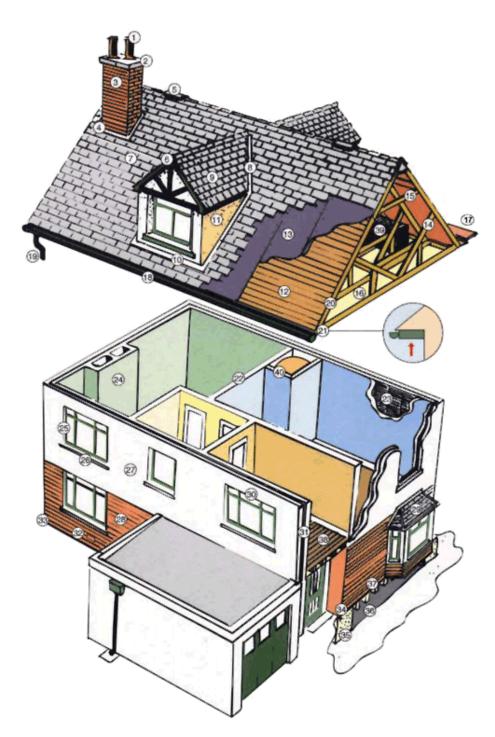
Sectional Diagram showing elements of a typical house

Reference may be made in this report to some or all of the above component parts of the property. This diagram may assist you in locating and understanding these items.

- 1) Chimney pots
- 2) Coping stone
- 3) Chimney head
- 4 Flashing
- 5 Ridge ventilation
- 6 Ridge board
- 7) Slates / tiles
- 8 Valley guttering
- 9 Dormer projection
- 10) Dormer flashing
- 11) Dormer cheeks
- 12) Sarking
- (13) Roof felt
- (14) Trusses
- (15) Collar
- (16) Insulation
- 17) Parapet gutter
- (18) Eaves guttering
- 19) Rainwater downpipe
- 20) Verge boards/skews
- 21) Soffit boards
- 22) Partition wall
- 23) Lath / plaster
- 24) Chimney breast
- (25) Window pointing
- 6) Window sills
- 27) Rendering
- 28) Brickwork / pointing
- 29) Bay window projection
- 30 Lintels
- (31) Cavity walls / wall ties
- 32) Subfloor ventilator
- 33) Damp proof course
- 34) Base course
- (35) Foundations
- 36) Solum
- 37) Floor joists
- 38) Floorboards
- 39) Water tank
- 40 Hot water tank
