Home Report

Scottish Single Survey

Property address	West Wing Carzield House Kirkmahoe Dumfries DG1 1SY
Customer	Mr & Mrs W Colquhoun
Customer address	West Wing Carzield House Kirkmahoe Dumfries DG1 1SY
Prepared by	Shepherd Chartered Surveyors
Date of inspection	05/05/2026

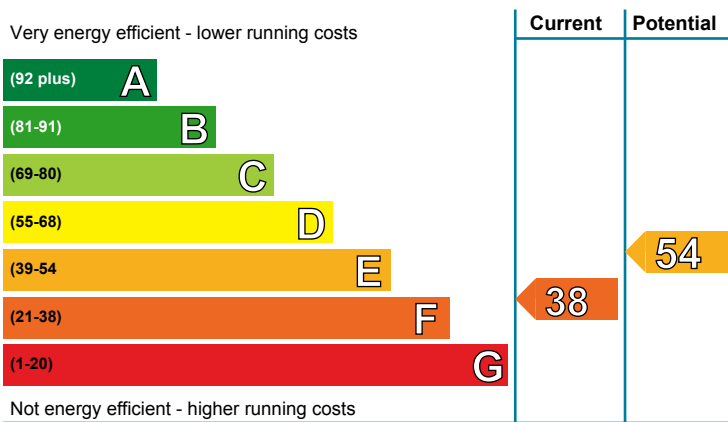
Energy Efficiency Rating

This graph shows the current efficiency of your home, taking into account both energy efficiency and fuel costs. The higher this rating, the lower your fuel bills are likely to be.

Your current rating is **band F (38)**. The average rating for EPCs in Scotland is **band D (61)**.

The potential rating shows the effect of undertaking all of the improvement measures listed within your recommendations report.

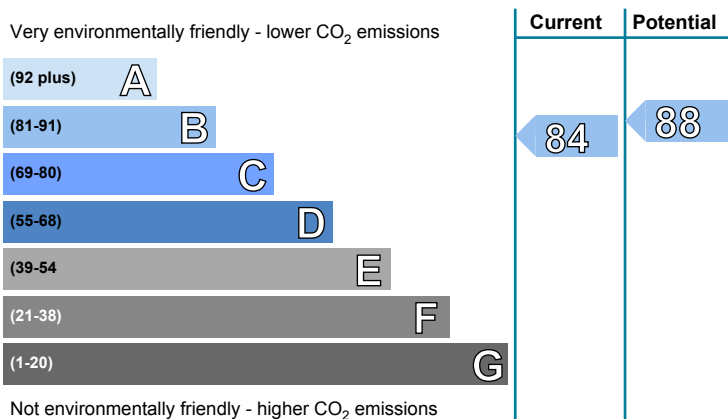
Environmental Impact (CO₂) Rating

This graph shows the effect of your home on the environment in terms of carbon dioxide (CO₂) emissions. The higher the rating, the less impact it has on the environment.
