Inchstelly Farmhouse,
Alves,
Elgin,
IV30 8UY

Home Report

Single Survey

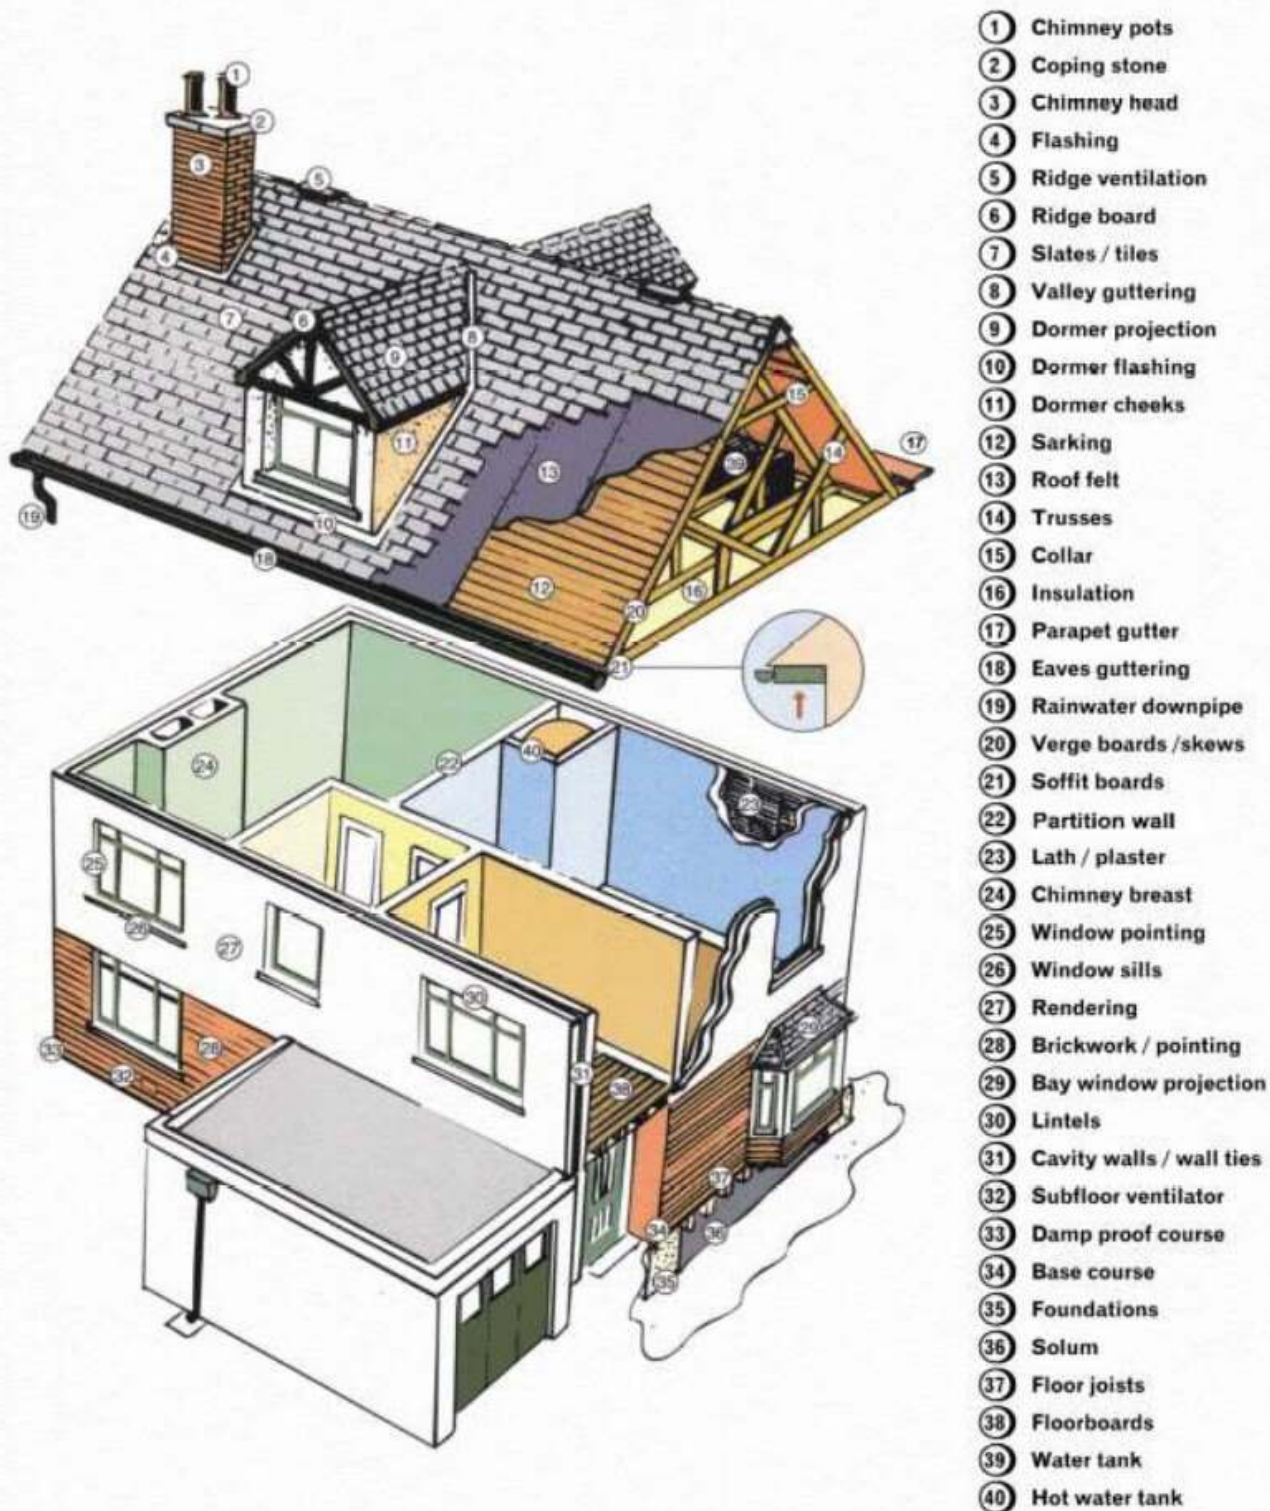
Sectional Diagram showing elements of a typical house

Reference may be made in this report to some or all of the above component parts of the property. This diagram may assist you in locating and understanding these items.
