# YOUR ONESURVEY HOME REPORT

East Hillhead Farm  
Mauchline  
KA5 6HA

# SINGLE SURVEY

A report on the condition of the property, with categories  
being rated from 1 to 3.

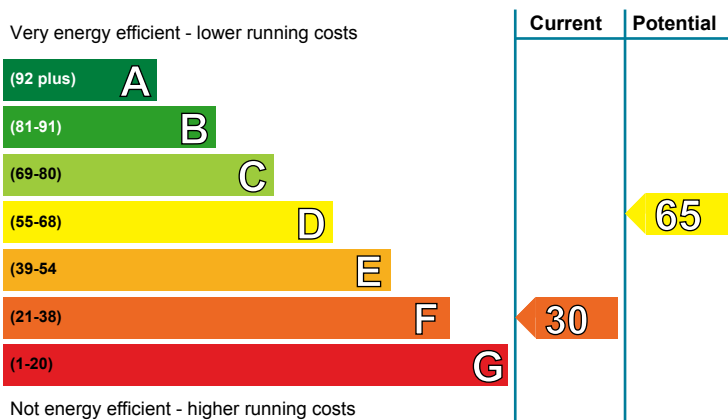
## Energy Efficiency Rating

This graph shows the current efficiency of your home, taking into account both energy efficiency and fuel costs. The higher this rating, the lower your fuel bills are likely to be.

Your current rating is **band F (30)**. The average rating for EPCs in Scotland is **band D (61)**.

The potential rating shows the effect of undertaking all of the improvement measures listed within your recommendations report.
