YOUR ONESURVEY
HOME REPORT

10 Broomlands Court
Kelso
TD5 7SR

HOME REPORT

SINGLE SURVEY

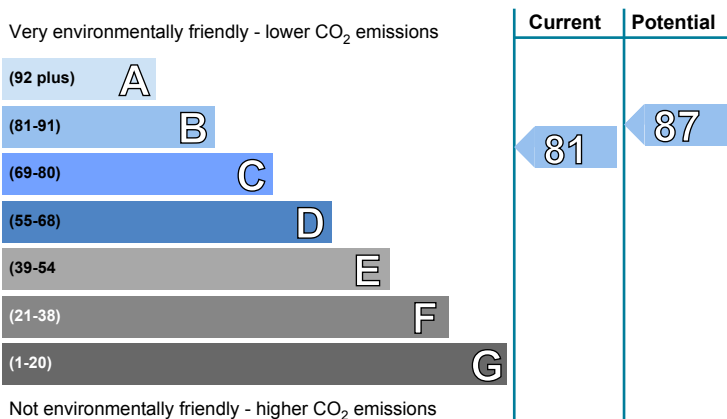
Environmental Impact (CO₂) Rating

This graph shows the effect of your home on the environment in terms of carbon dioxide (CO₂) emissions. The higher the rating, the less impact it has on the environment.
