Home Report

Scottish Single Survey

Property address	High Williamshaw Old Glasgow Road Stewarton Kilmarnock KA3 5JR
-------------------------	--

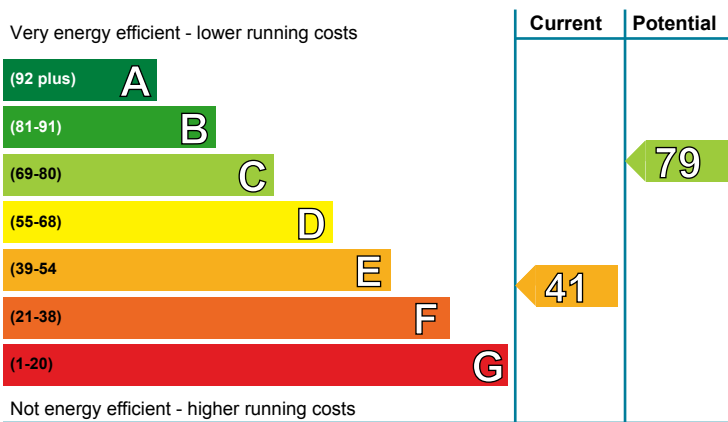
Energy Efficiency Rating

This graph shows the current efficiency of your home, taking into account both energy efficiency and fuel costs. The higher this rating, the lower your fuel bills are likely to be.

Your current rating is **band E (41)**. The average rating for EPCs in Scotland is **band D (61)**.

The potential rating shows the effect of undertaking all of the improvement measures listed within your recommendations report.

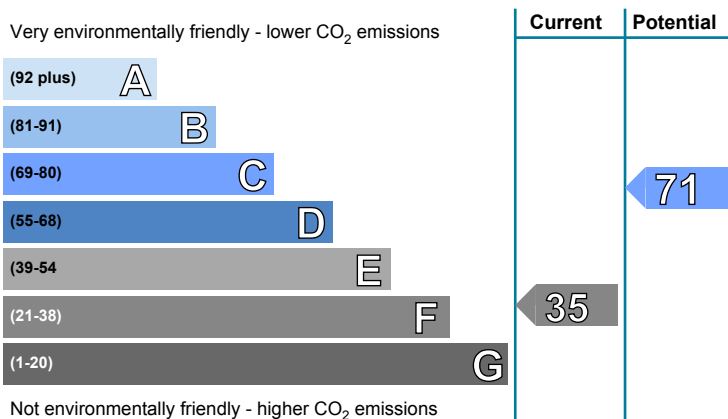
Environmental Impact (CO₂) Rating

This graph shows the effect of your home on the environment in terms of carbon dioxide (CO₂) emissions. The higher the rating, the less impact it has on the environment.
