# Home Report

# Scottish Single Survey

survey report on:

| Property address | 1 Holding<br>Mainholm<br>Ayr<br>KA6 5HD |

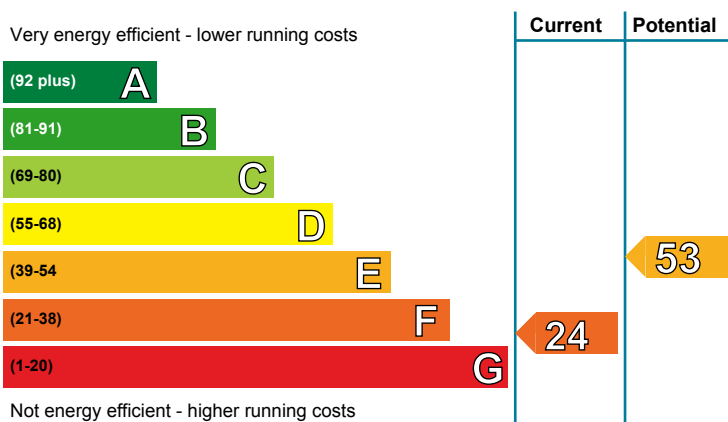
## Energy Efficiency Rating

This graph shows the current efficiency of your home, taking into account both energy efficiency and fuel costs. The higher this rating, the lower your fuel bills are likely to be.

Your current rating is **band F (24)**. The average rating for EPCs in Scotland is **band D (61)**.

The potential rating shows the effect of undertaking all of the improvement measures listed within your recommendations report.

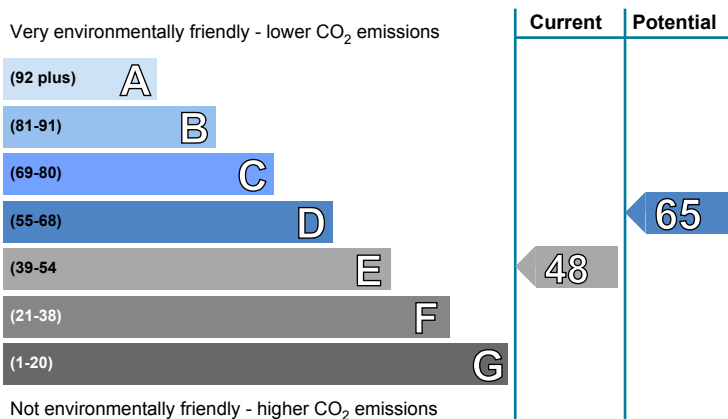
## Environmental Impact (CO<sub>2</sub>) Rating

This graph shows the effect of your home on the environment in terms of carbon dioxide (CO<sub>2</sub>) emissions. The higher the rating, the less impact it has on the environment.
