Home Report

Scottish Single Survey

Property address	Balide Maybole KA19 7QE
-------------------------	-------------------------------

Prepared by	Shepherd Chartered Surveyors
--------------------	------------------------------

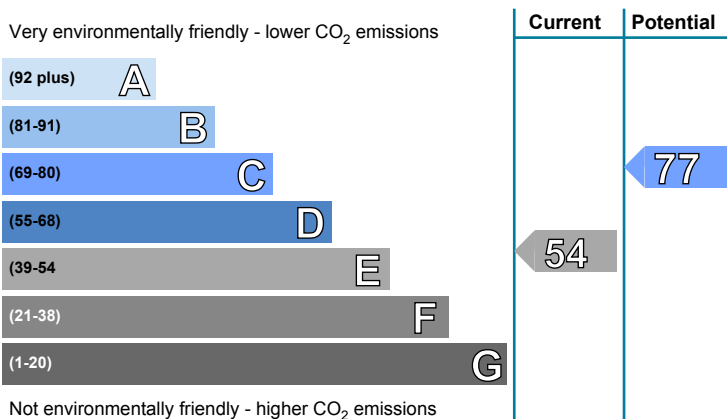
Environmental Impact (CO₂) Rating

This graph shows the effect of your home on the environment in terms of carbon dioxide (CO₂) emissions. The higher the rating, the less impact it has on the environment.
