# Home Report

East Craigieloch, Lintrathen  
Kirriemuir DD8 5JJ

# Single Survey

## Survey report on:

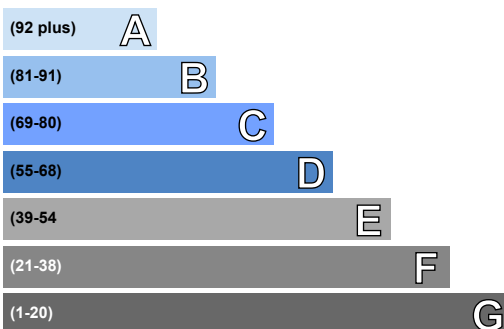
The potential rating shows the effect of undertaking all of the improvement measures listed within your recommendations report.

Very environmentally friendly - lower CO<sub>2</sub> emissions

Not environmentally friendly - higher CO<sub>2</sub> emissions

| Current | Potential |
