Home Report

Tigh-An-Dalloch Rosemill Road
Bridgefoot Dundee DD3 0RW

Single Survey

Property Address	Tigh-An-Dalloch Rosemill Road Bridgefoot Dundee DD3 0RW
Customer	Stella Dailly
Prepared by	Graham + Sibbald Property Consultants Limited
Date of Inspection	17/10/2025

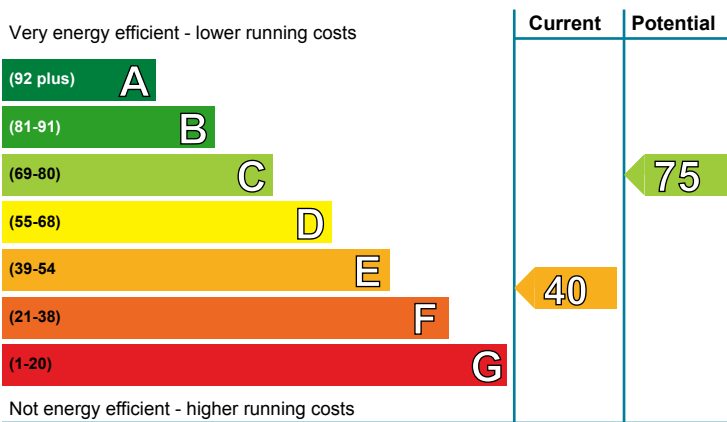
Energy Efficiency Rating

This graph shows the current efficiency of your home, taking into account both energy efficiency and fuel costs. The higher this rating, the lower your fuel bills are likely to be.

Your current rating is **band E (40)**. The average rating for EPCs in Scotland is **band D (61)**.

The potential rating shows the effect of undertaking all of the improvement measures listed within your recommendations report.
