# Home Report

# Single Survey

<b>Property address</b>	Holme Farm Lentran Inverness IV3 8RN
<b>Customer</b>	The Executors of the Late David Skene
<b>Customer address</b>	Holme Farm Lentran Inverness IV3 8RN
<b>Prepared by</b>	Shepherd Chartered Surveyors
<b>Date of inspection</b>	01/04/2026

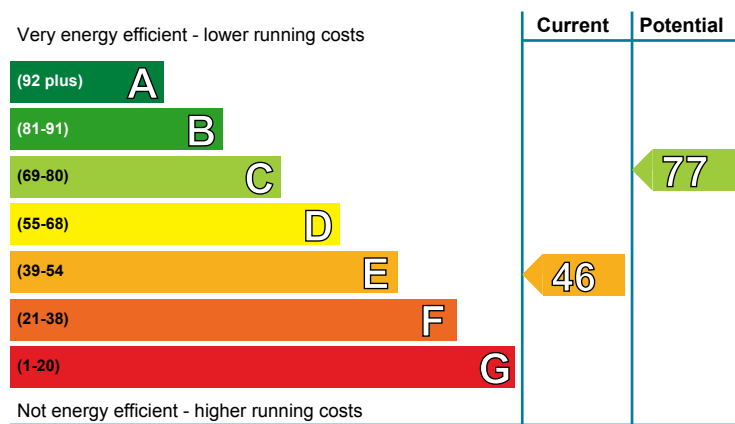
## Energy Efficiency Rating

This graph shows the current efficiency of your home, taking into account both energy efficiency and fuel costs. The higher this rating, the lower your fuel bills are likely to be.

Your current rating is **band E (46)**. The average rating for EPCs in Scotland is **band D (61)**.

The potential rating shows the effect of undertaking all of the improvement measures listed within your recommendations report.

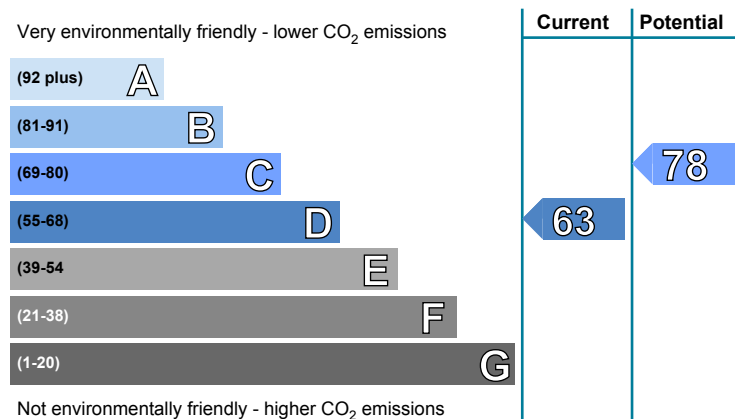
## Environmental Impact (CO<sub>2</sub>) Rating

This graph shows the effect of your home on the environment in terms of carbon dioxide (CO<sub>2</sub>) emissions. The higher the rating, the less impact it has on the environment.
