HOME REPORT

33 Kirkland Street
Dalry, Castle Douglas
DG7 3UX

SINGLE SURVEY

Executive Of	Mrs. Alice Ferguson
Selling address	33 Kirkland Street Dalry, Castle Douglas DG7 3UX
Date of Inspection	10/11/2025
Prepared by	John Kemptsell, BSc (Hons) MRICS Dumfries - Allied Surveyors Scotland Ltd

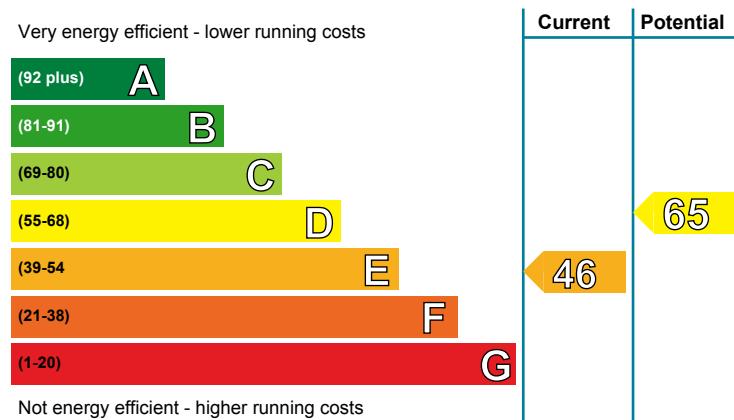
Energy Efficiency Rating

This graph shows the current efficiency of your home, taking into account both energy efficiency and fuel costs. The higher this rating, the lower your fuel bills are likely to be.

Your current rating is **band E (46)**. The average rating for EPCs in Scotland is **band D (61)**.

The potential rating shows the effect of undertaking all of the improvement measures listed within your recommendations report.

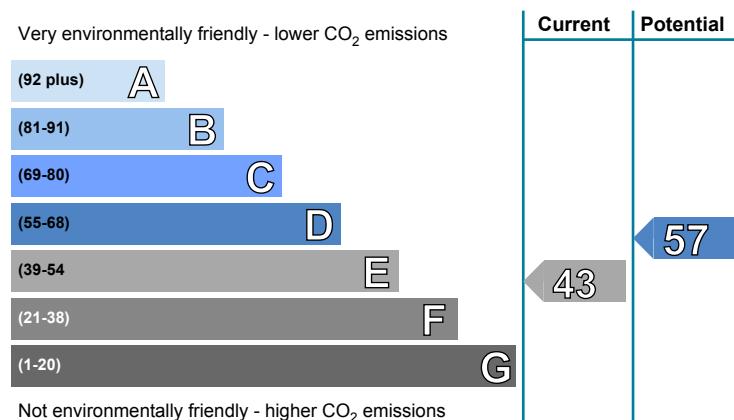
Environmental Impact (CO₂) Rating

This graph shows the effect of your home on the environment in terms of carbon dioxide (CO₂) emissions. The higher the rating, the less impact it has on the environment.
