# Home Report

# Scottish Single Survey

<b>Property address</b>	Sandrum Thornhill DG3 5EW
<b>Customer</b>	Diane Fung & Others
<b>Customer address</b>	Sandrum Thornhill DG3 5EW
<b>Prepared by</b>	Shepherd Chartered Surveyors
<b>Date of inspection</b>	06/03/2024

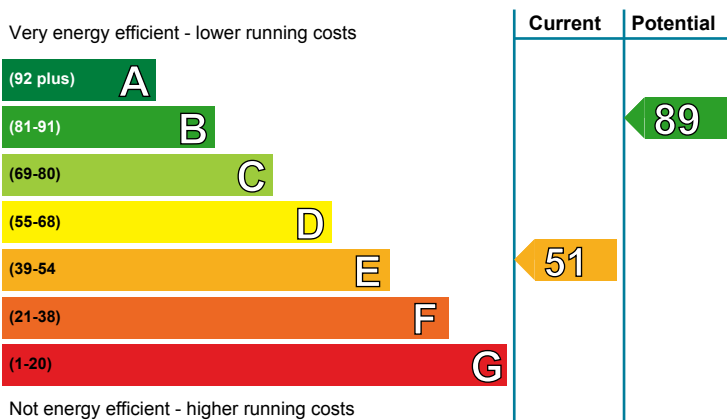
## Energy Efficiency Rating

This graph shows the current efficiency of your home, taking into account both energy efficiency and fuel costs. The higher this rating, the lower your fuel bills are likely to be.

Your current rating is **band E (51)**. The average rating for EPCs in Scotland is **band D (61)**.

The potential rating shows the effect of undertaking all of the improvement measures listed within your recommendations report.
